Software Bugs or Features - Troubleshooting the Black Box: Part 1

Tom Oshiro, Ph.D., DABR
Associate Professor – Radiological Sciences
UCLA David Geffen School of Medicine

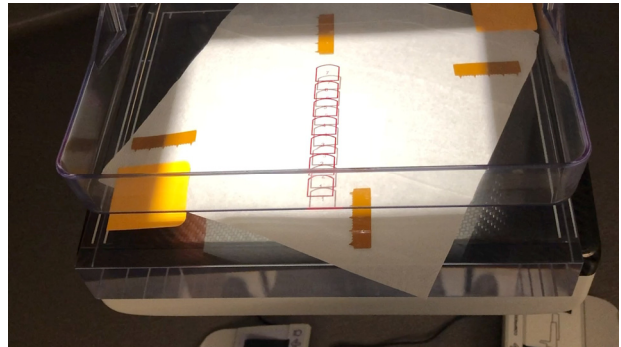
X-ray to light field – Tomo

- Centered Gafchromic strips with light field
- During acquisition, collimators opened
- After acquisition, the collimators close
- No user interaction

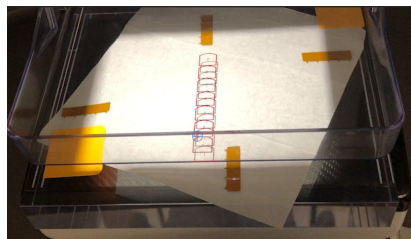
Prescribed field

Tomosynthesis mode:

- Compliance failed
 - X-ray extends beyond planned area @ left, right, anterior

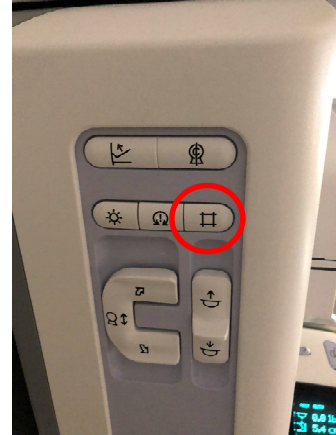
Software issue

- Programming of collimation button
- Prior models had deactivated this button (tomo)
- New version was not disabled - allowed beam restriction in tomo
 - When the field size was set smaller - the beam opened up anyway

- Escalated through the vendor
 - Showed difference in operation on systems
 - Acknowledged the 'bug' & issued a patch
- Workaround
 - Advised techs to not to push the collimation button during tomo exposures
 - Same patient dose compared to normal operation (less clinical impact)
