MR Safety: Case Review of Real MRI Safety Incidents

Joel P. Felmlee, Ph.D.

AAPM Summer Meeting 2014

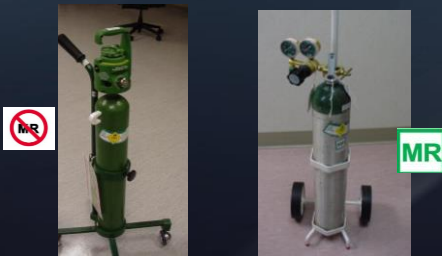
- A green oxygen tank found in zone 3 of MRI area after weekend call at busy hospital

- Ferromagnetic tank was noted in zone 3, but not removed.
- Weekend patient had brought and exchanged tank at MRI as their oxygen tank was low
 - We found that this is common practice
 - Makes ferromagnetic tank control within hospital very difficult
- Elevated issue as process problem
- Communicated to MR technologists via e-mail and “town hall” meeting
- No injuries , identified a process gap and developed a staff education plan to address issue

Deaths have occurred from ferromagnetic oxygen tanks entering zone 4. An area should be designated for storage of these devices outside of zone 3.

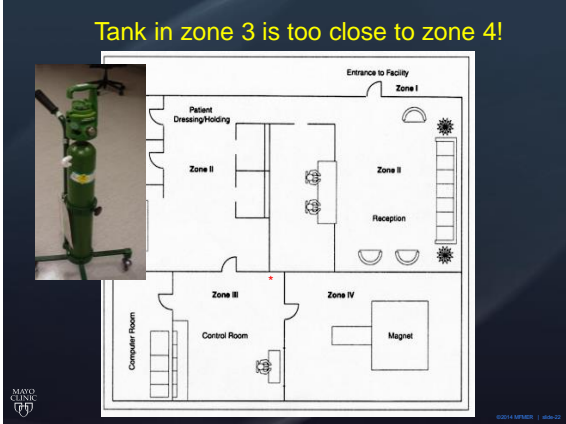
Tank in zone 3 is too close to zone 4!
