The Art of the Image: The Identification and Remediation of
Image Artifacts in Projection Radiography, part II

Alisa Walz-Flannigan, Ph.D. DABR
Mayo Clinic, Rochester, Minnesota
Walzflannigan.alisa@mayo.edu

American Association of Physicists Meeting, Indianapolis
8/7/2013

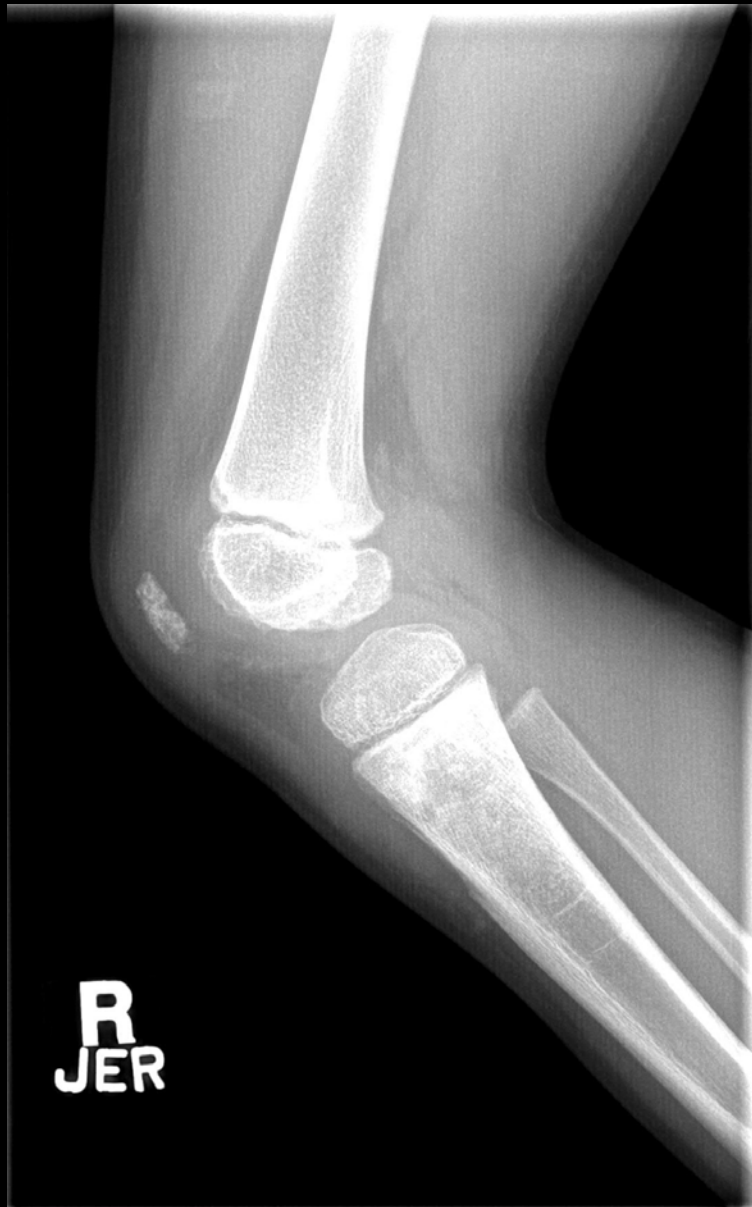
Wrong line-rate grid

Windowed to show grid-lines

Grid positioned transverse; grid removal software failed

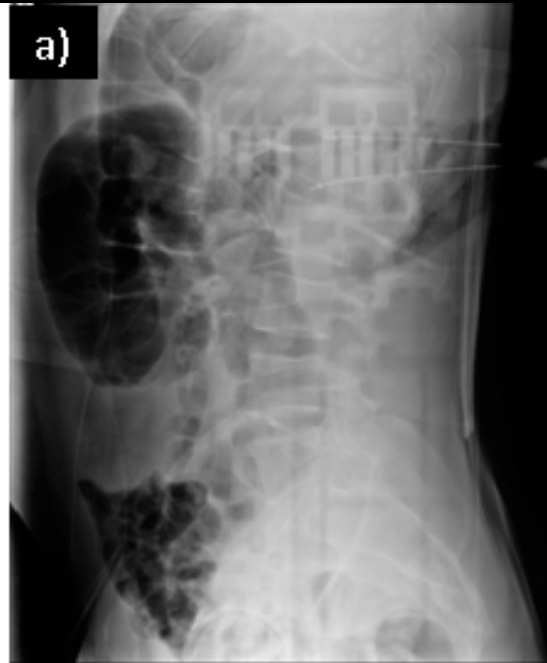
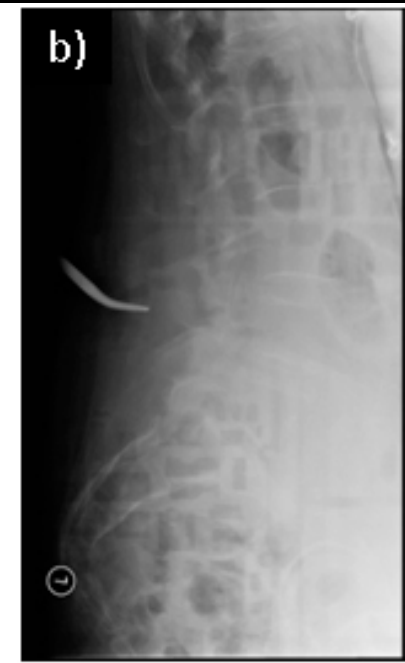
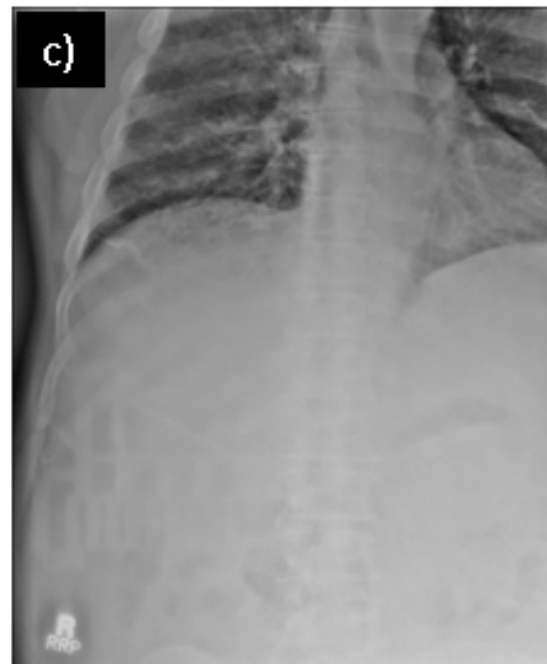
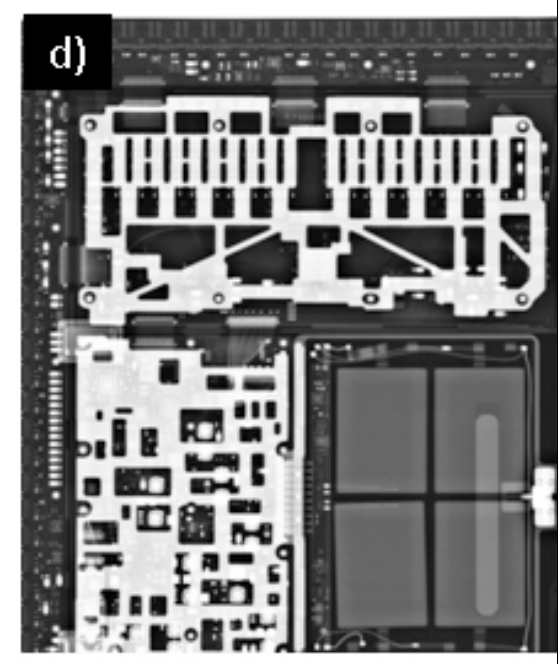
Wireless detector

- Backscatter through the back of the detector.
- Frequently seen with large patients.

Temporary fix: place lead aprons behind the detector

Longer term fix:
More shielding attached to the back of the detector ; provided by vendor.

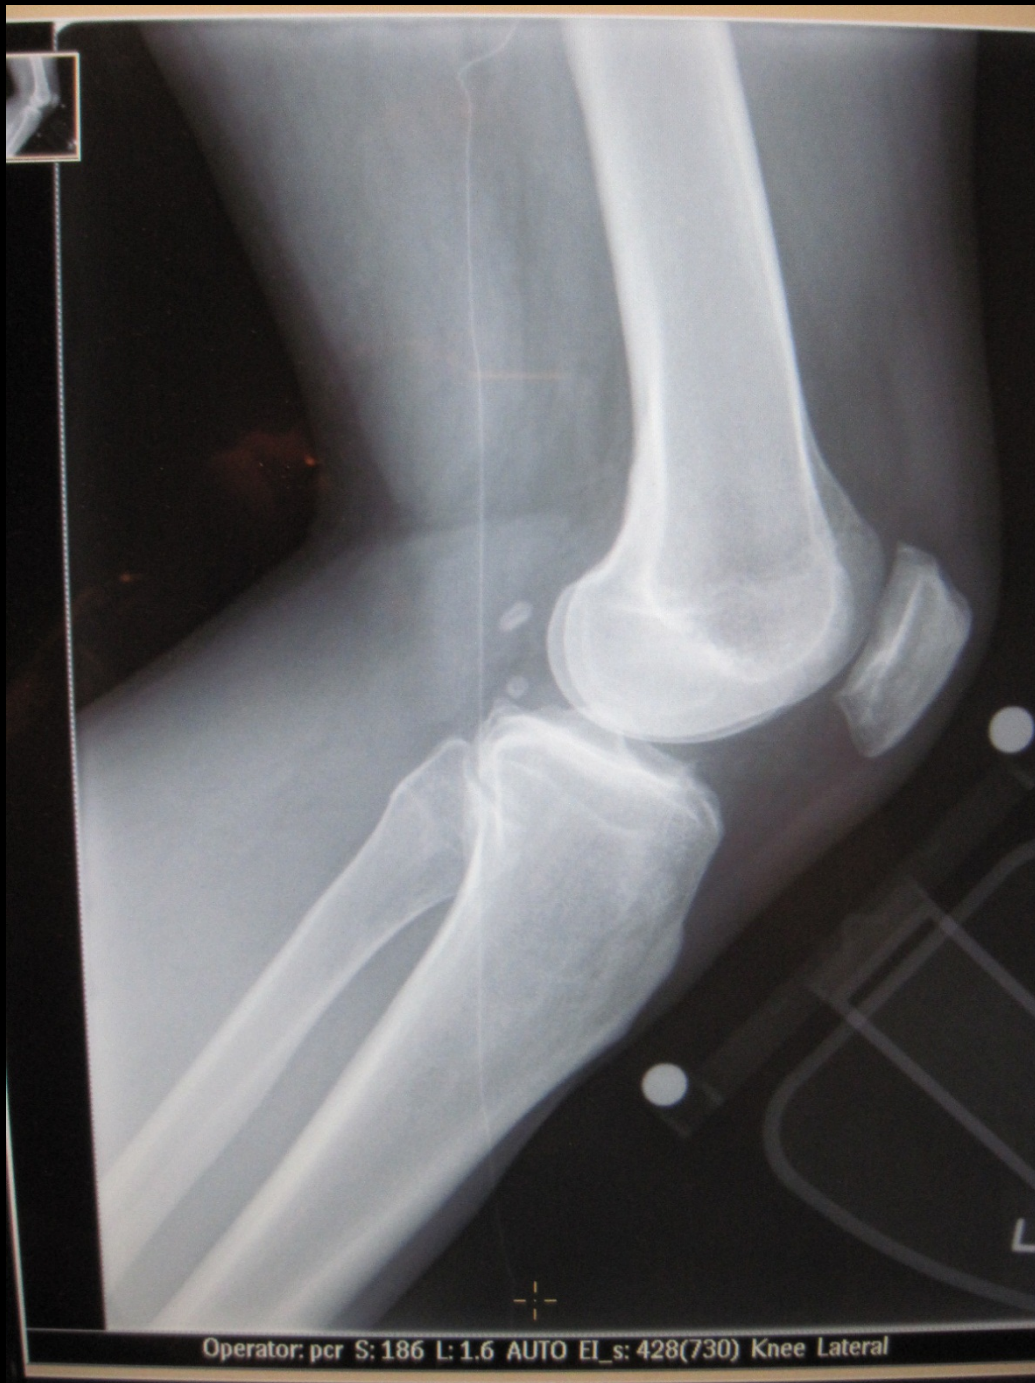
Dirt and dust
in the reader.

Resolved
itself.

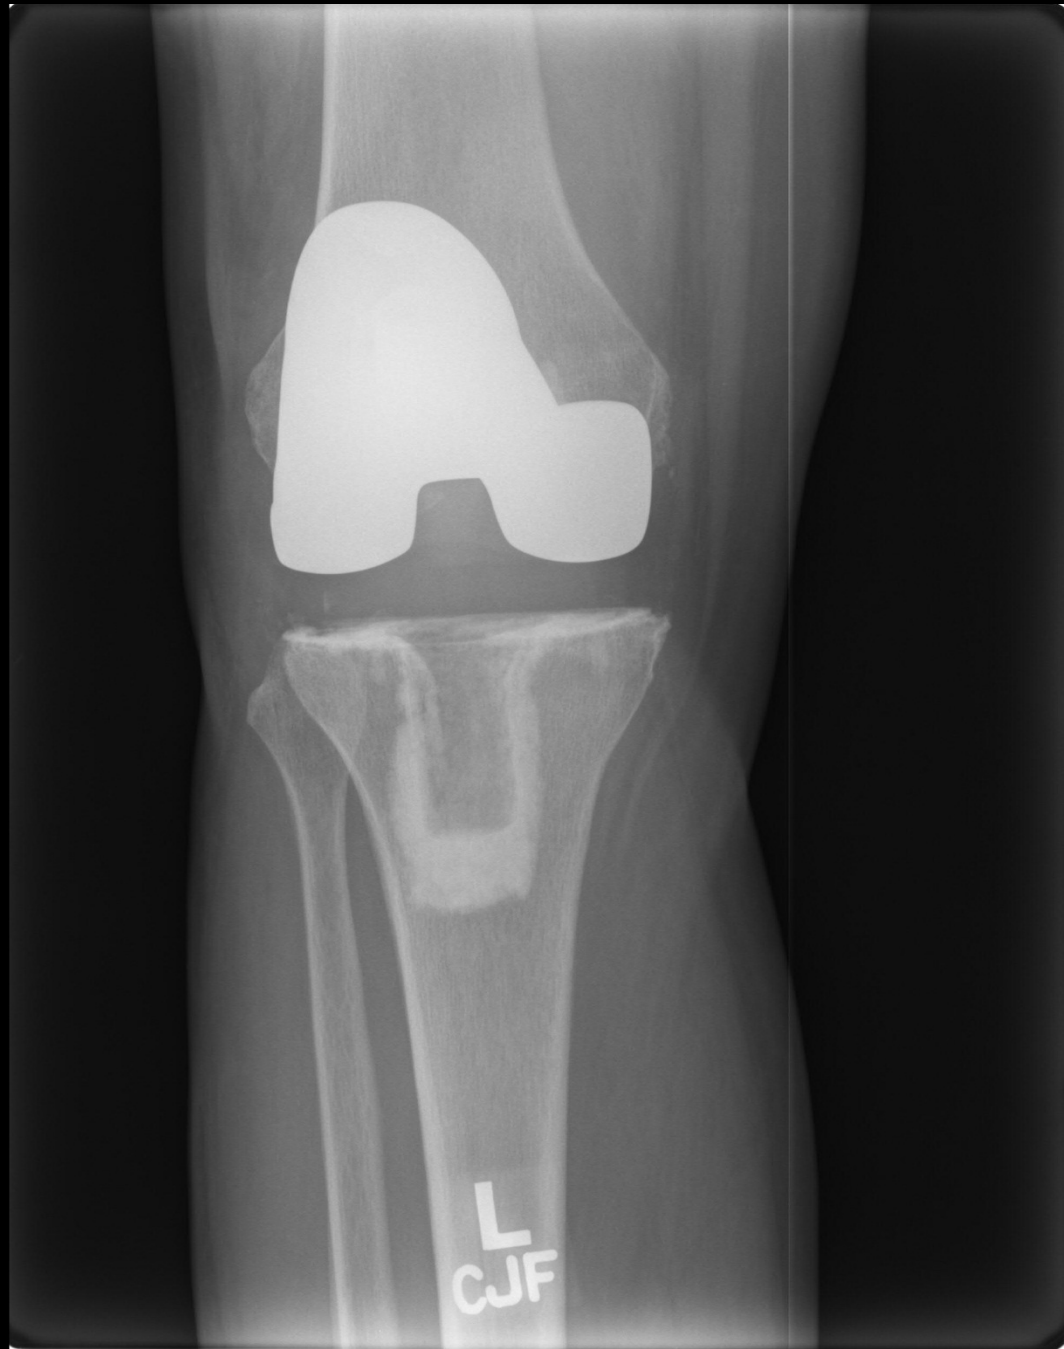
Dirt and dust
in the reader.

Reader
cleaned.

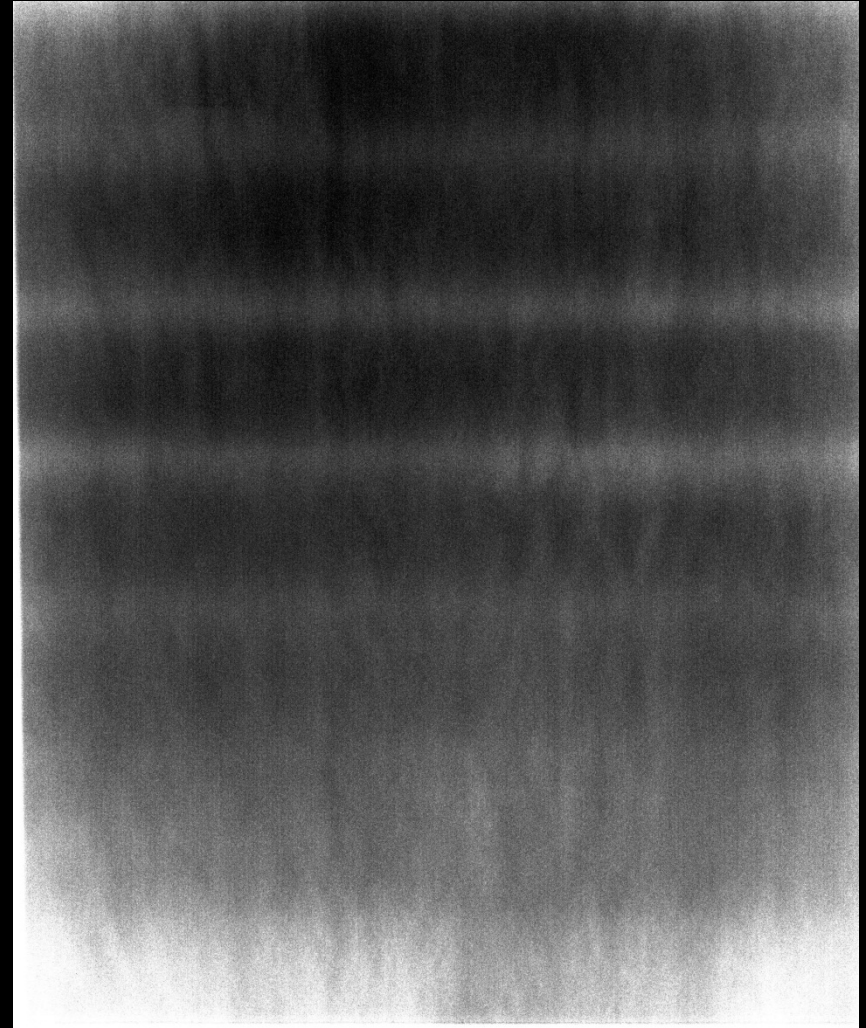
Phosphor wear

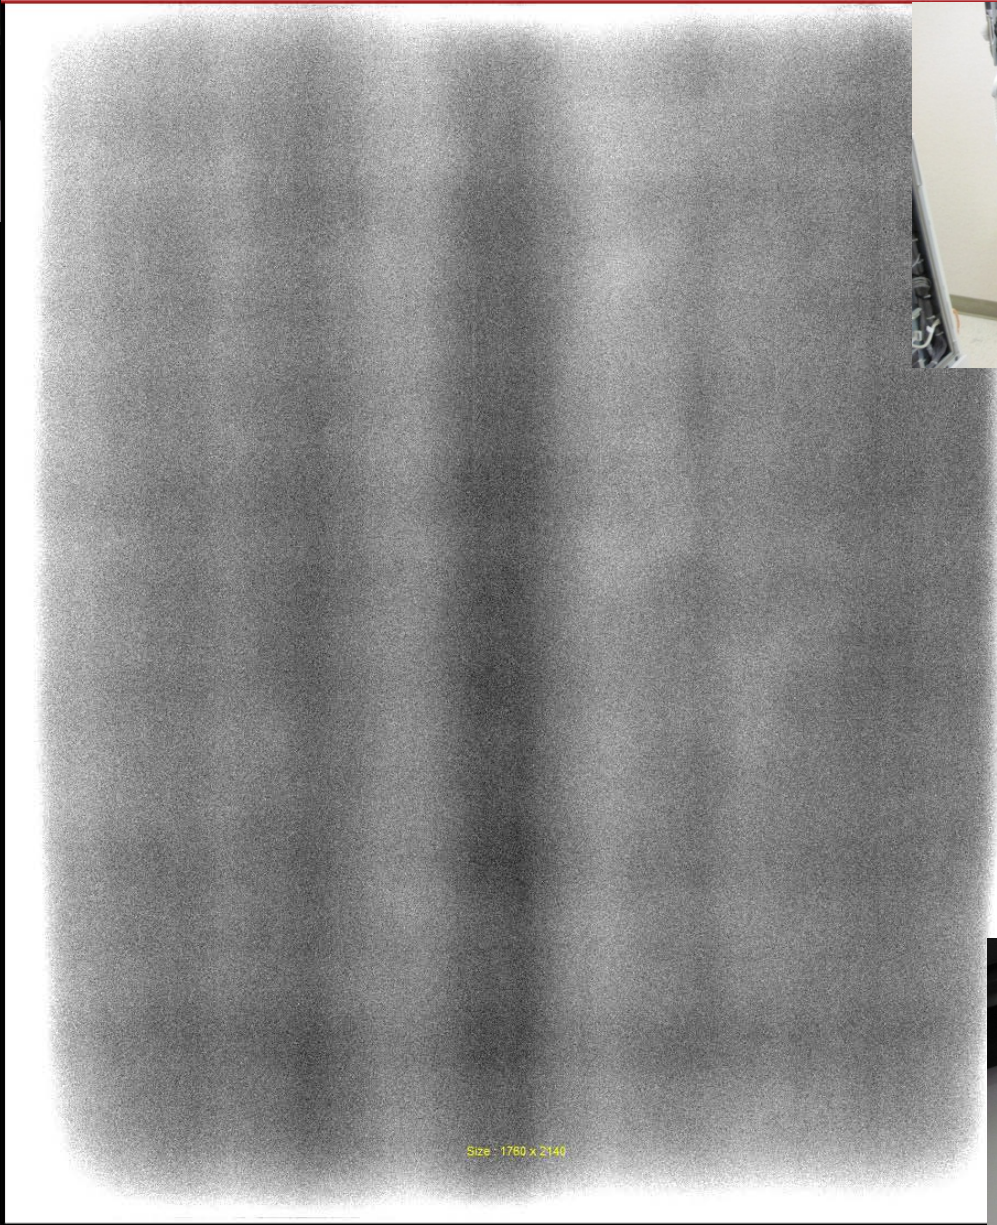
Roller damage

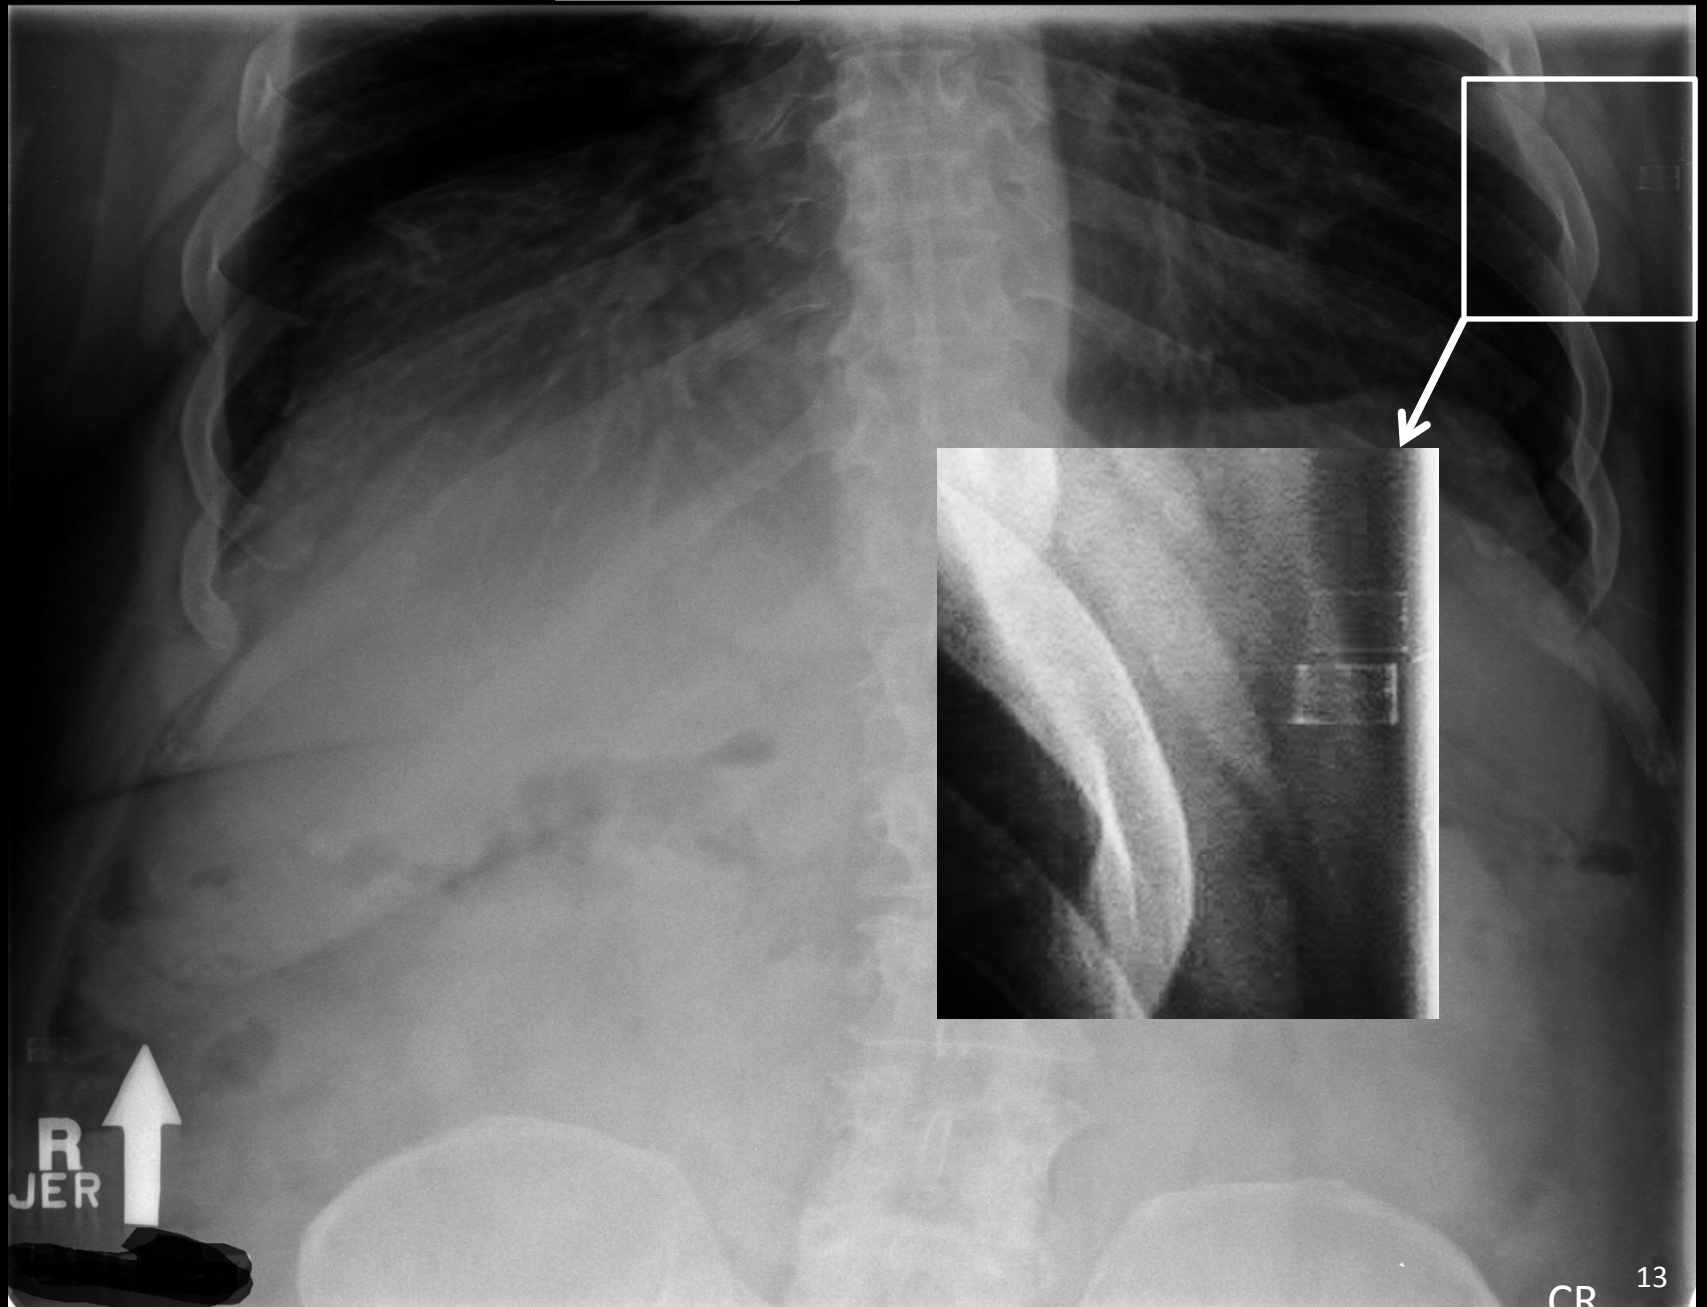
Wear marks

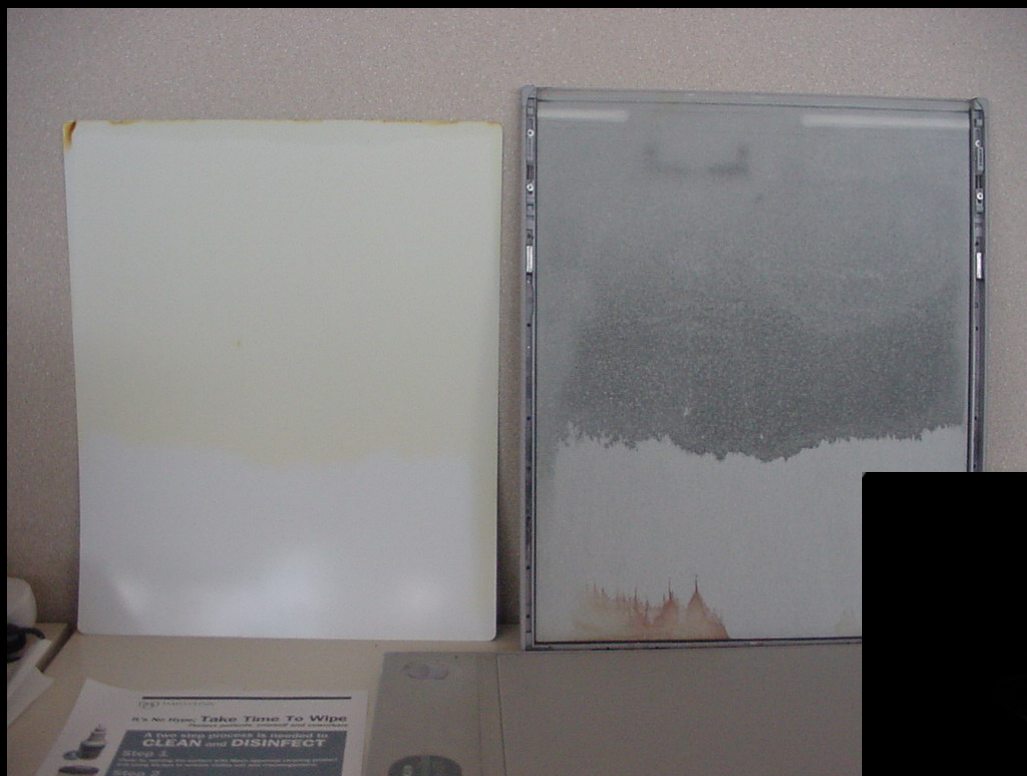
Plate yellowing from cleaning agent, Oxivir,

Resolution: Oxivir no longer used for cleaning cassettes for infection control. Switched to SaniCloth.

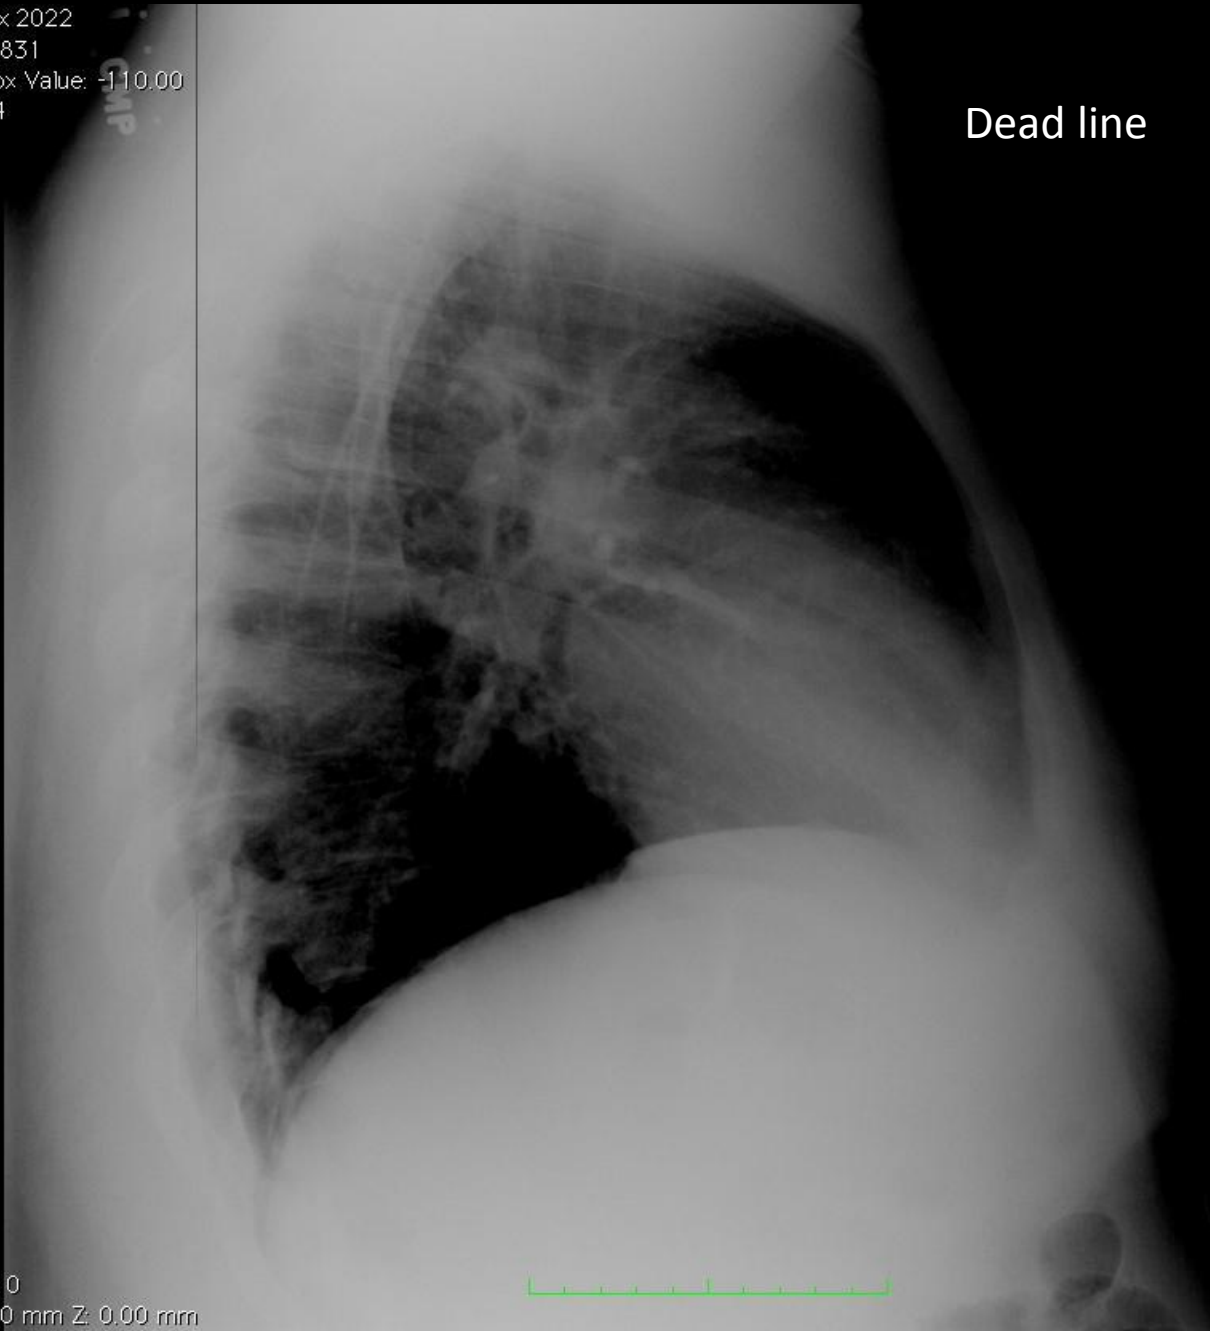
Dead line

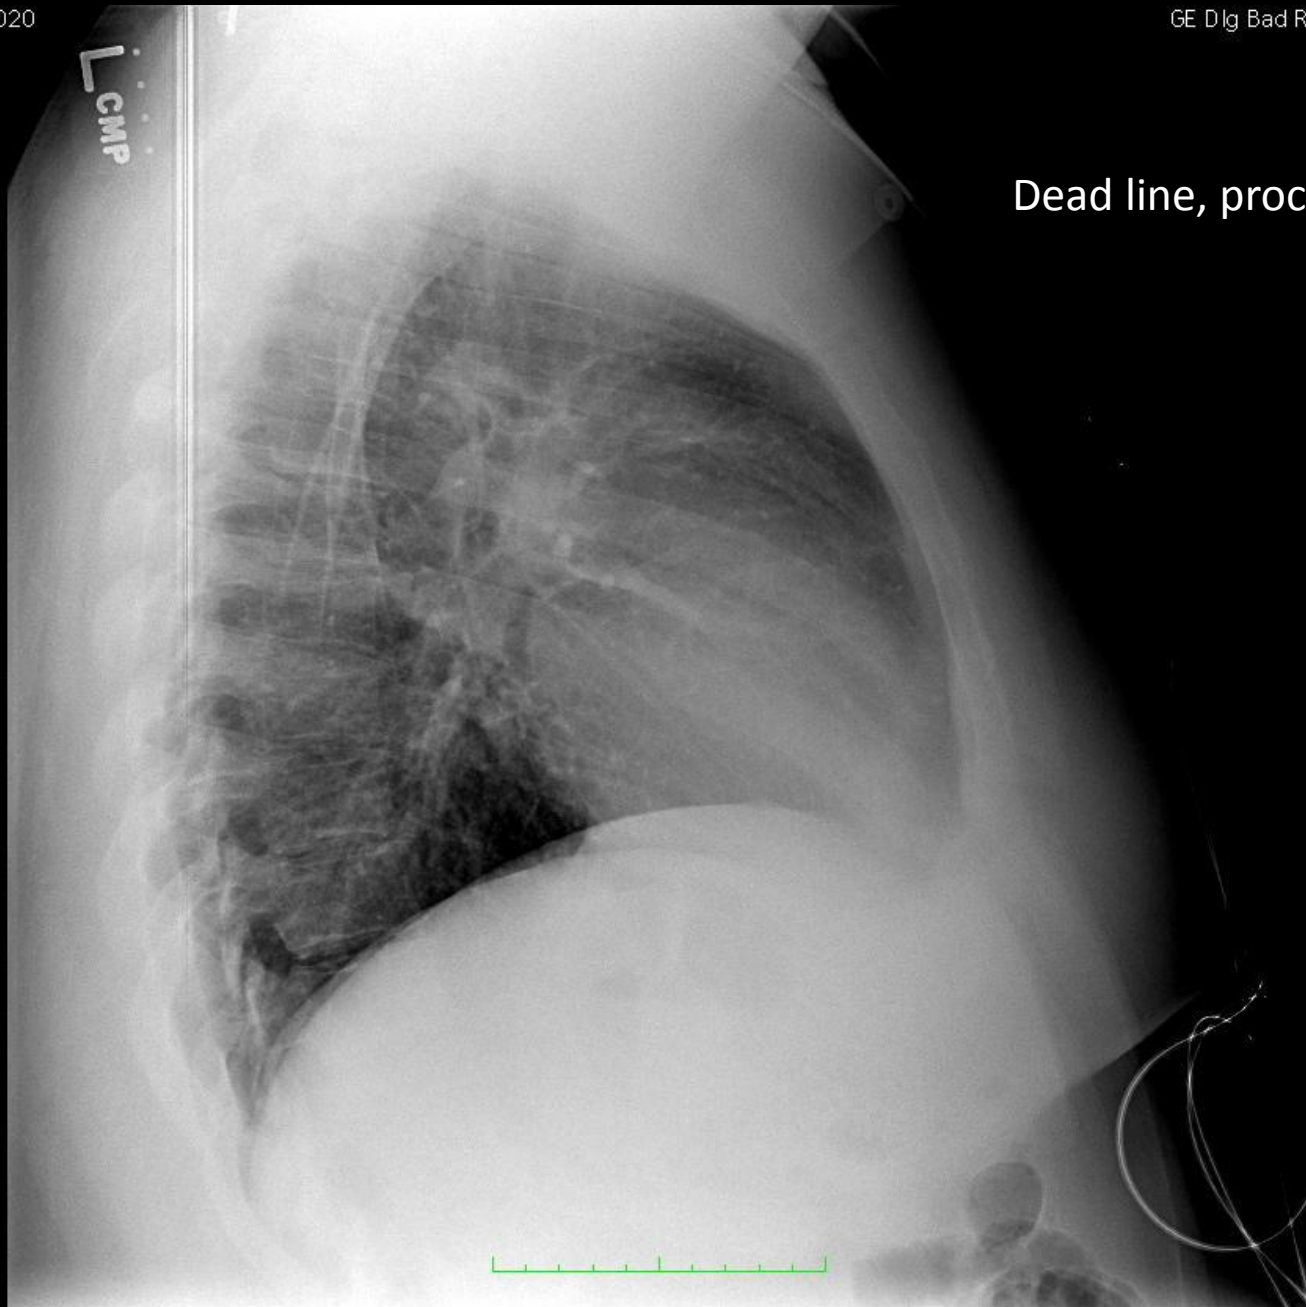
Dead line, processed

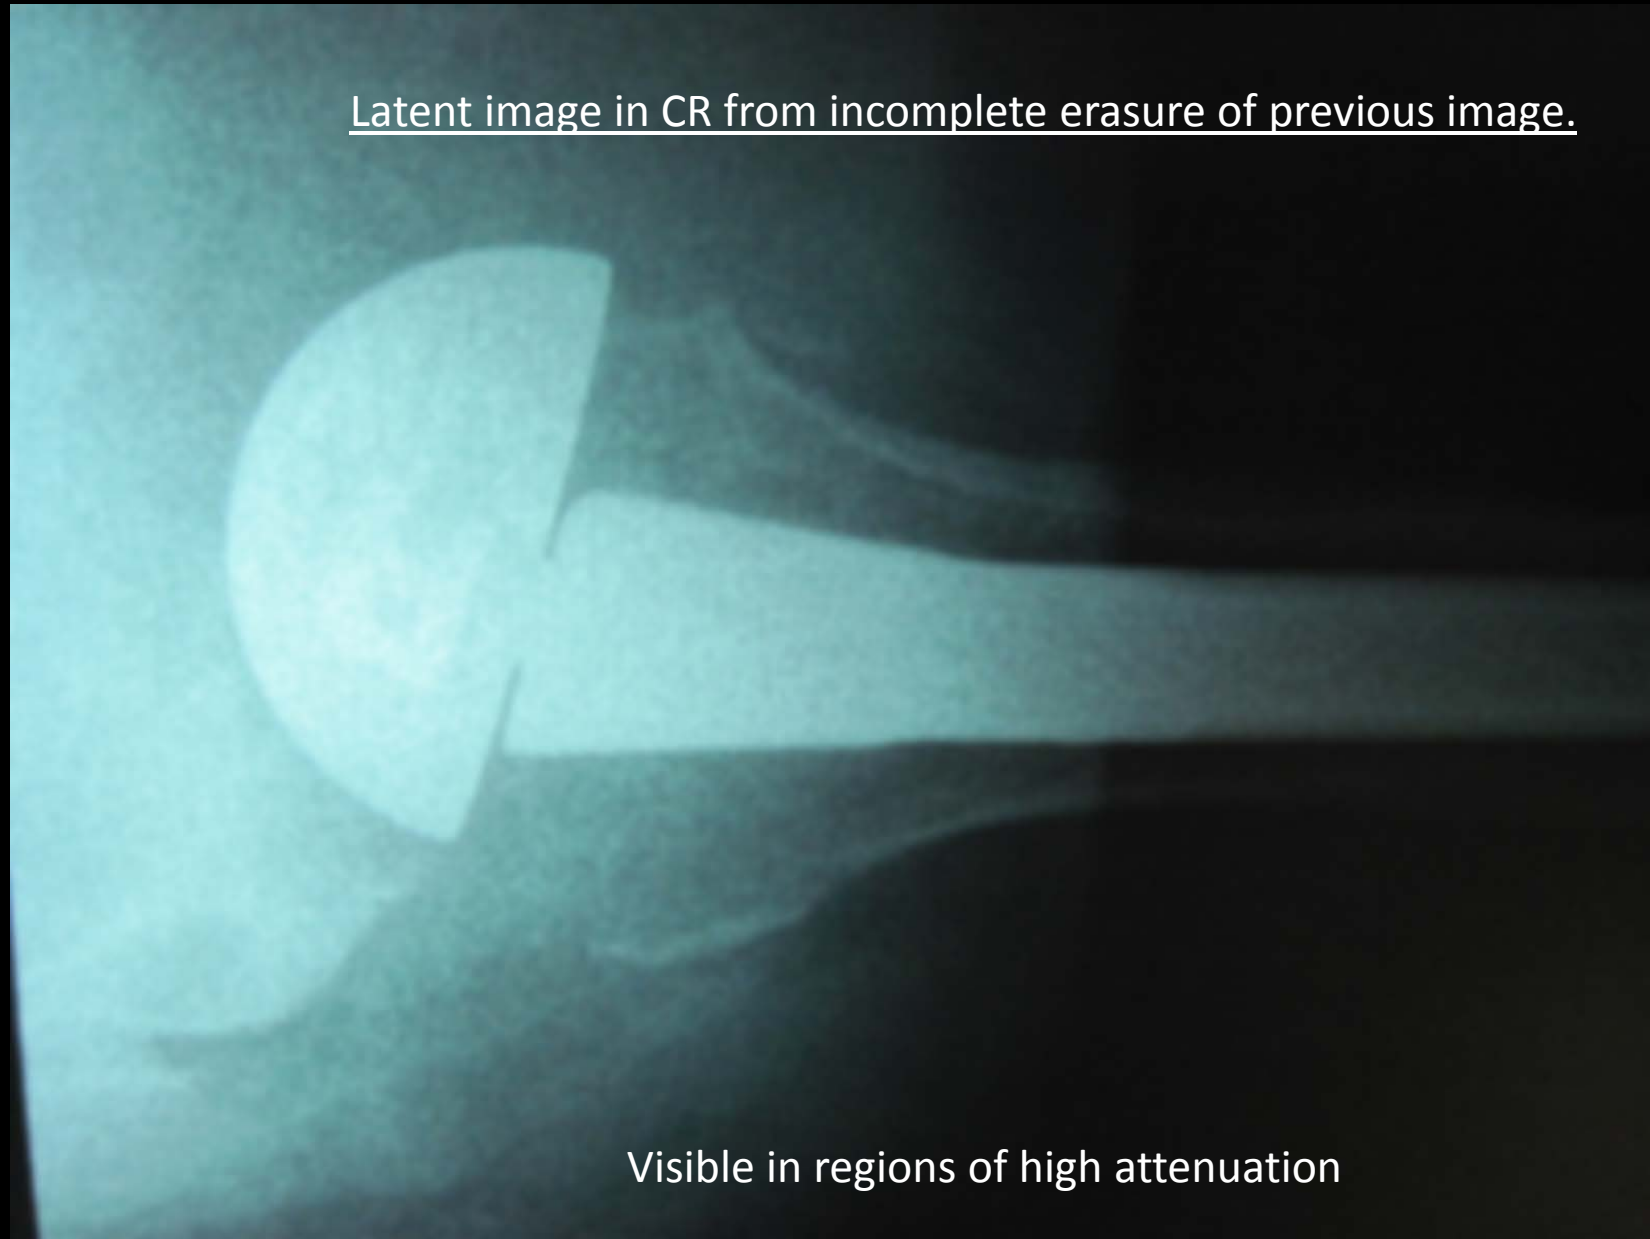
Latent image in CR from incomplete erasure of previous image.

Visible in regions of high attenuation

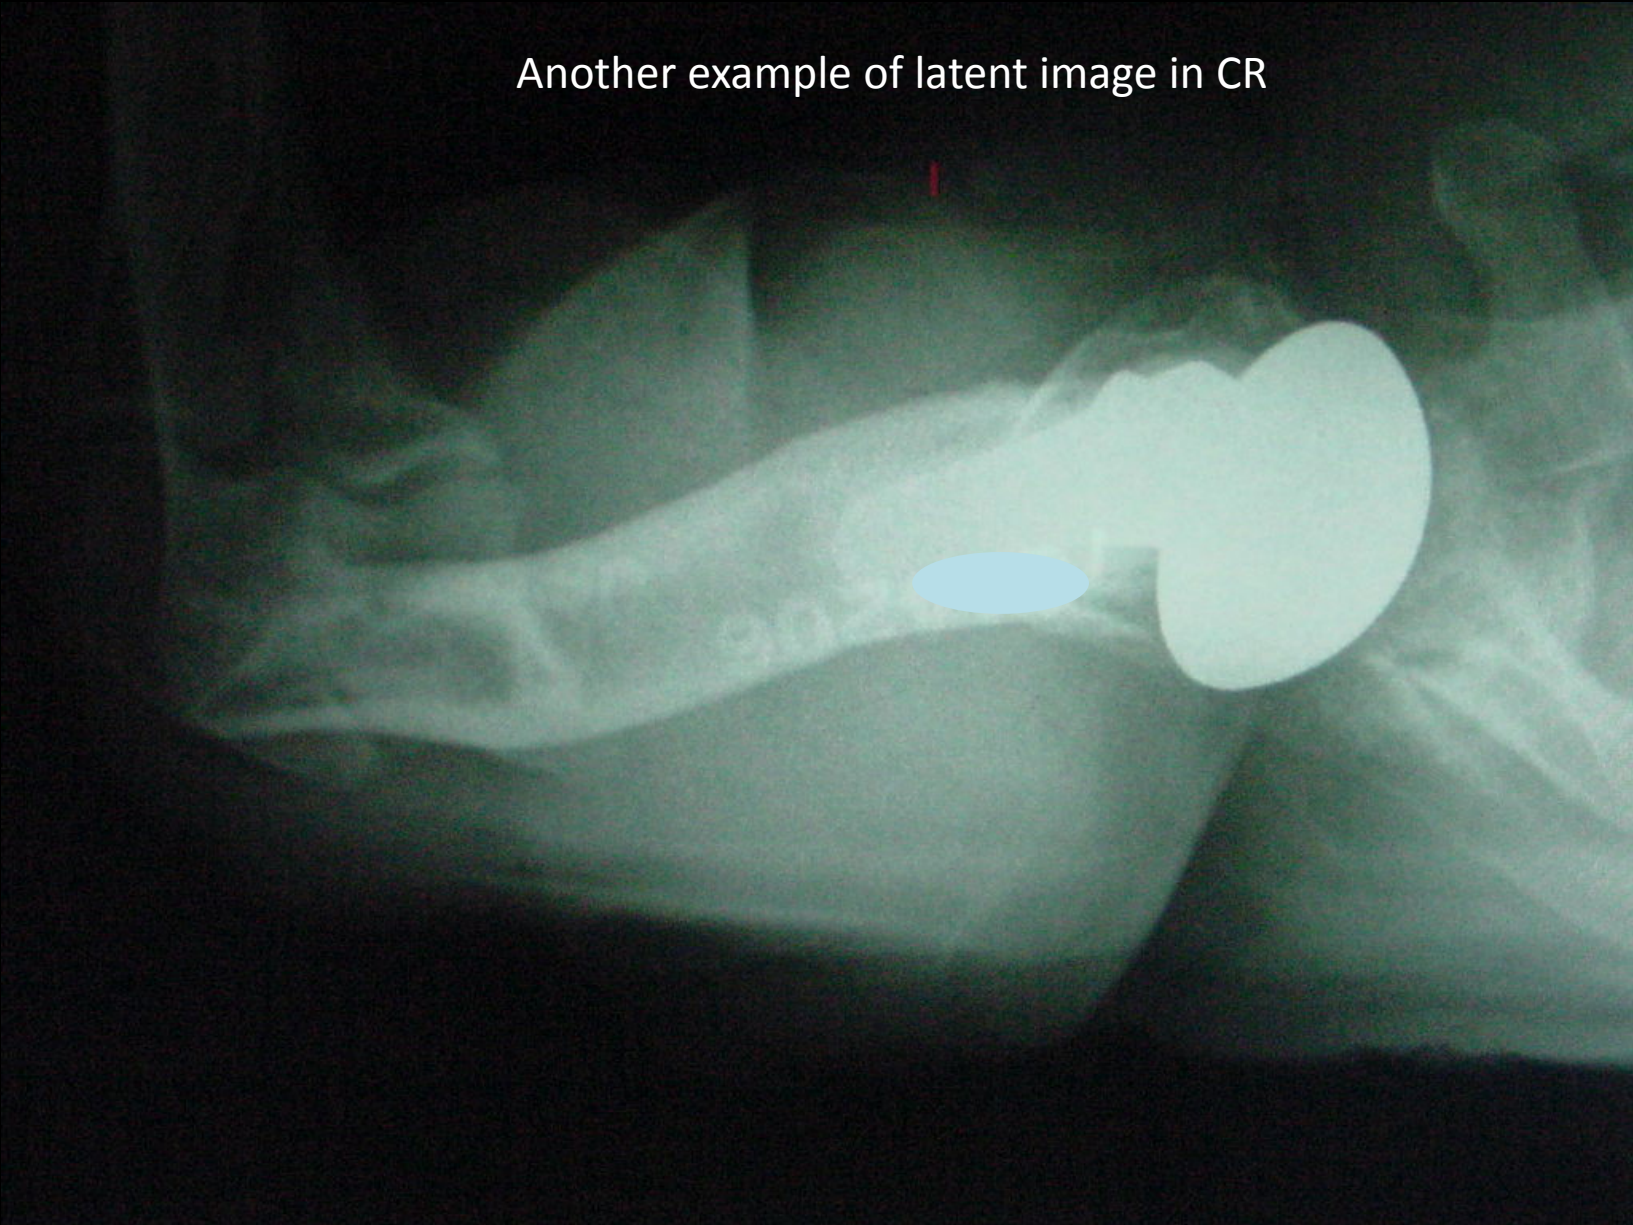
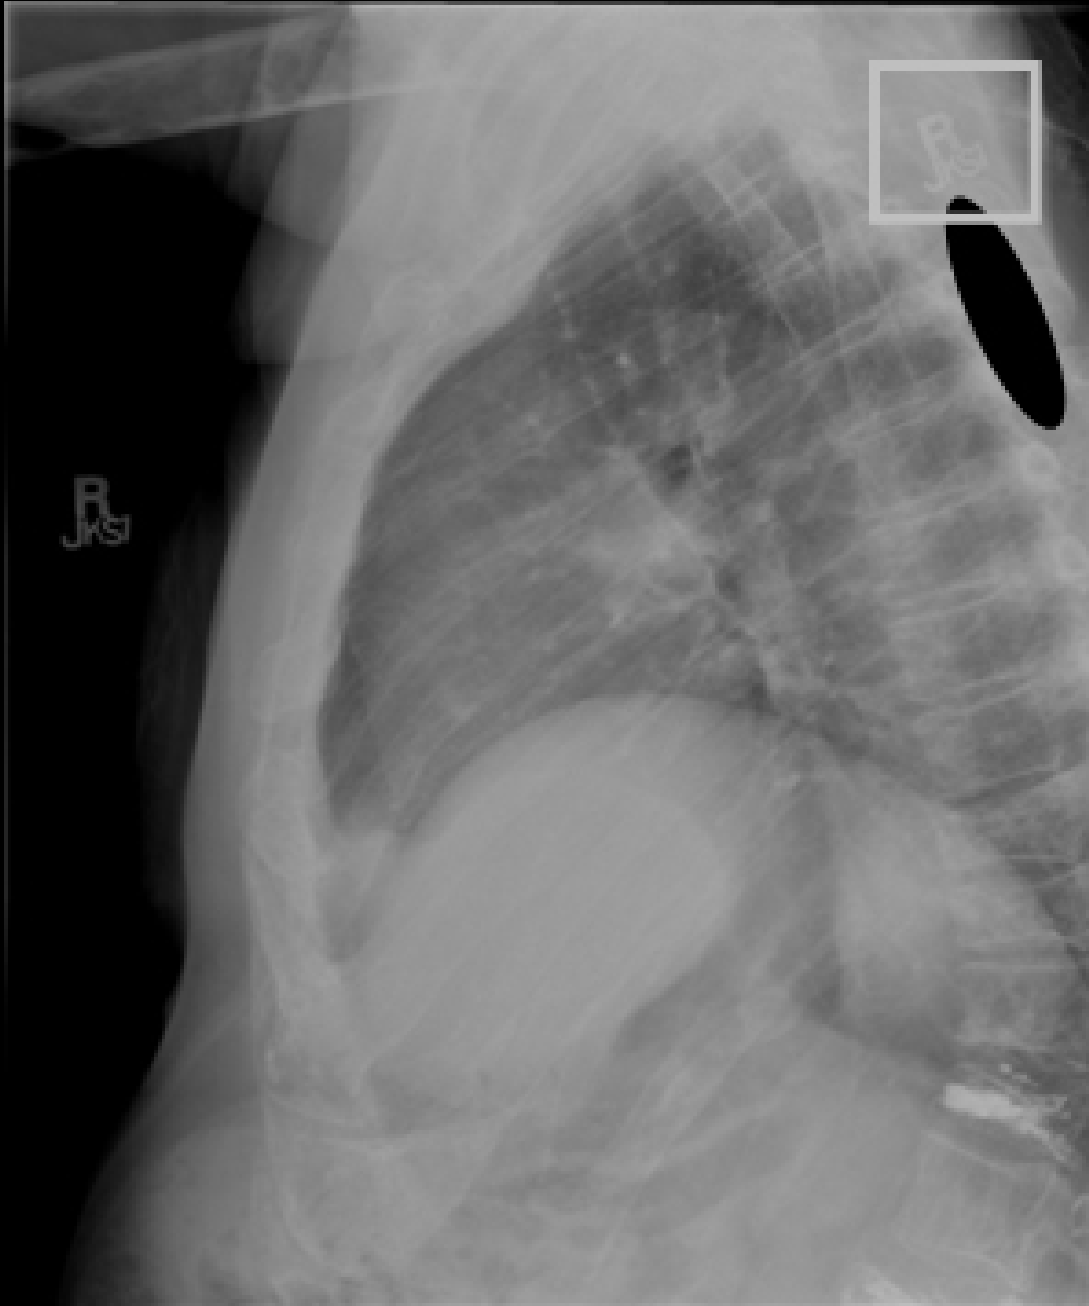
Another example of latent image in CR

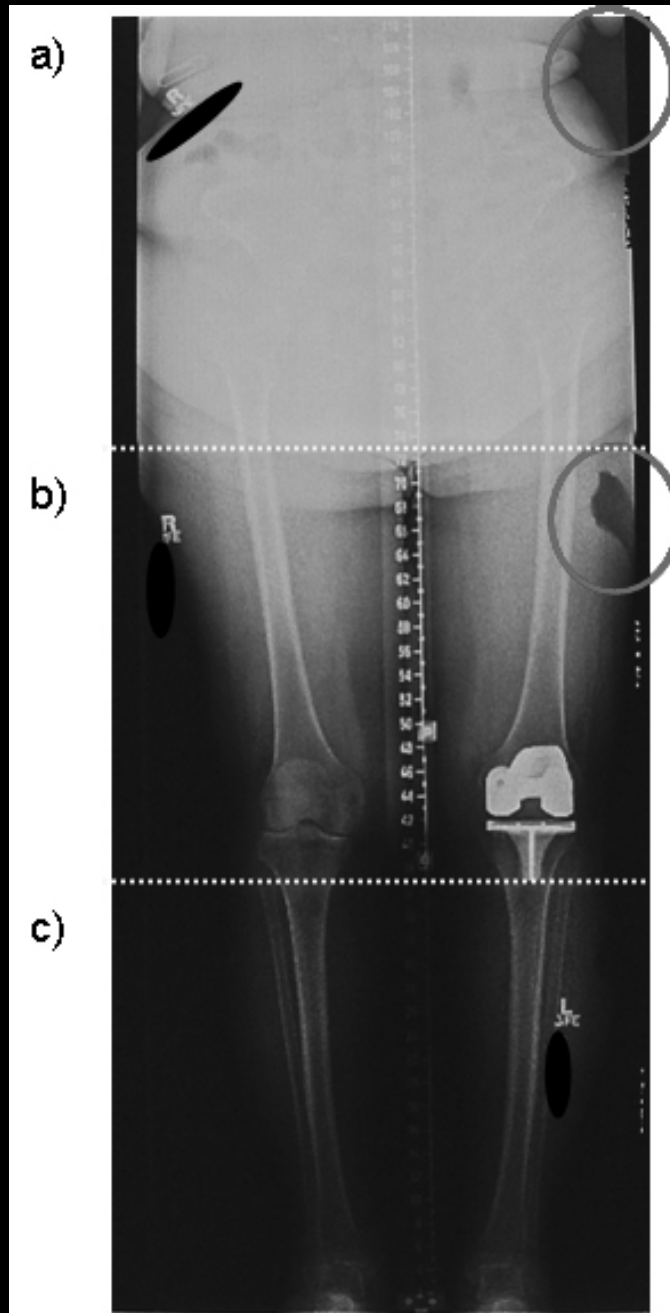
DR Lag

Lead marker from
prior image is visible

DR Lag
Stitched image

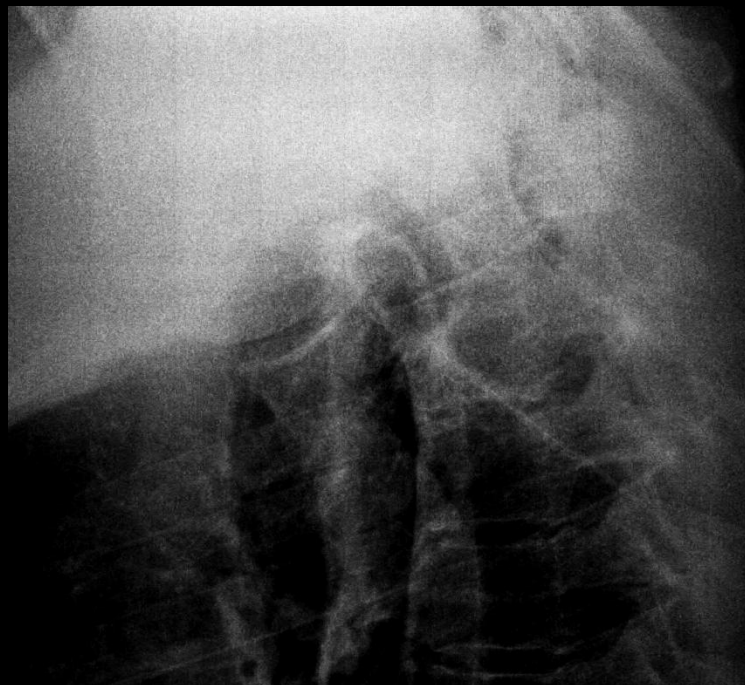
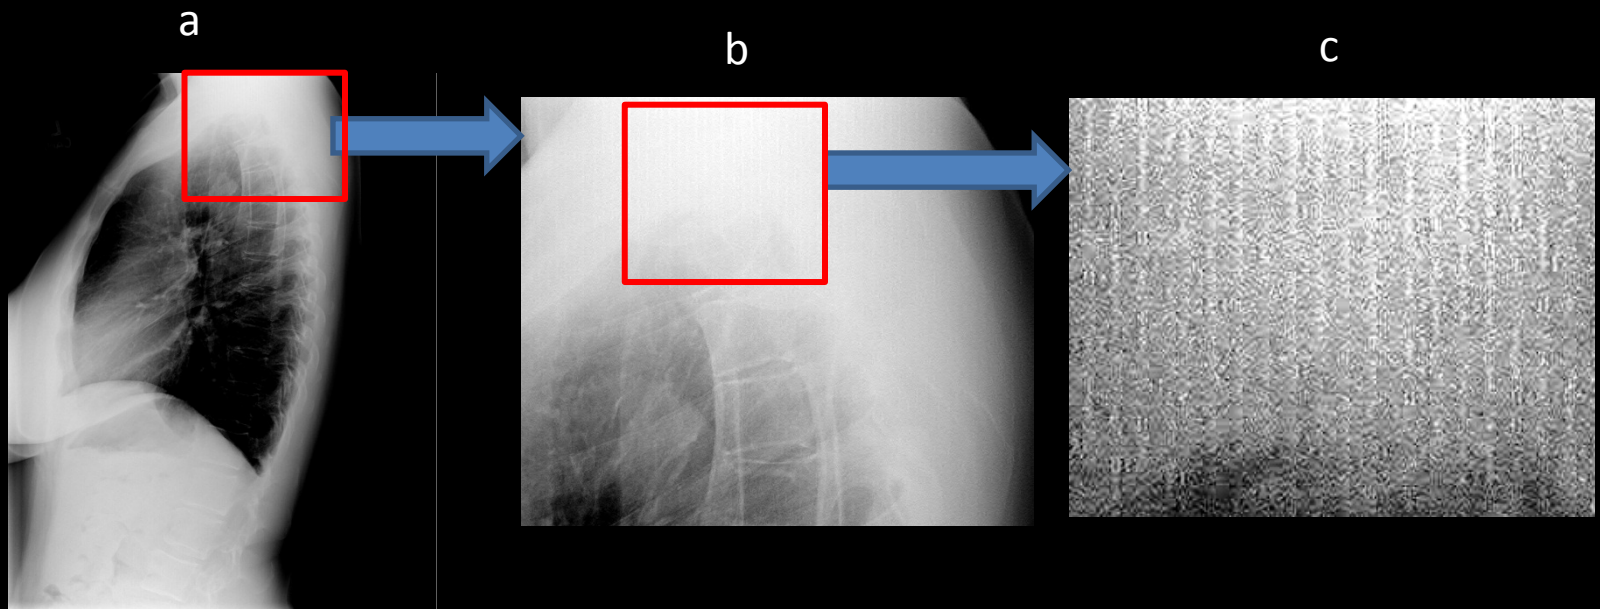
Visible detector structure
in anatomy

The corduroy artifact seen in the anatomy is caused by a combination of uniformly-spaced components within the detector and the sampling rate in the acquired image

Software update by vendor that changed the sampling rate fixed the problem.

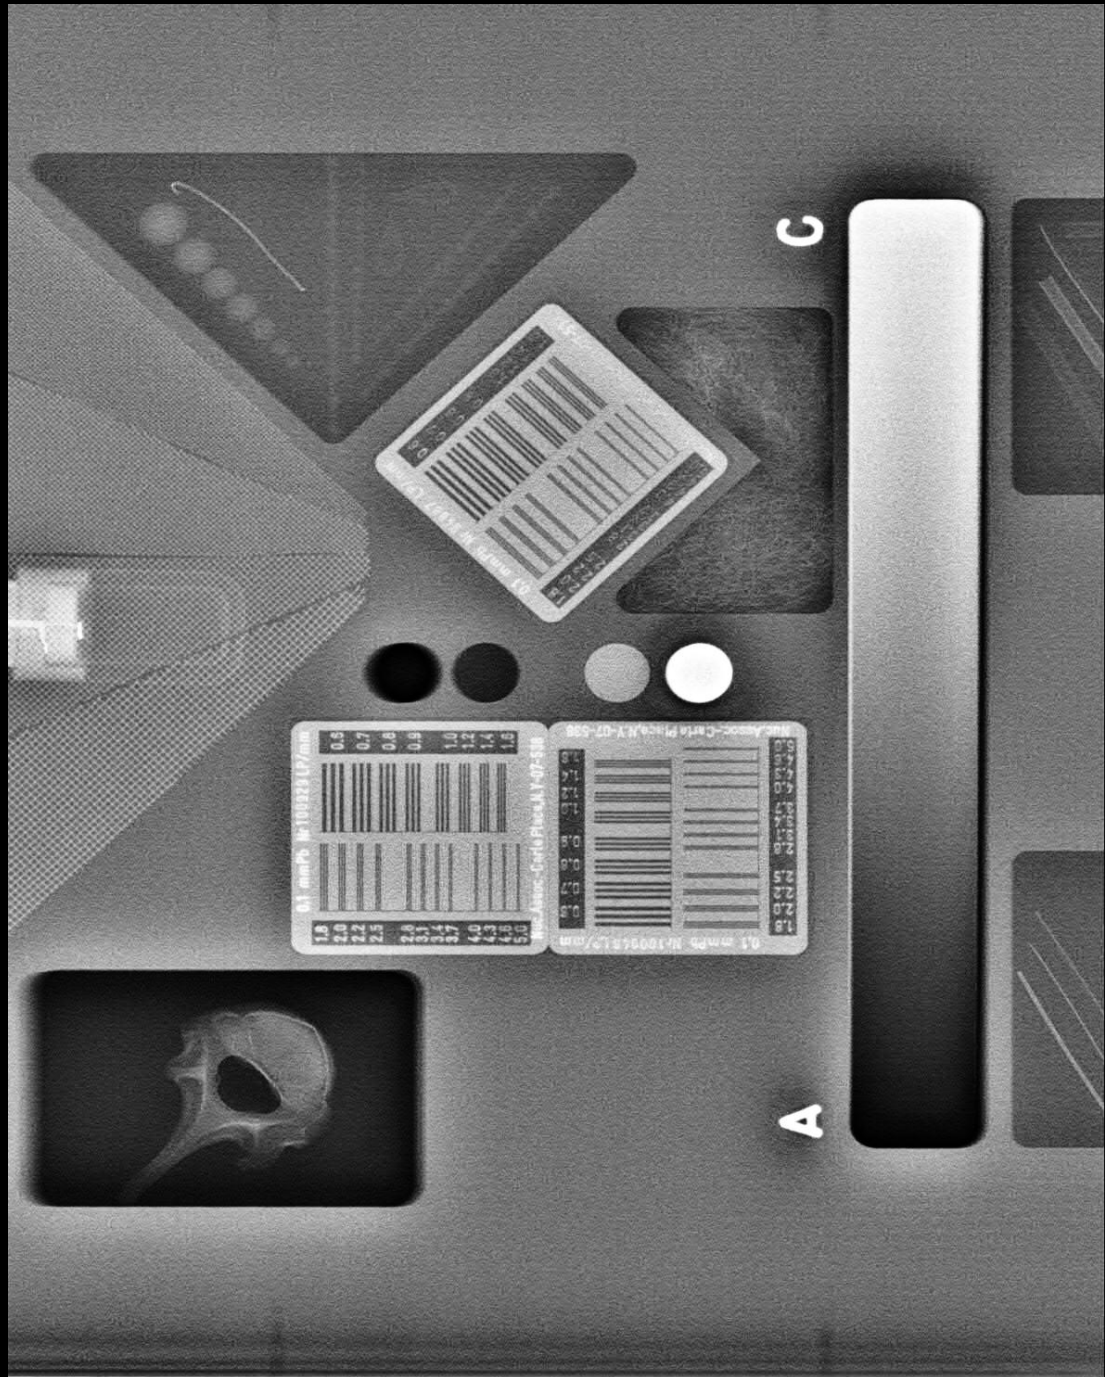
Slot scan system

Lines visible in rapid readout

Resolution:
Slower scan speed.
