The Art of the Image: The Identification and Remediation of
Image Artifacts in Projection Radiography, part II

Alisa Walz-Flannigan, Ph.D. DABR
Mayo Clinic, Rochester, Minnesota
Walzflannigan.alisa@mayo.edu

American Association of Physicists Meeting, Indianapolis
8/7/2013

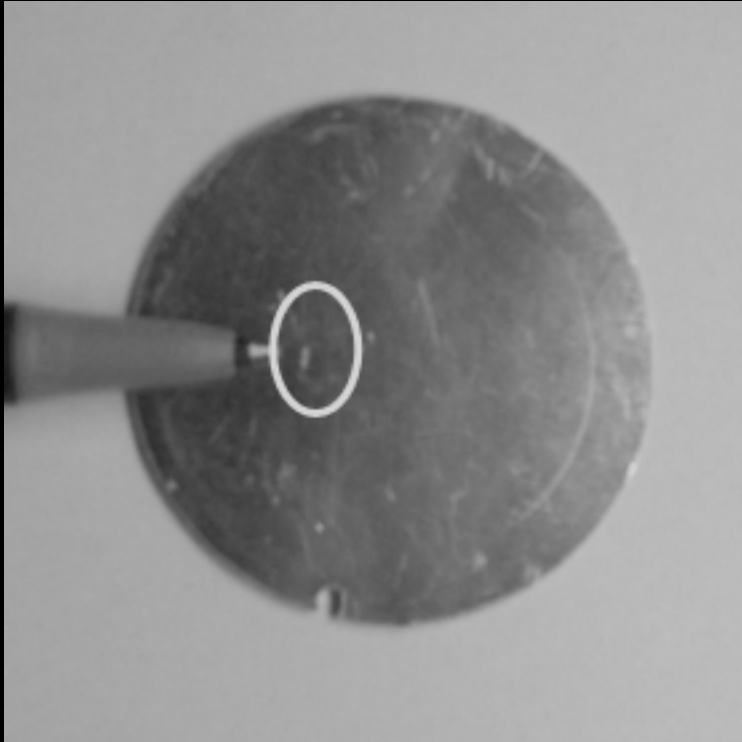
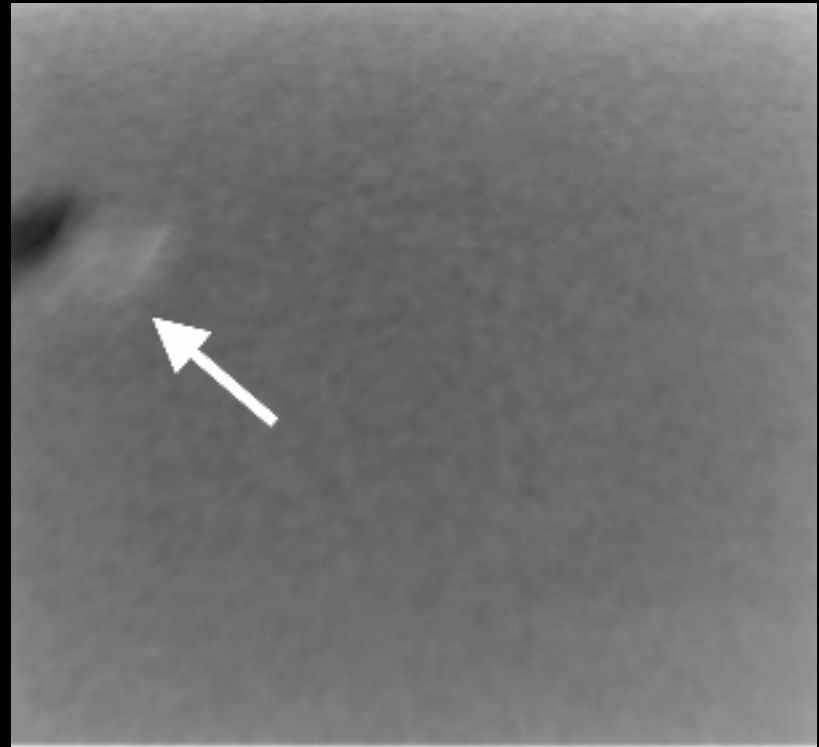
Defect in calibration. Visible with change in SID.

Resolution: New filter and recalibration.

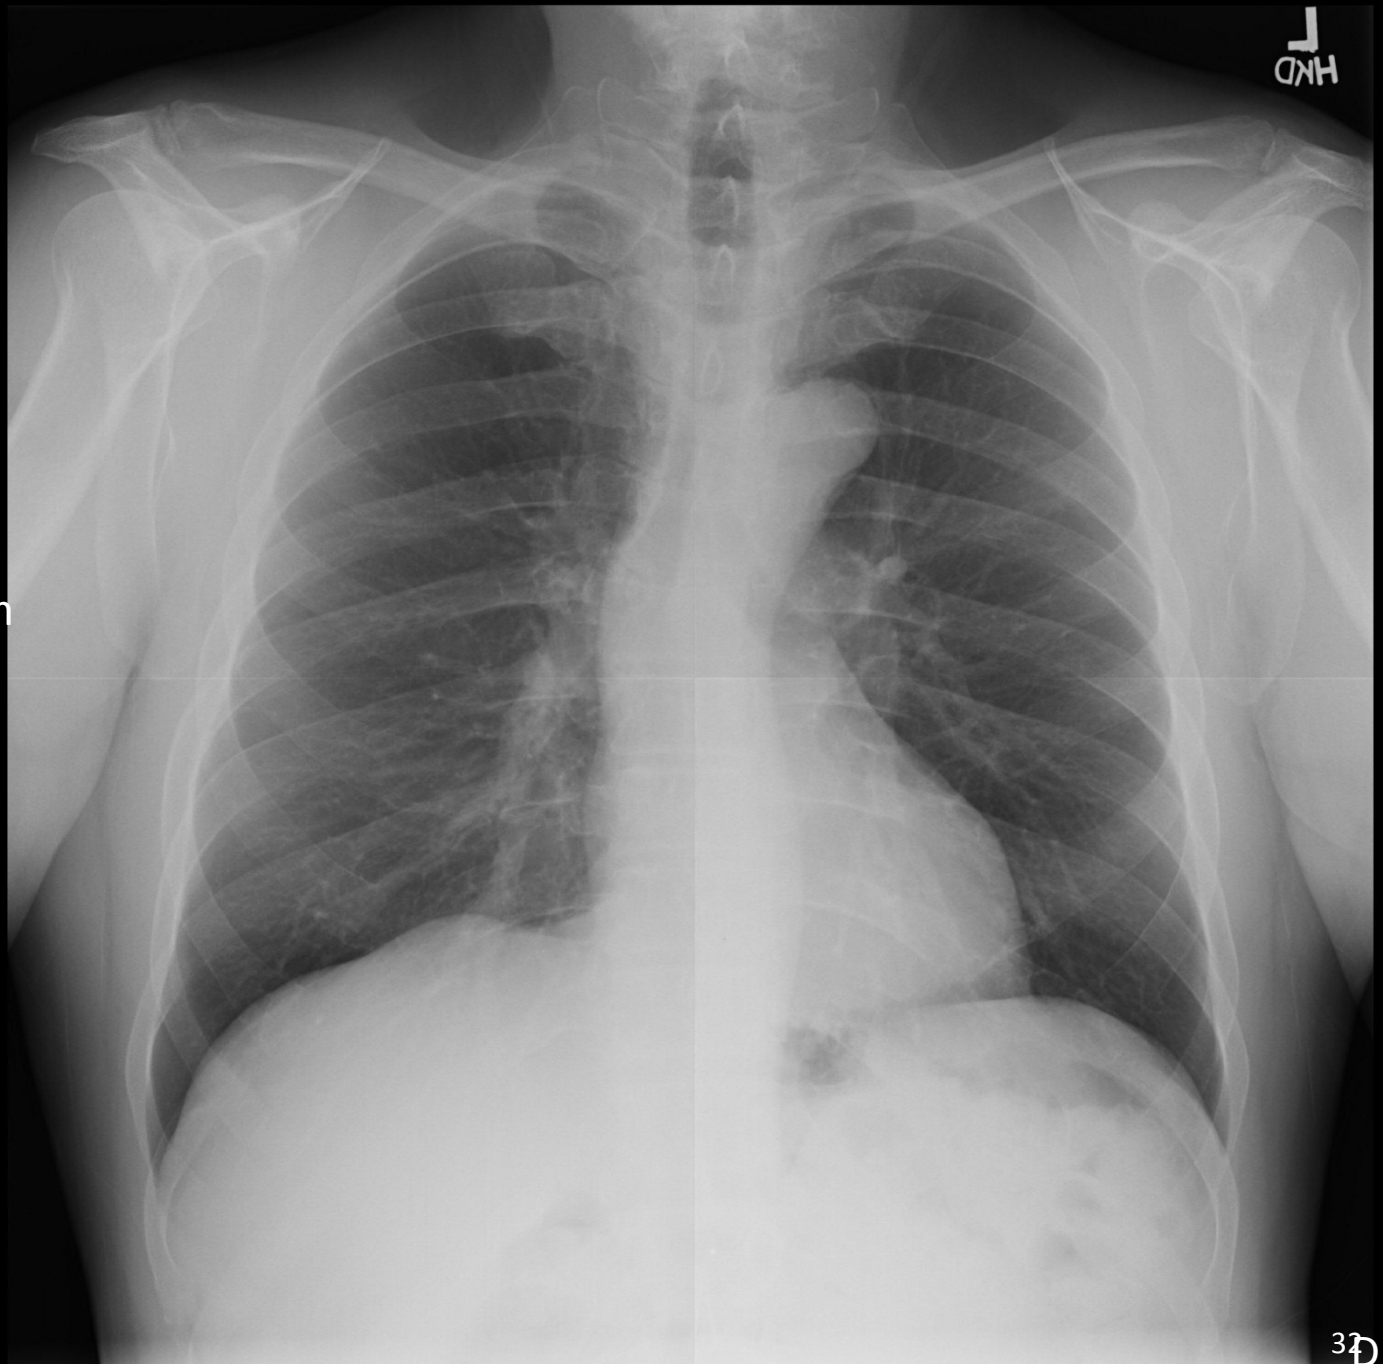
Visible detector
tiling

Seen with room
temperature
change and use.

Resolution:
recalibration; room
temperature
stabilization

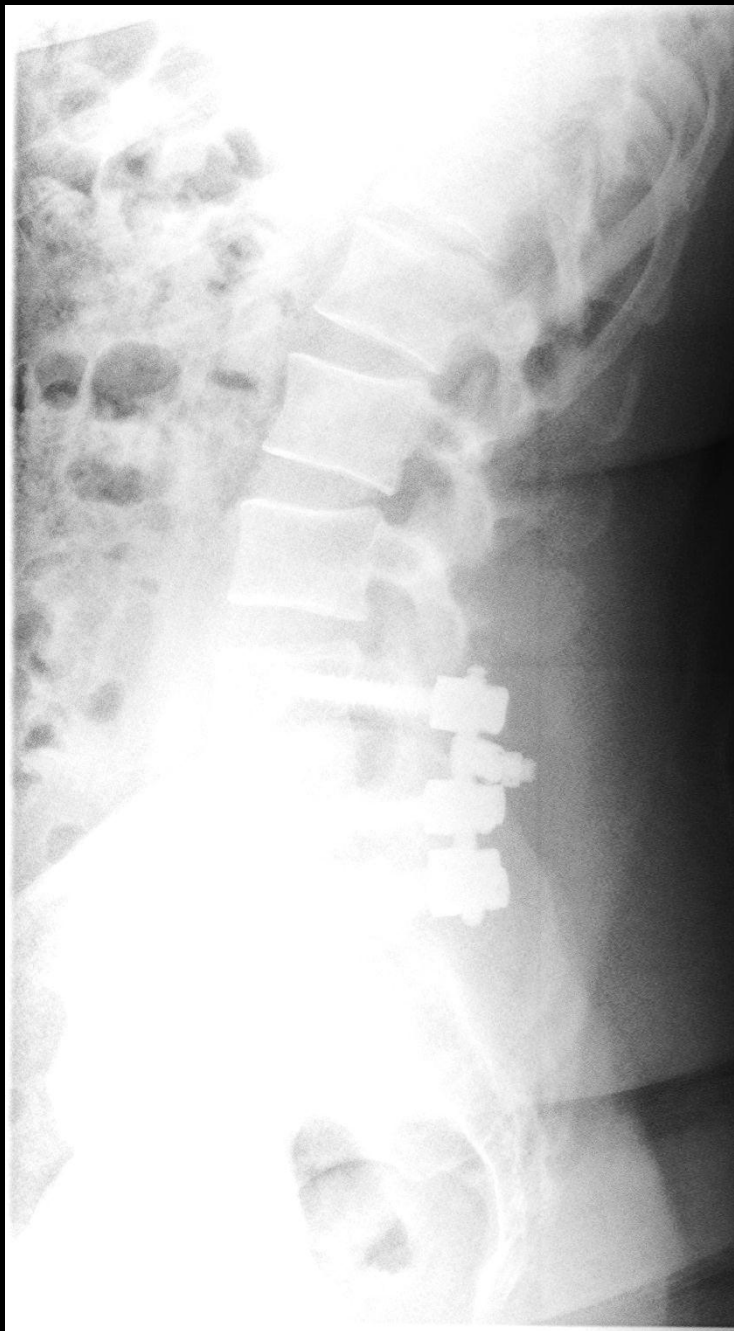
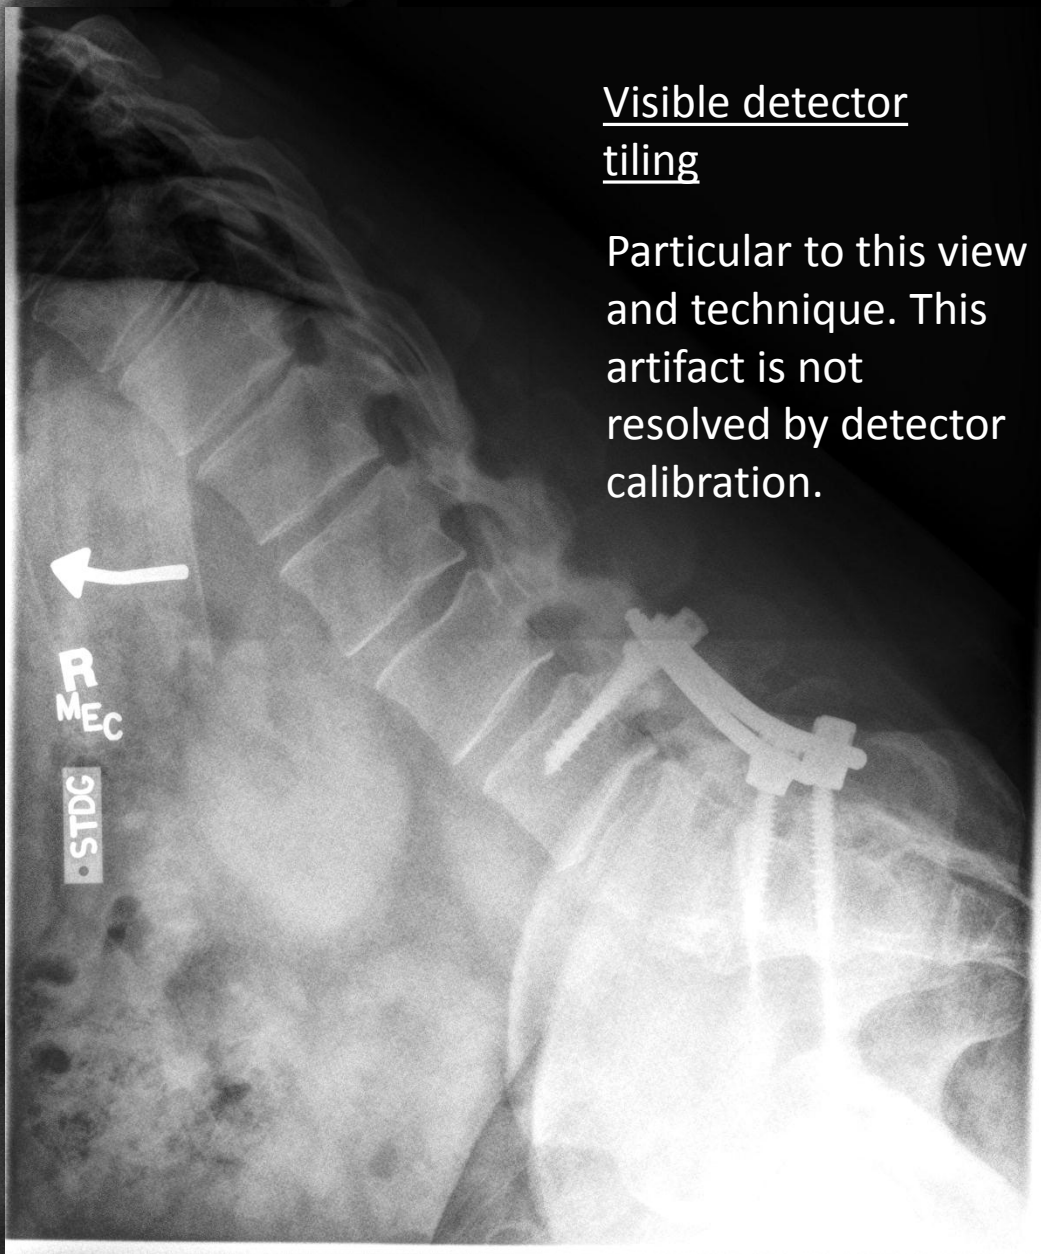
Visible detector tiling

Particular to this view and technique. This artifact is not resolved by detector calibration.

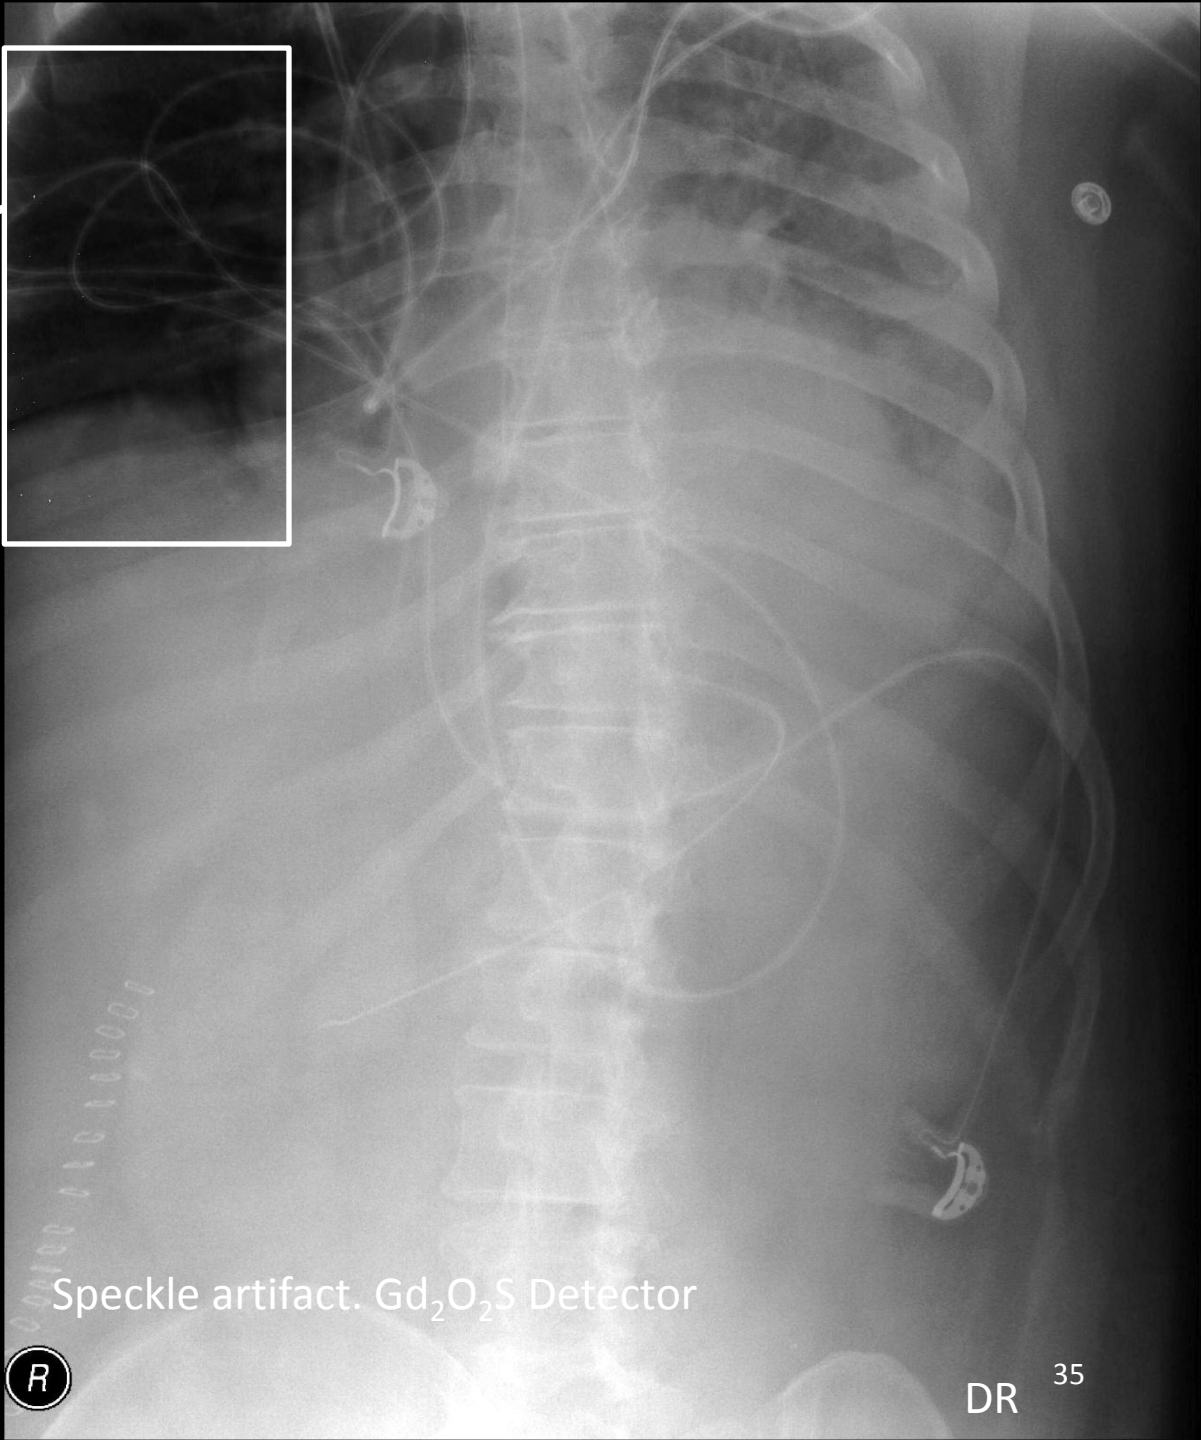
Speckle artifact. Gd_2O_2S Detector

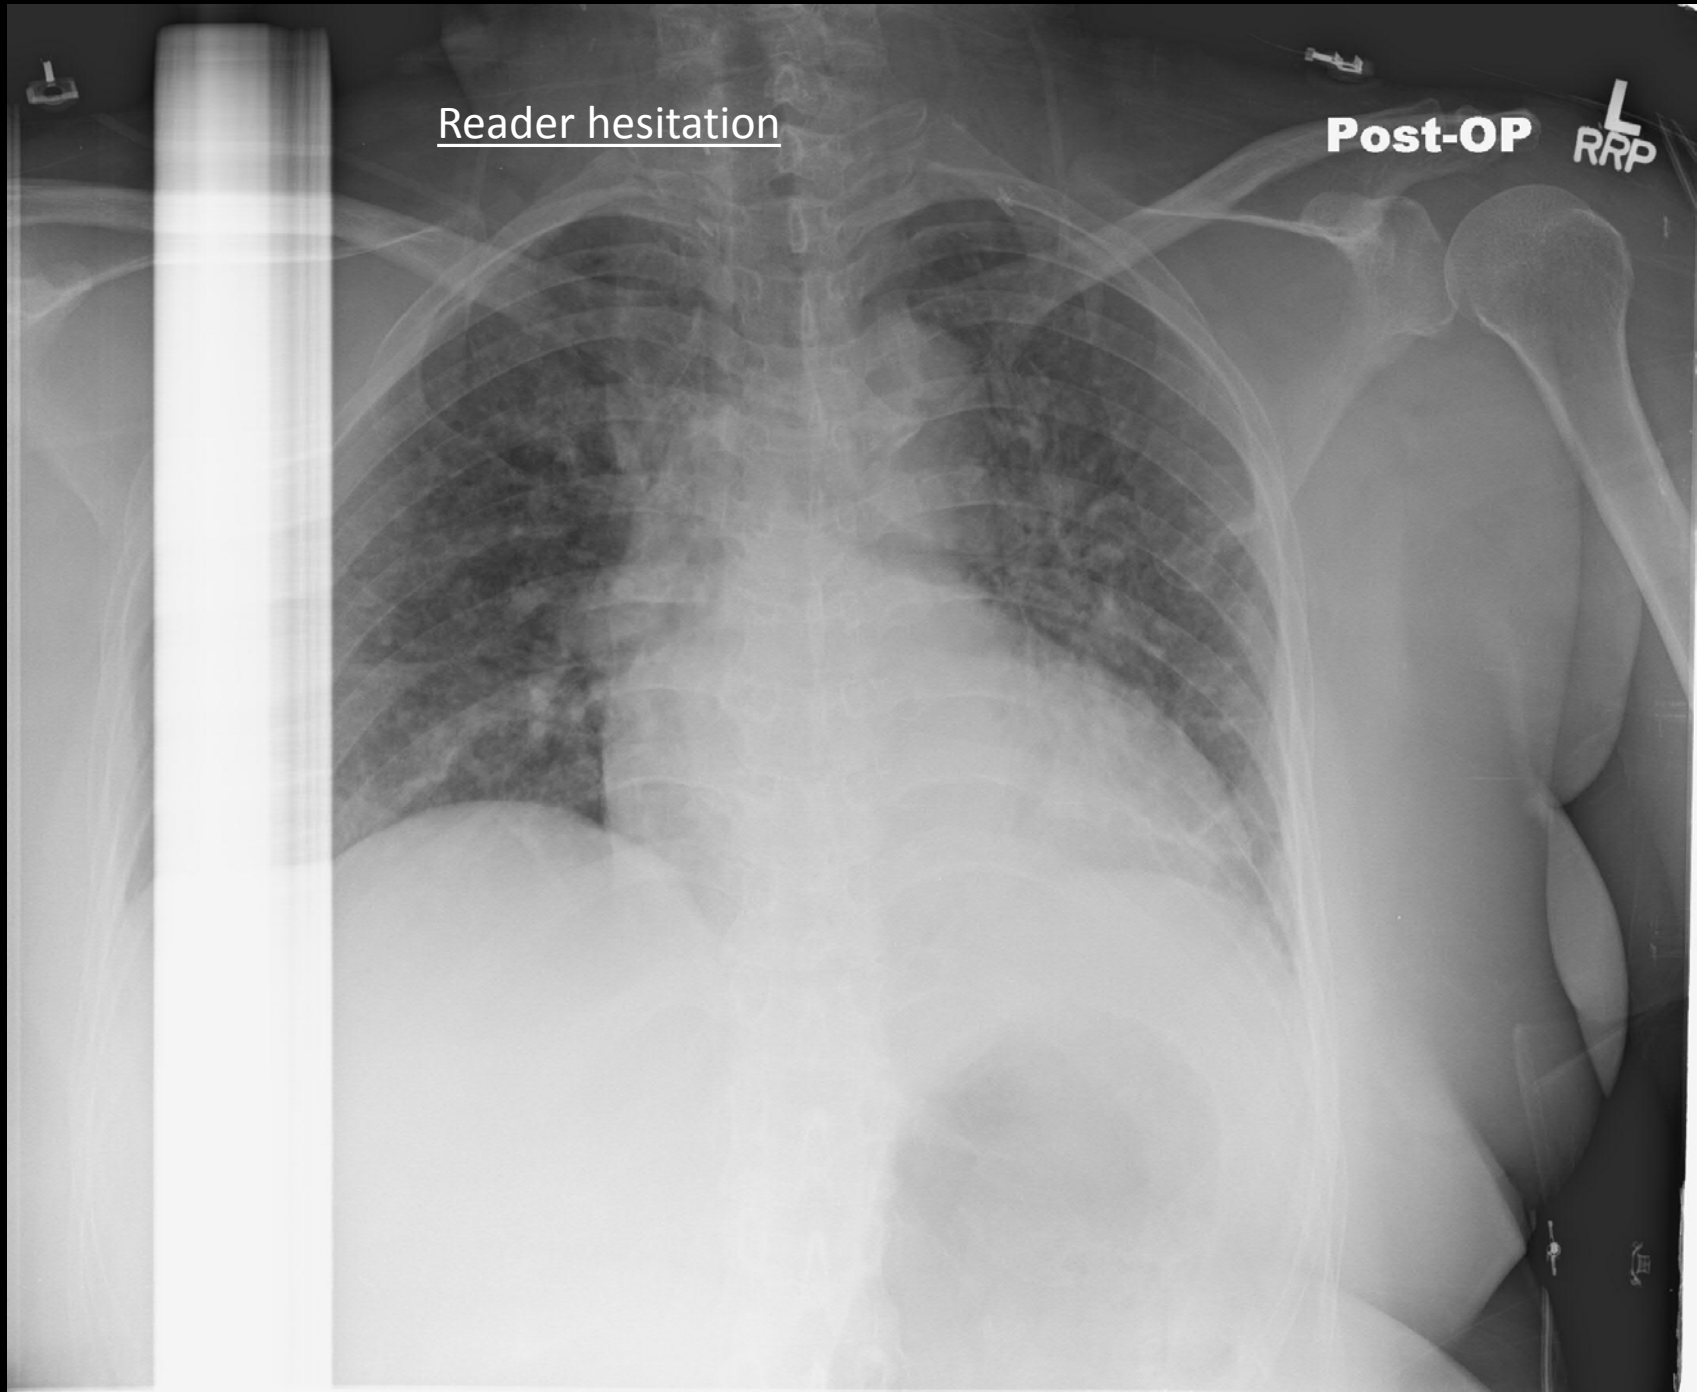
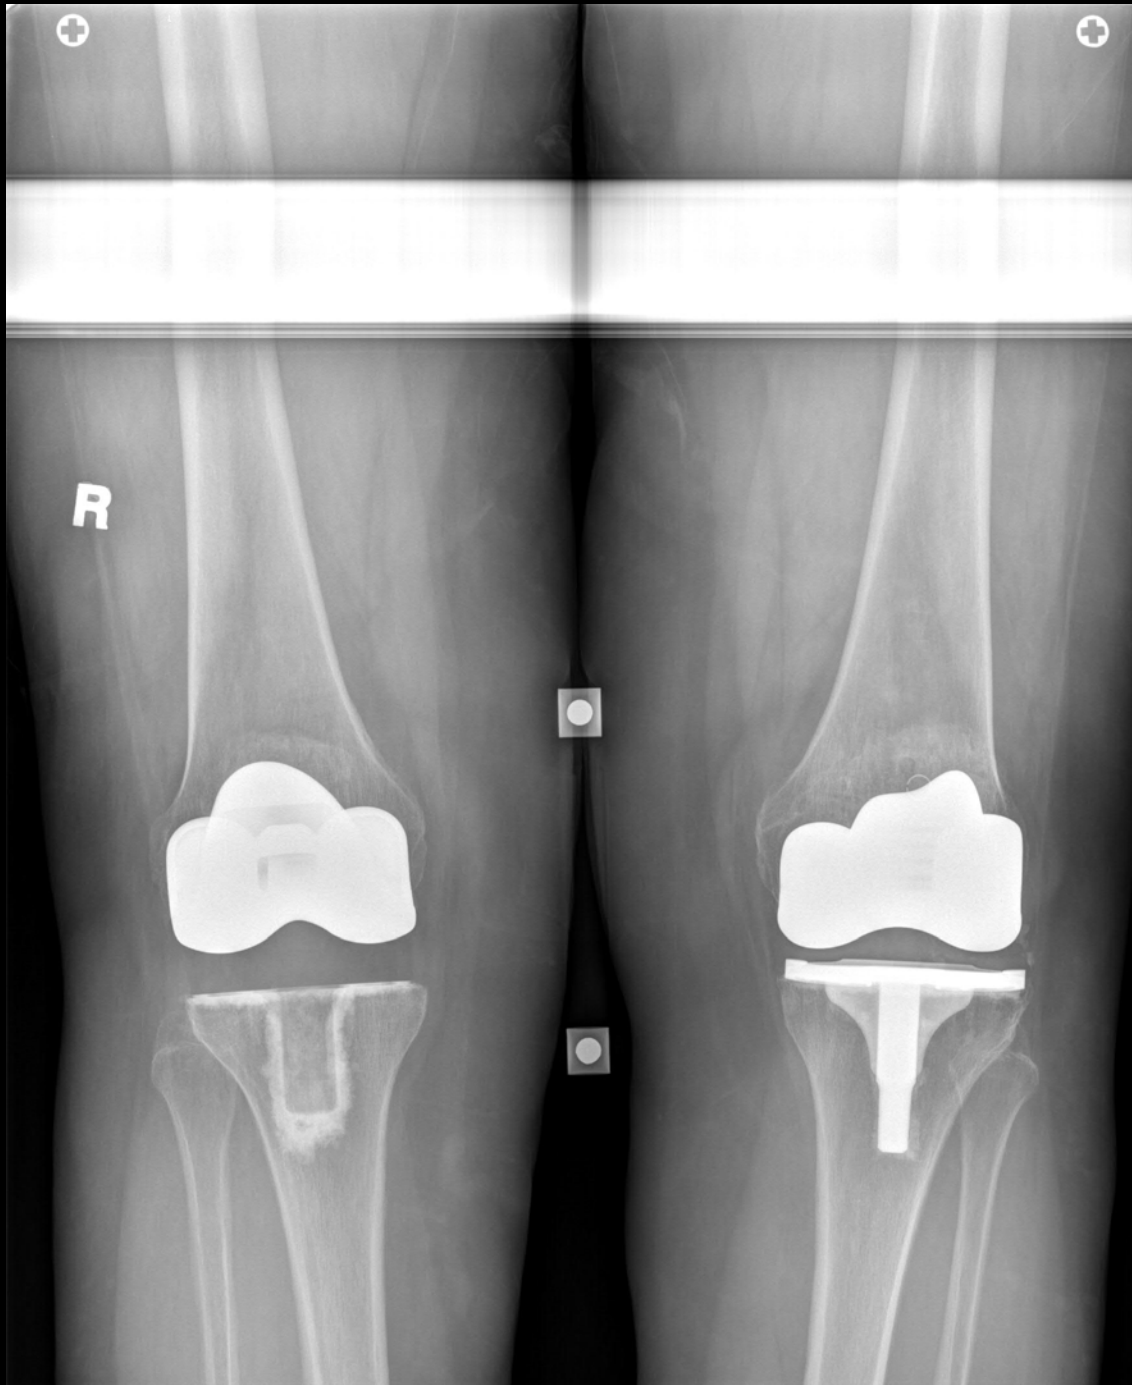
Reader hesitation

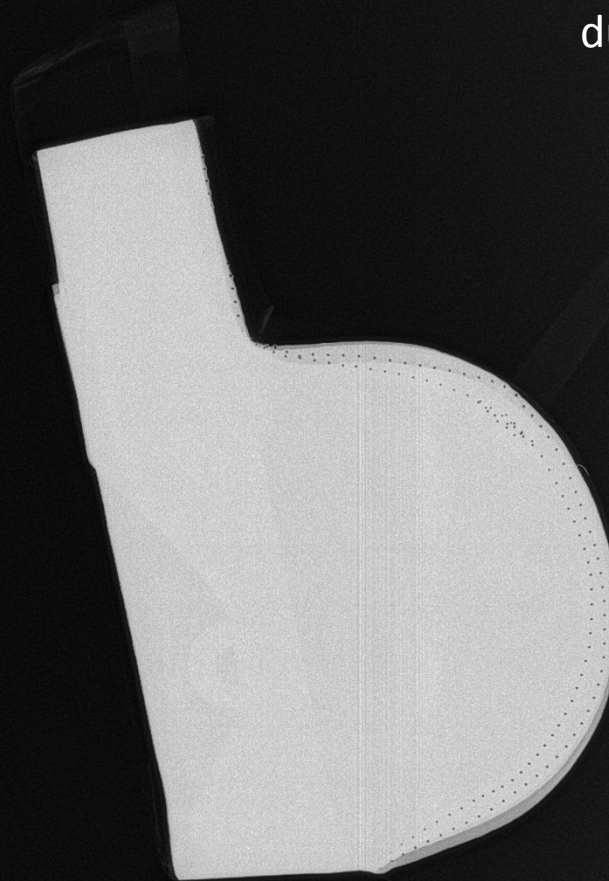
Readout interference

Source: Bumped
during readout

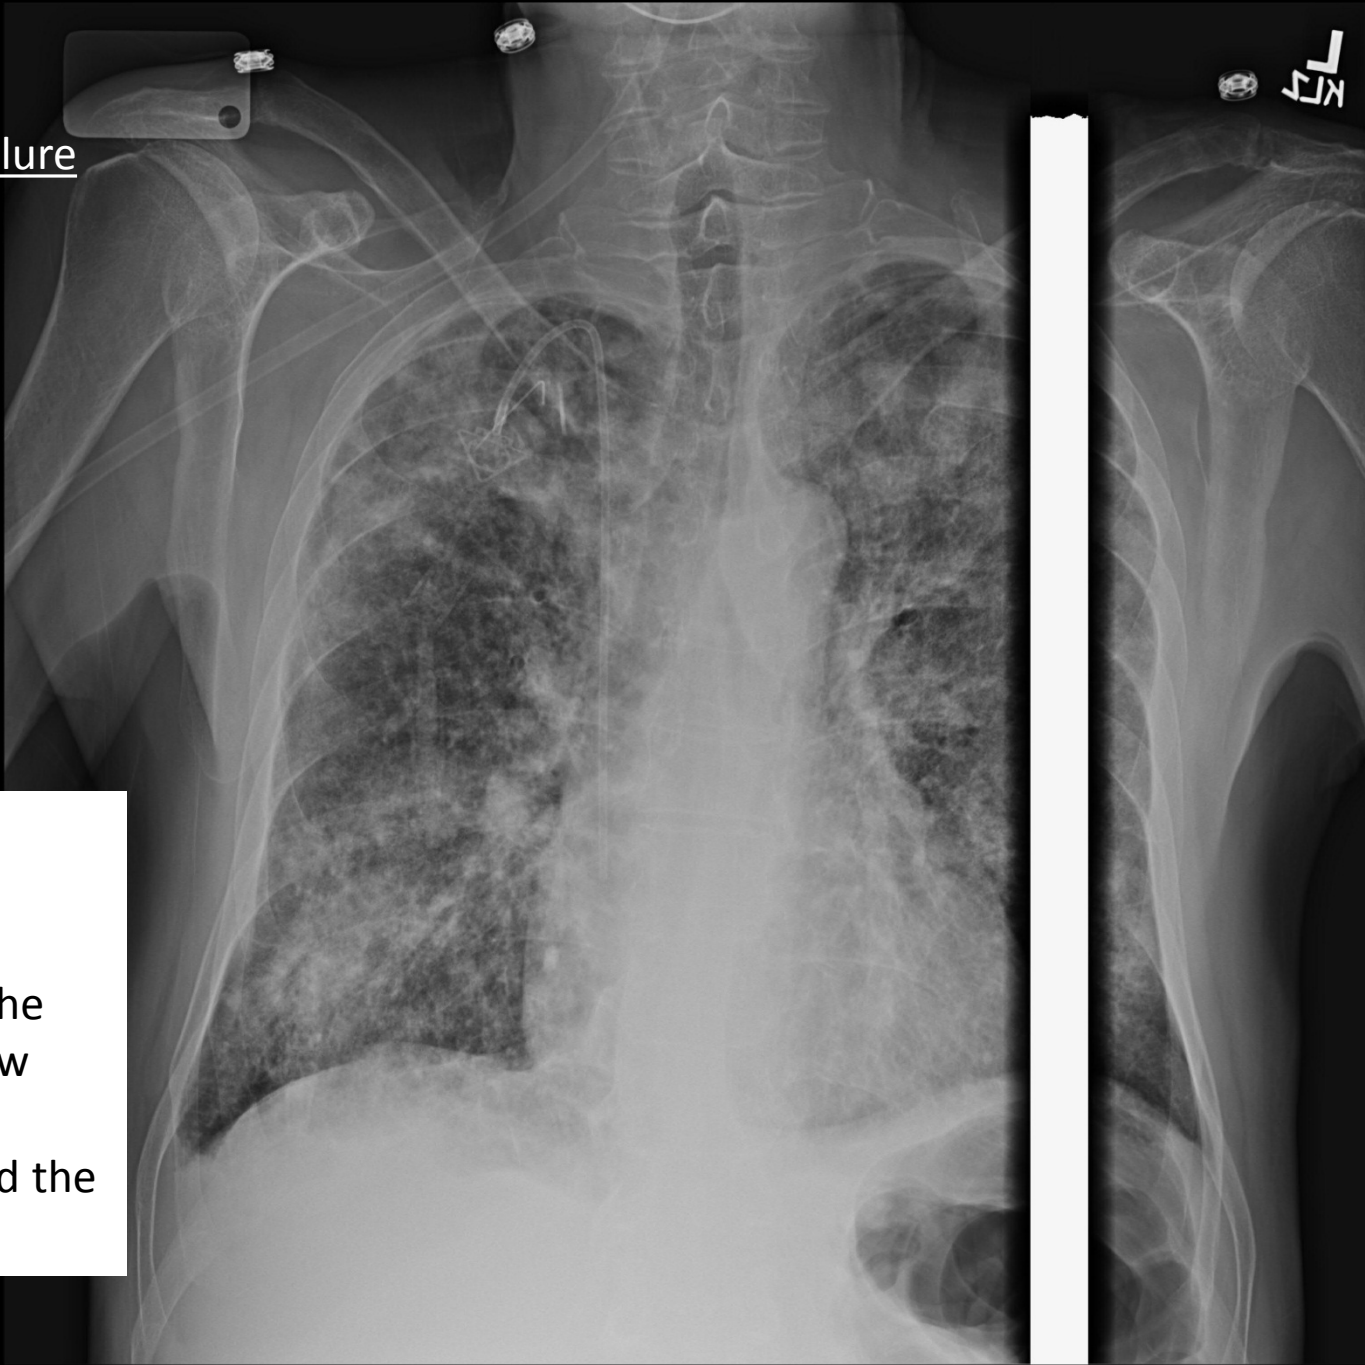
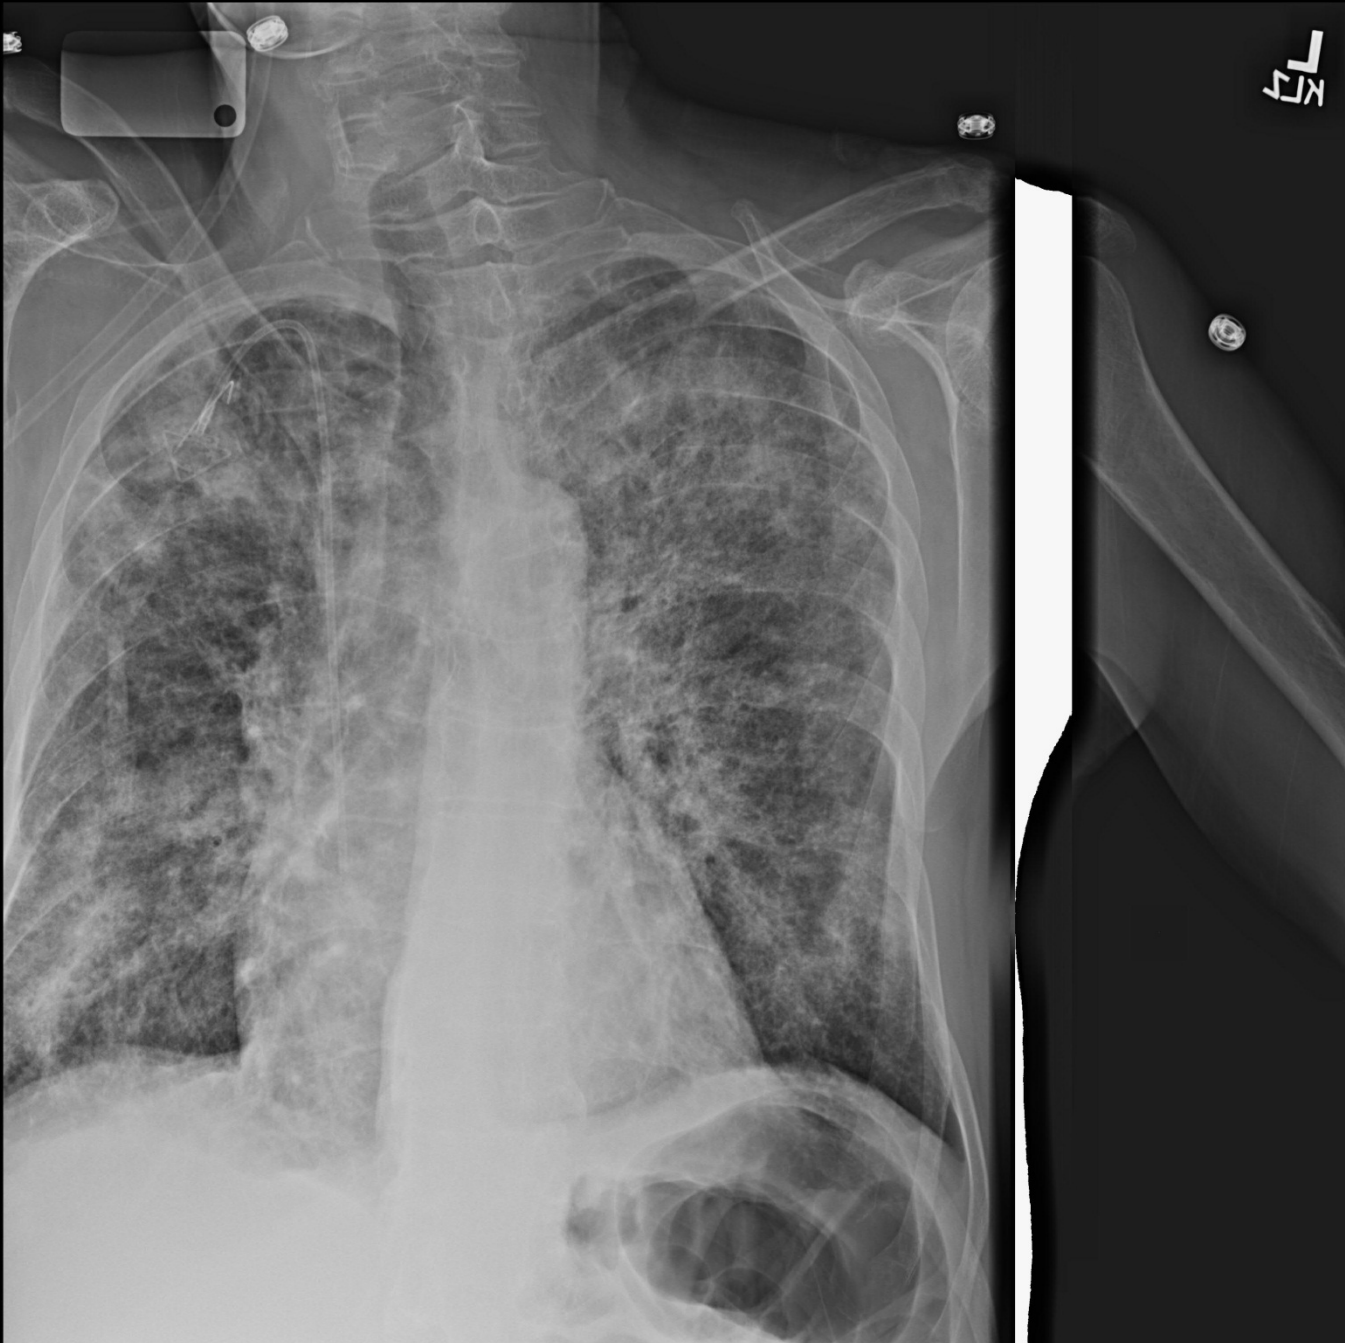
Readout failure

unknown

Rebooted the system a few times.

Recalibrated the detector.

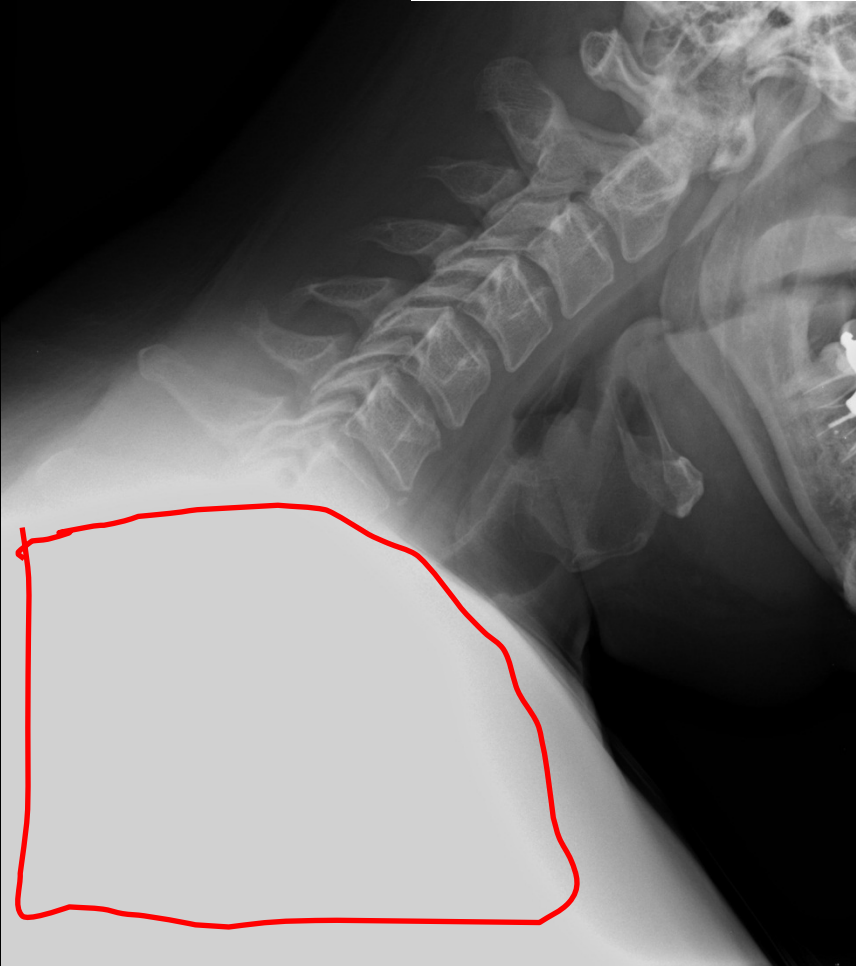
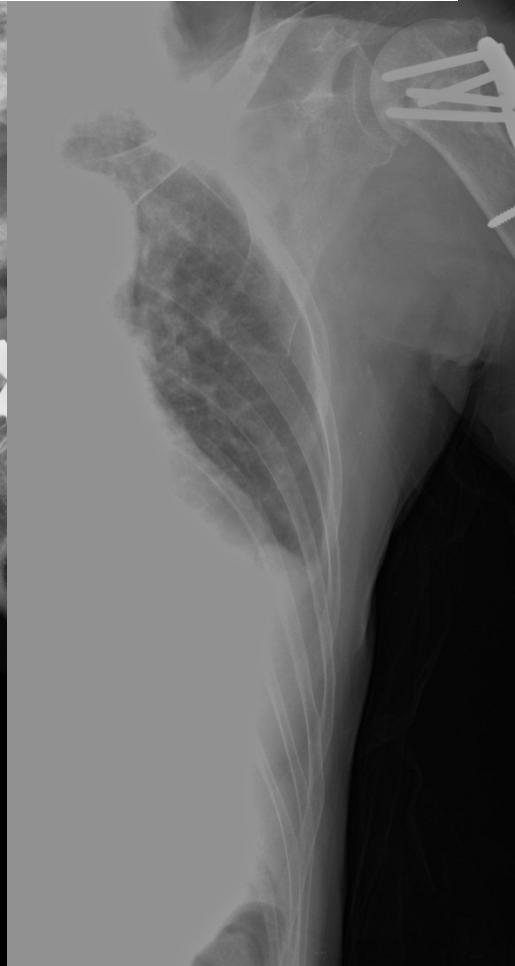
Issue: Histogram clipping. Image data outside of the Values of Interest are discarded and not recoverable.

Re-processed the images under a different setting with a fixed latitude
This issue is addressed by an upgrade to vendor software.

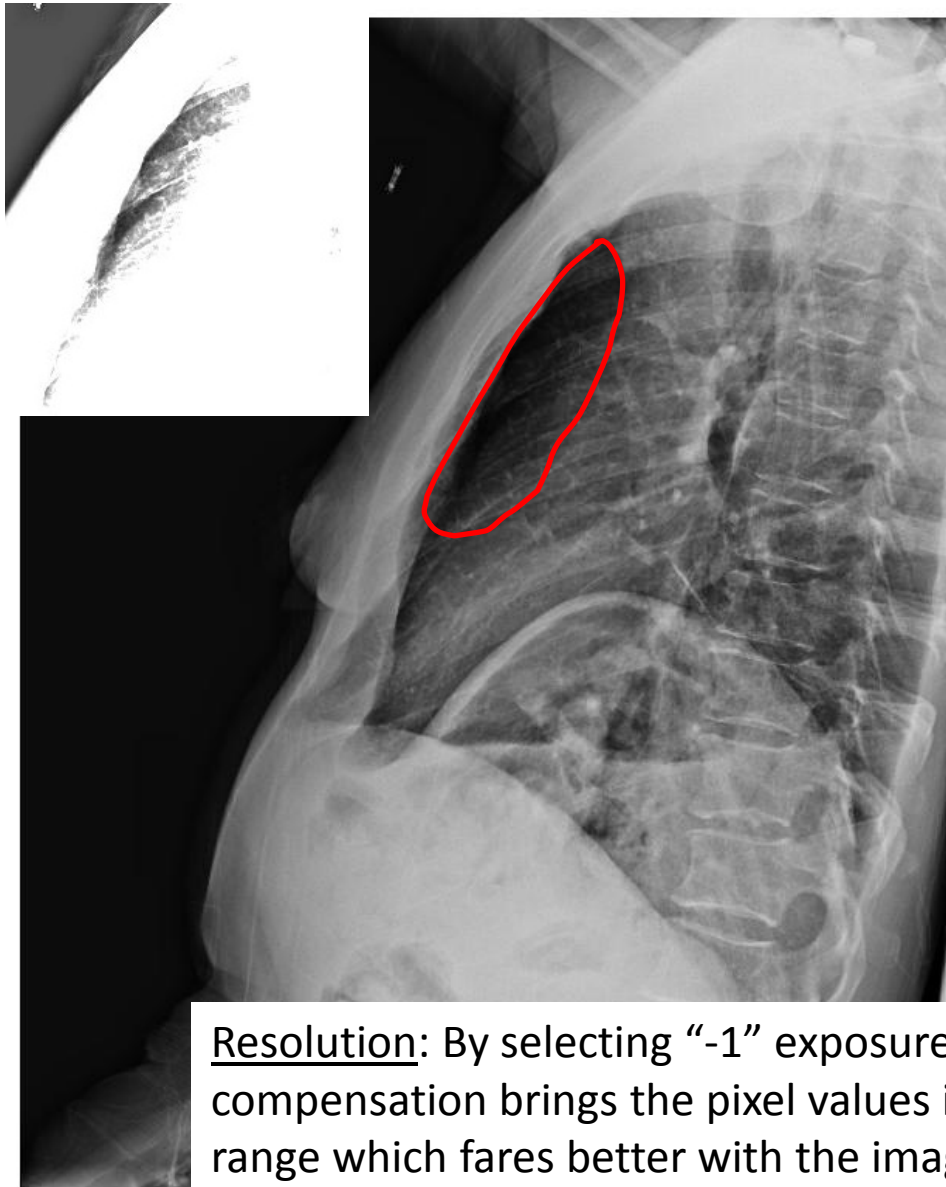
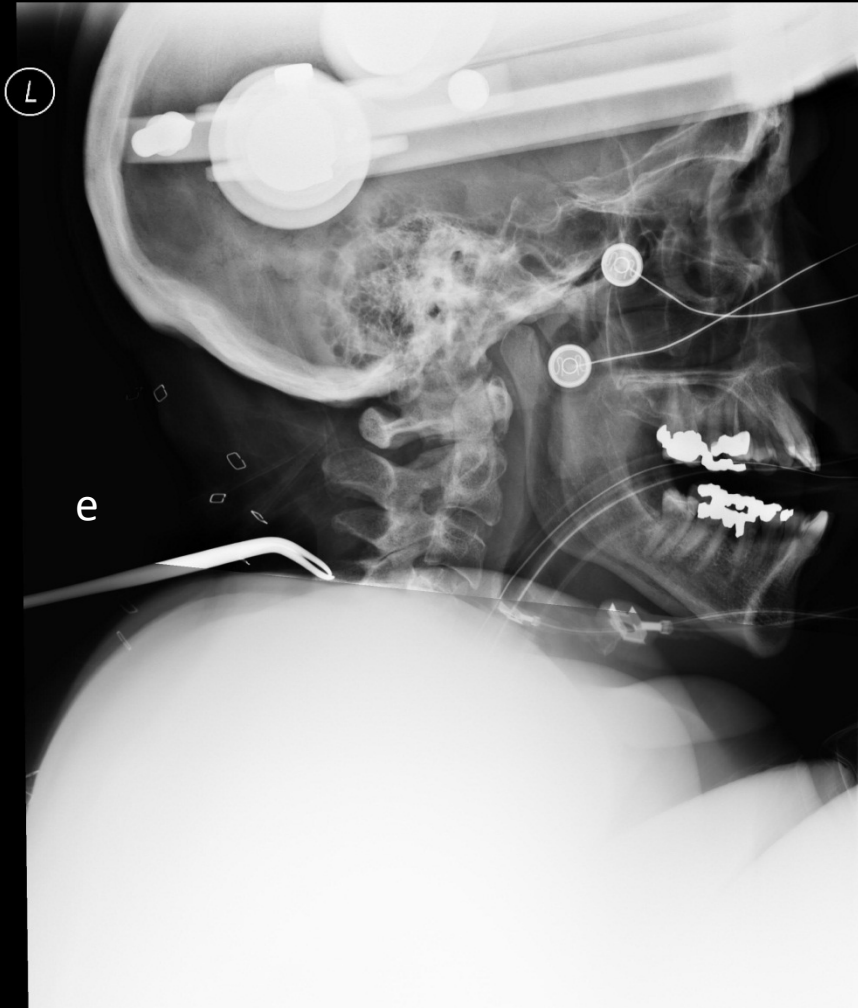
Issue: Image processing failure/Overexposure

The detector is not saturated. Image data in the region is recoverable. However, it is difficult to see and must have an extreme window/level to be made visible. It is often seen with small patients in lateral chest images.

Resolution: By selecting “-1” exposure compensation brings the pixel values into a range which fares better with the image processing and remaining image quality is sufficient.

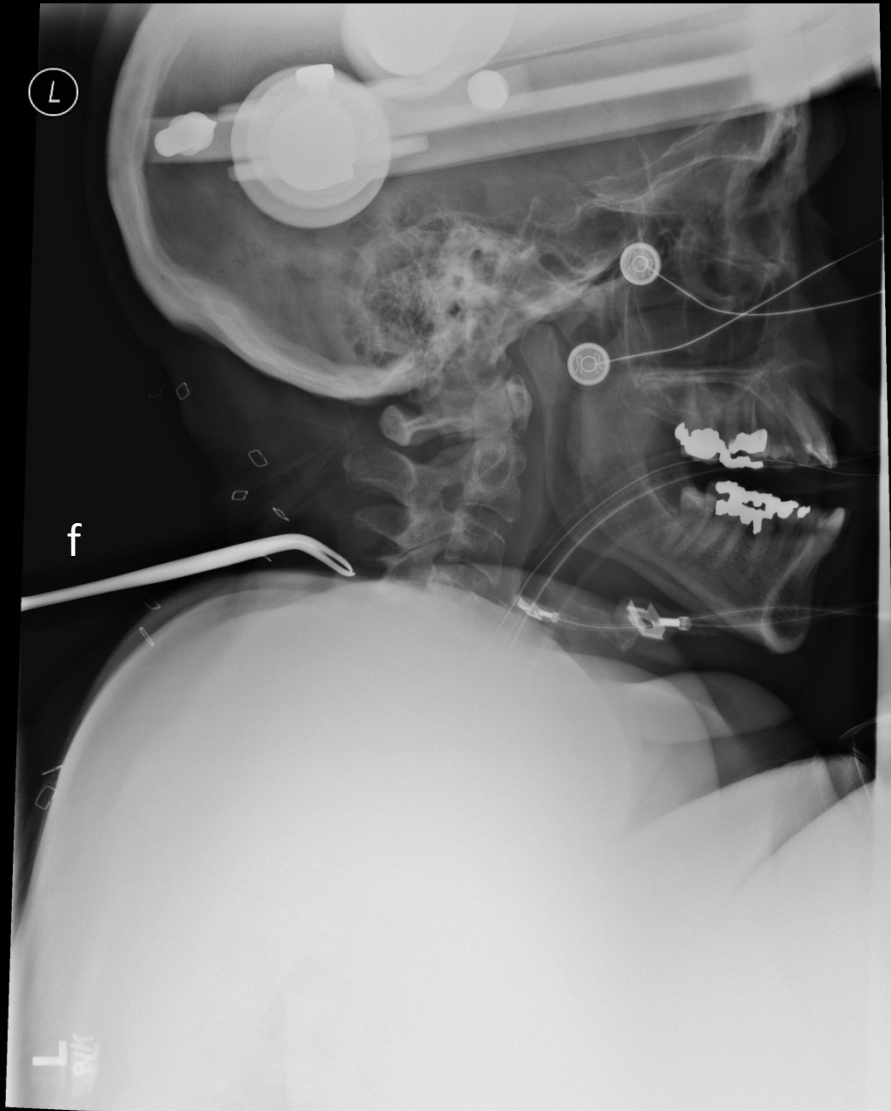
Issue: Incomplete image processing from incorrect shuttering.
Electronic shutter which selects region for processing triggers on the wrong area

Resolution: Shuttering can be manually modified.

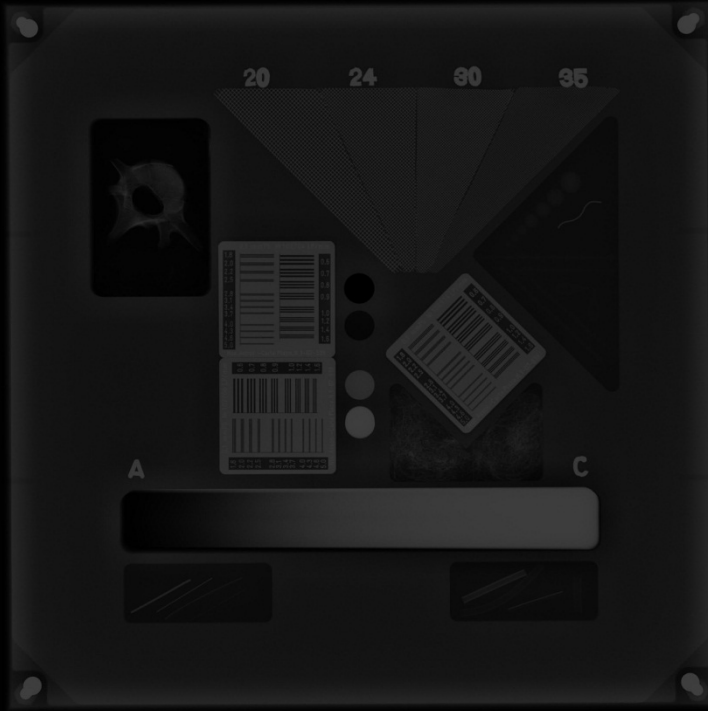
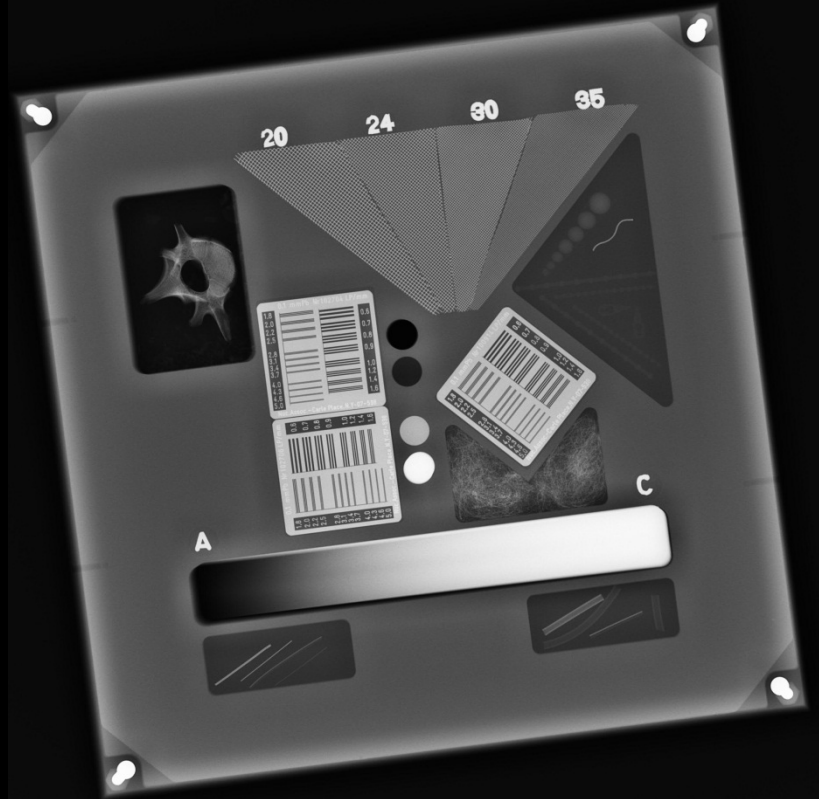
VOI LUT not received or recognized

VOI LUT recognized

Issue: VOI-LUT is not transmitted because of incorrect configuration. For the same system, this VOI-LUT is not recognized by downstream viewers.

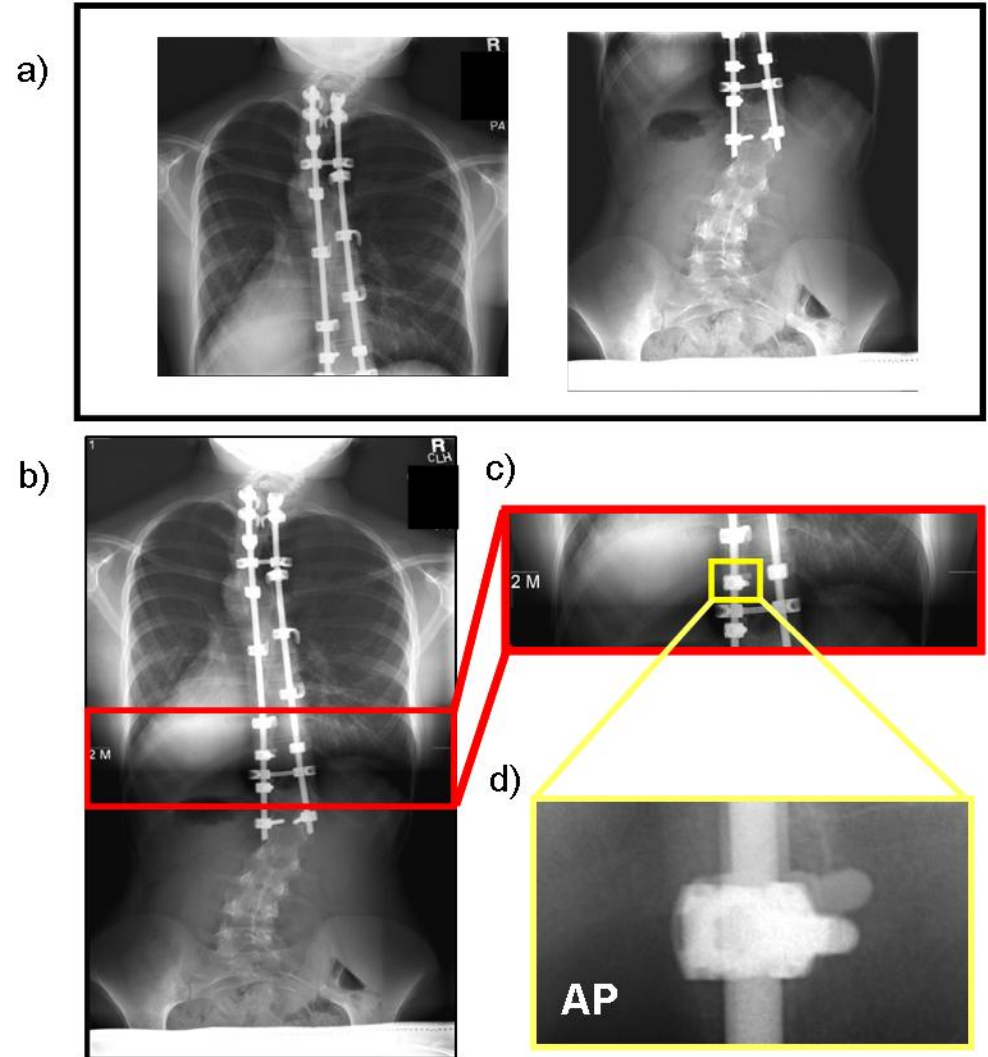
Stitching artifact

Different projections of the same object are combined into a single image.

Resolution: Vendor employs a different method for stitching where the source is stationary.
