# THE ART OF THE IMAGE: IDENTIFICATION AND REMEDIATION OF IMAGE ARTIFACTS IN MAMMOGRAPHY

#### William Geiser, MS DABR

Senior Medical Physicist MD Anderson Cancer Center

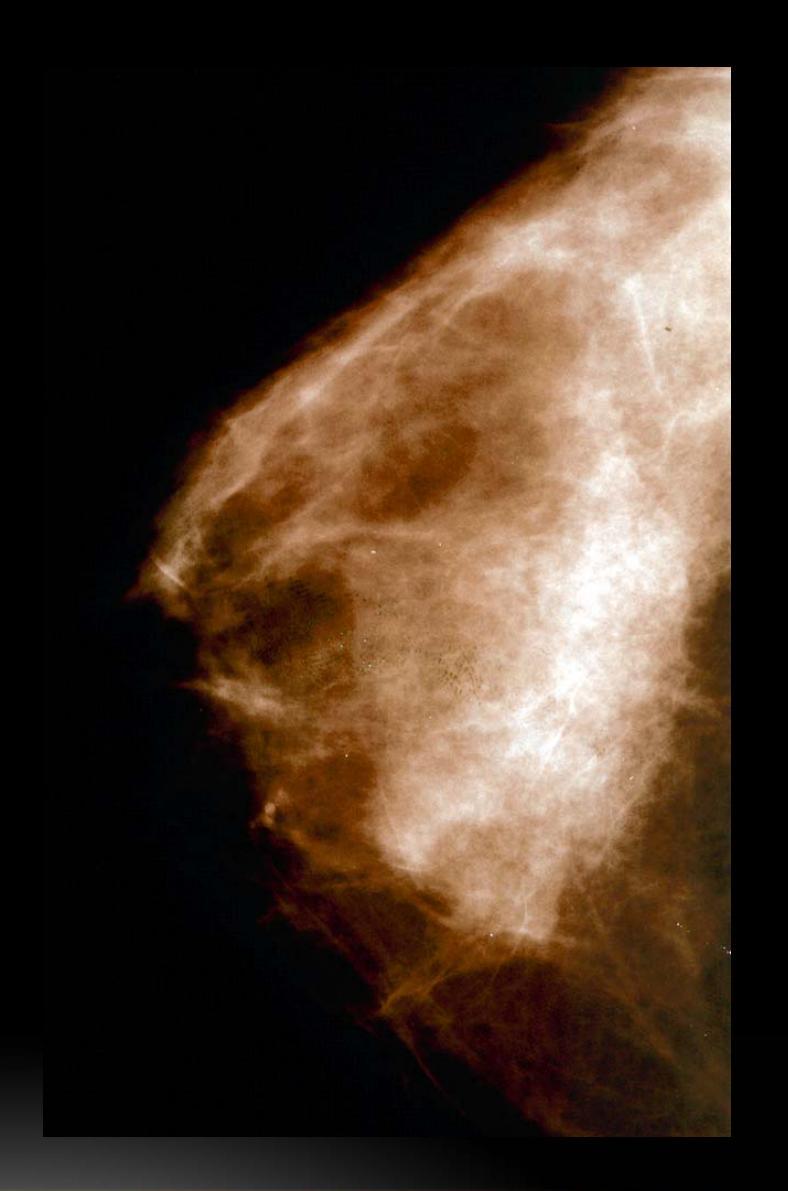
This incompletely fixed film is browned.

Film discoloration may result from incomplete or improper fixation.

Loss of circulation in the fixer tank, improperly mixed fixer, a low amount of fixer, or low fixer temperature may cause incomplete or improper fixation.

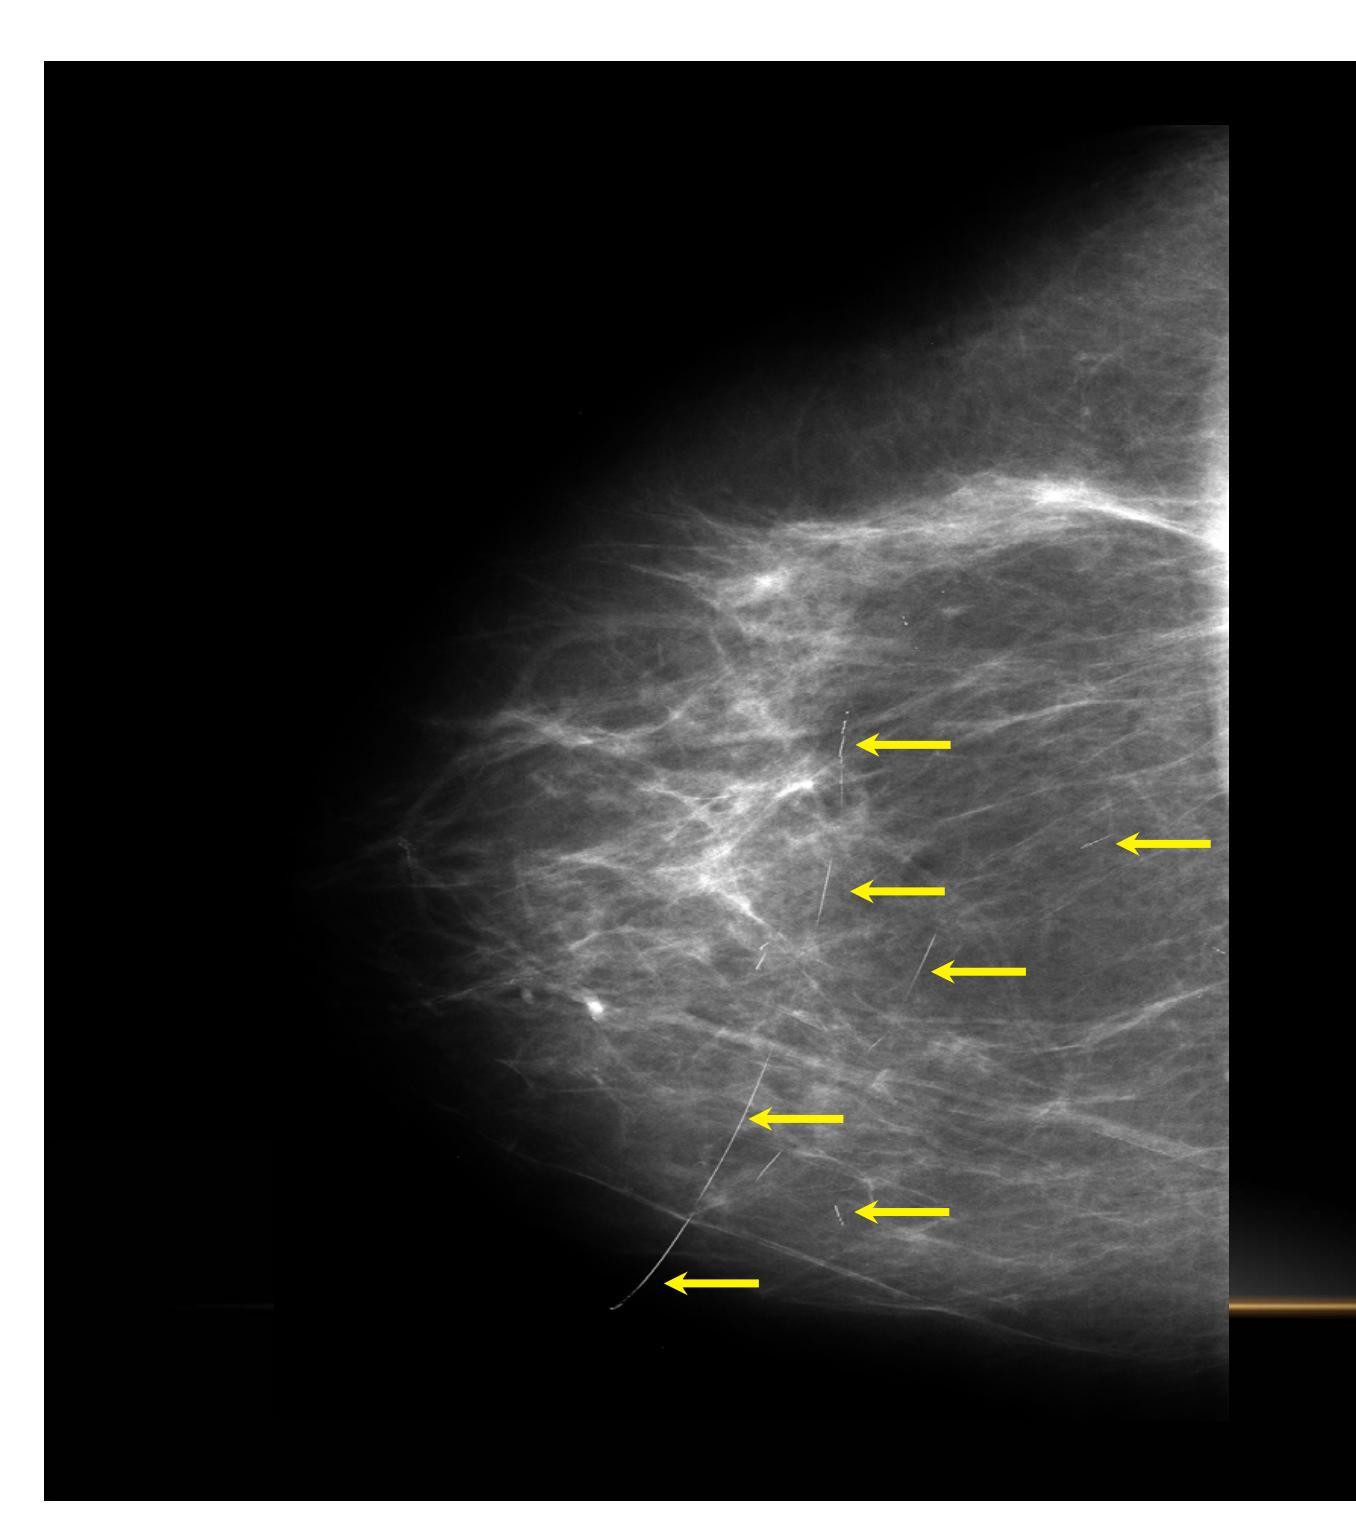
#### Scratches

Scratches and scrapes may result from dirty or worn rollers, incorrect tension on the drive chains, improperly positioned crossover rollers, misaligned guide shoes, improper alignment of the film on the feed tray, improperly mixed processor chemicals, or a deficient replenishment rate. Wedding rings, long fingernails are also causes of film scratches.

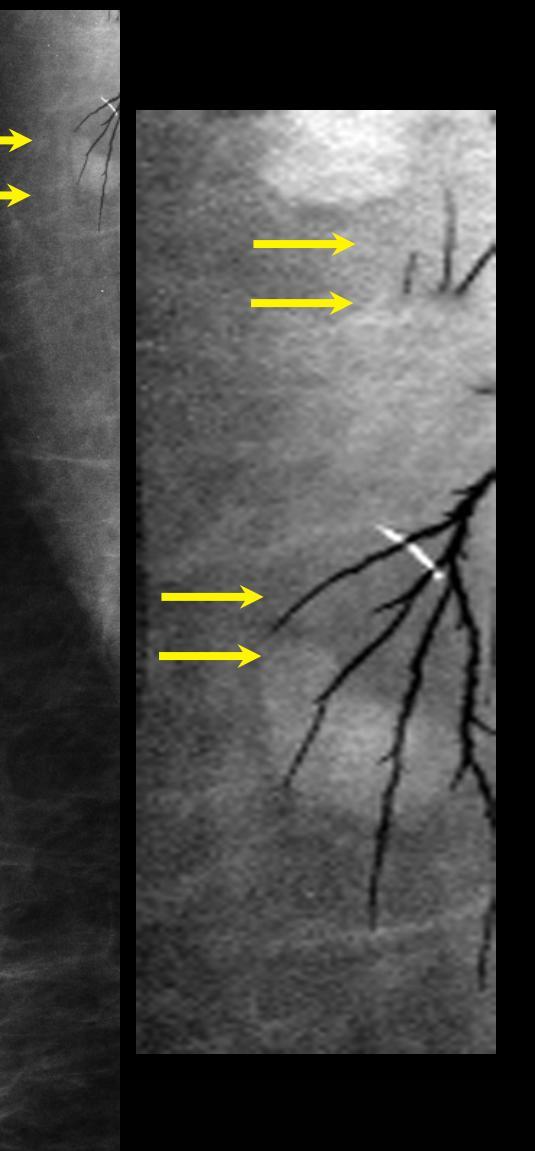
# Lightning-like static artifact .

• Static artifact may result from low humidity, under-replenishment of processor chemicals, improper film handling, or improper electrical grounding of the processor. Extremely dry air in the area may also be a cause.

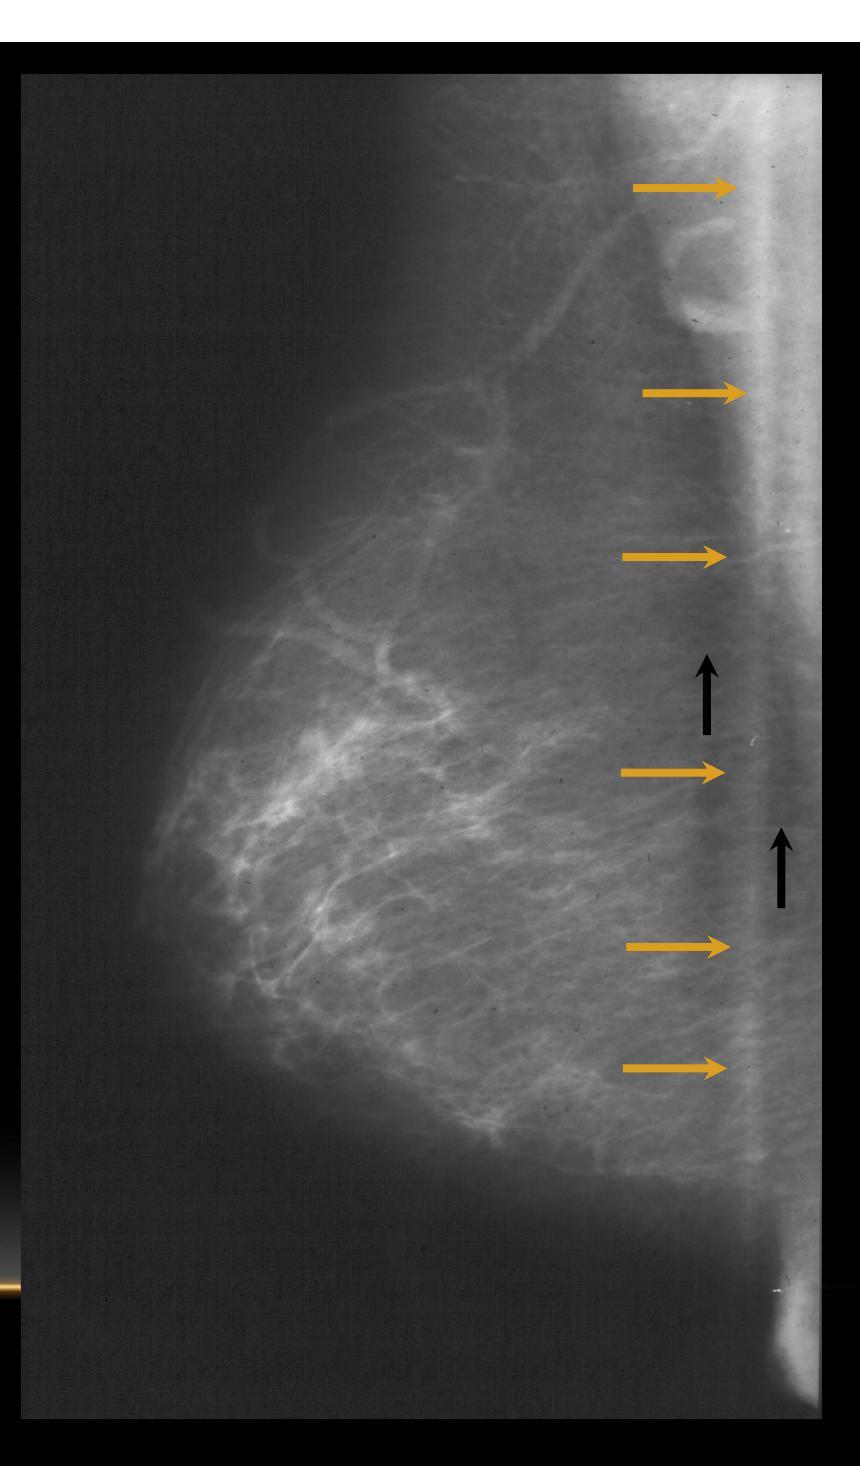
Linear crease artifact (black arrows) and adjacent poor screen-film contact (orange arrows) result from the film being folded in the cassette.

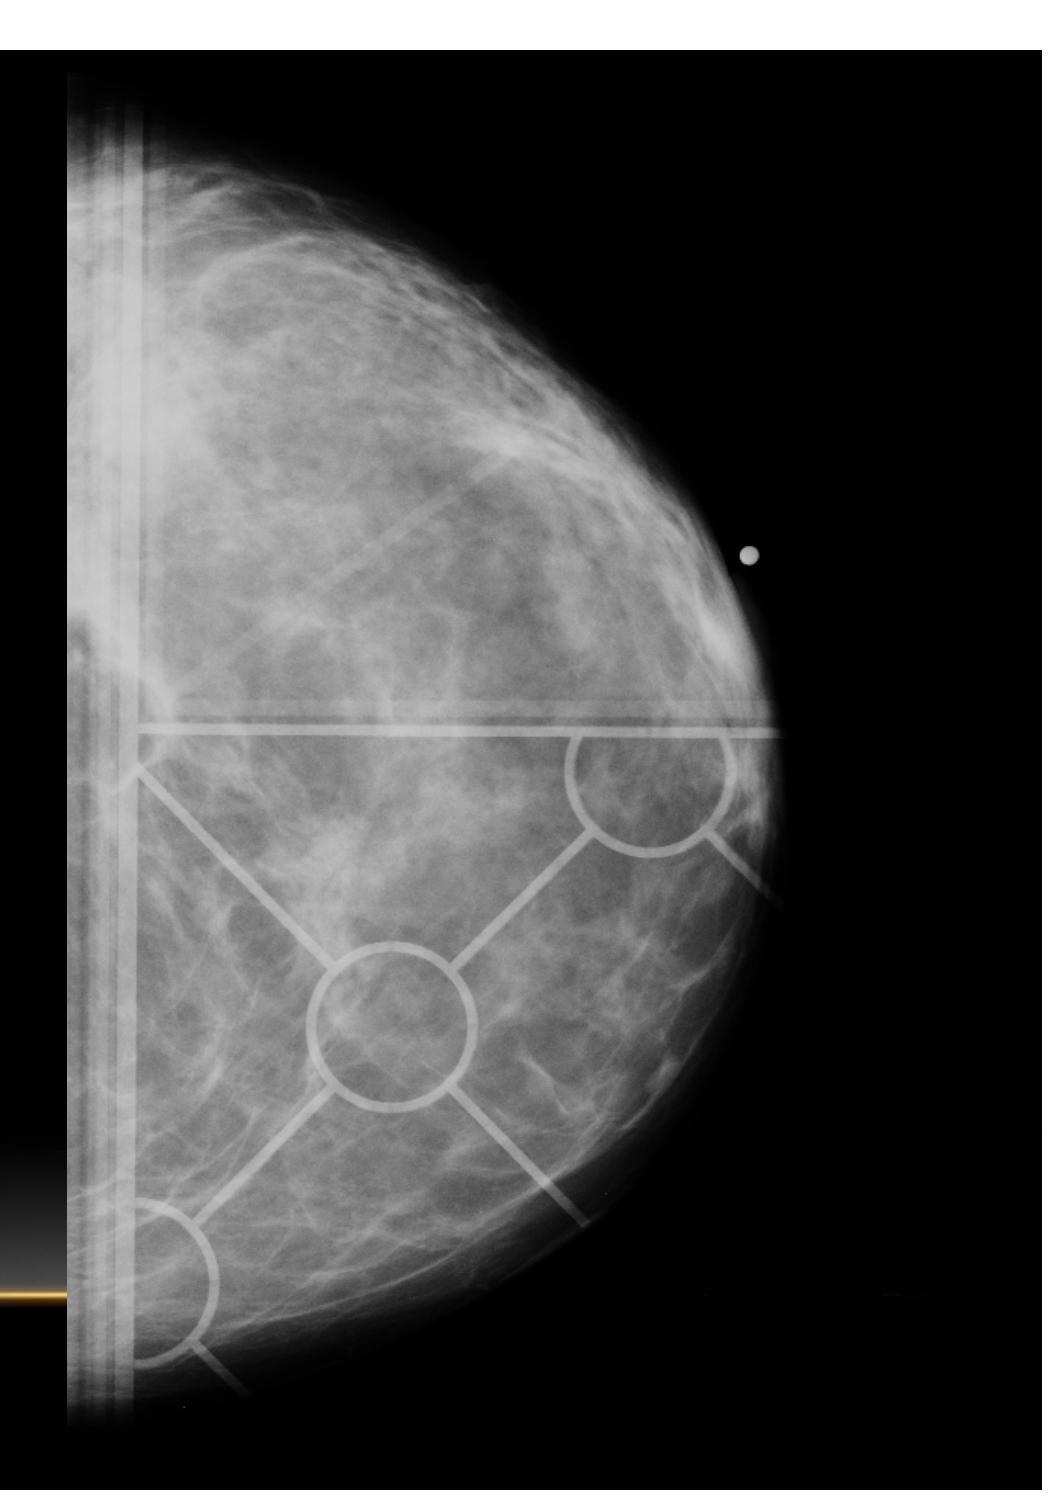
The internal structure of the cassette is superimposed on the image when the cassette is loaded upside-down into the Bucky tray.

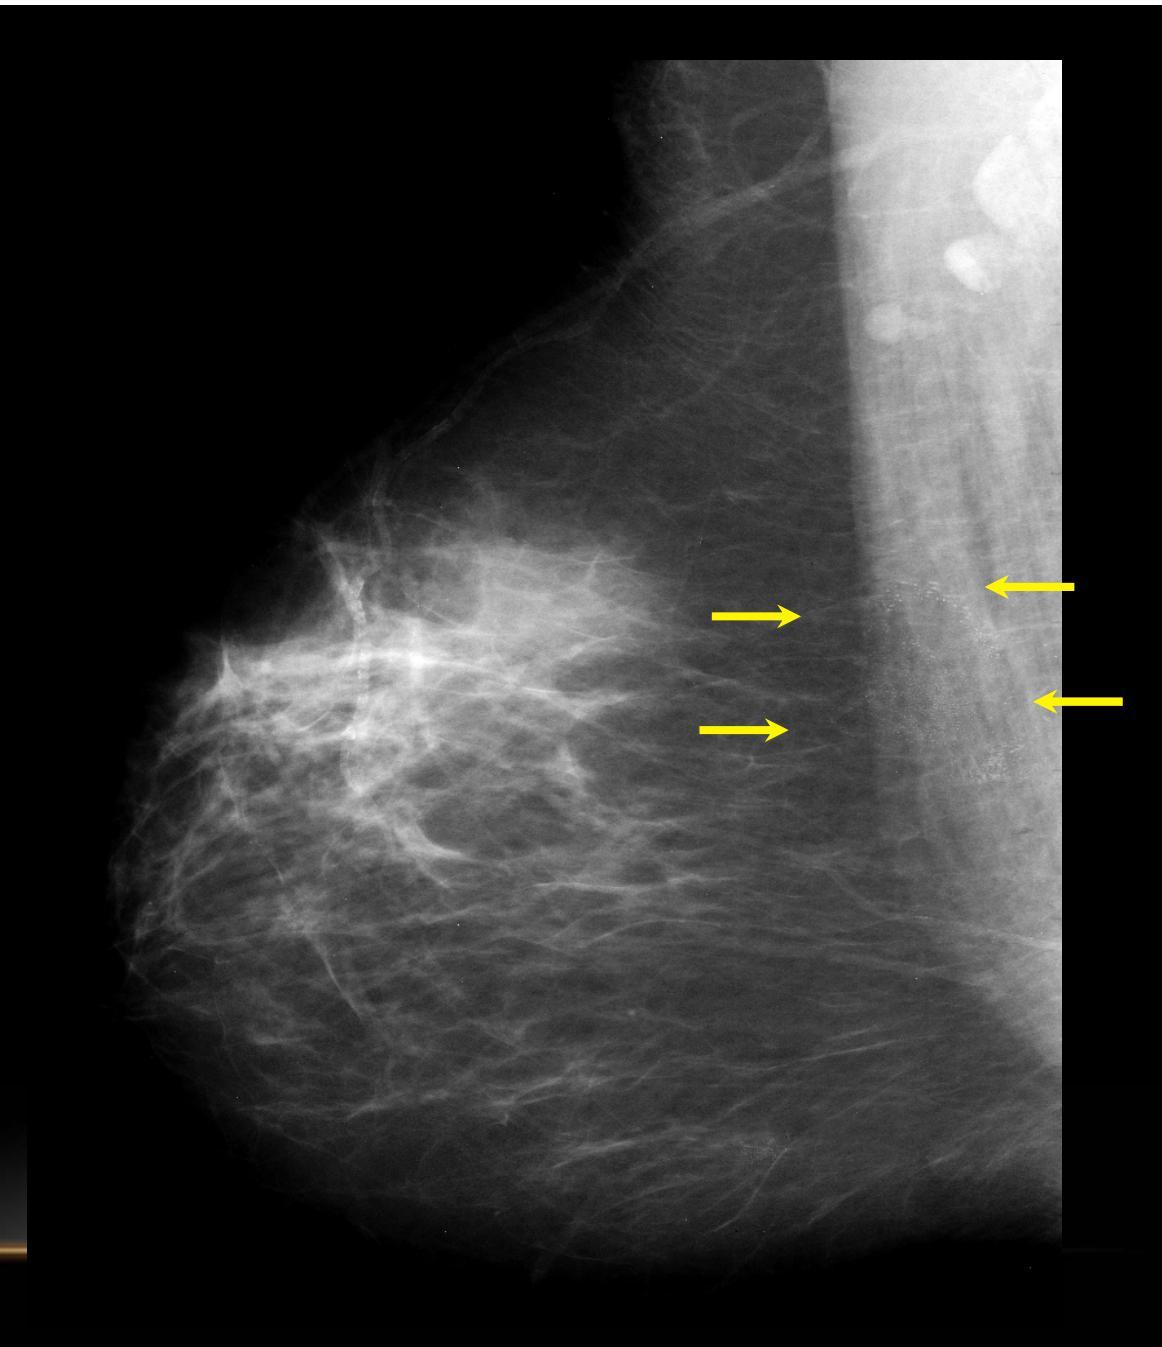
# Cleaning solution artifacts (arrows).

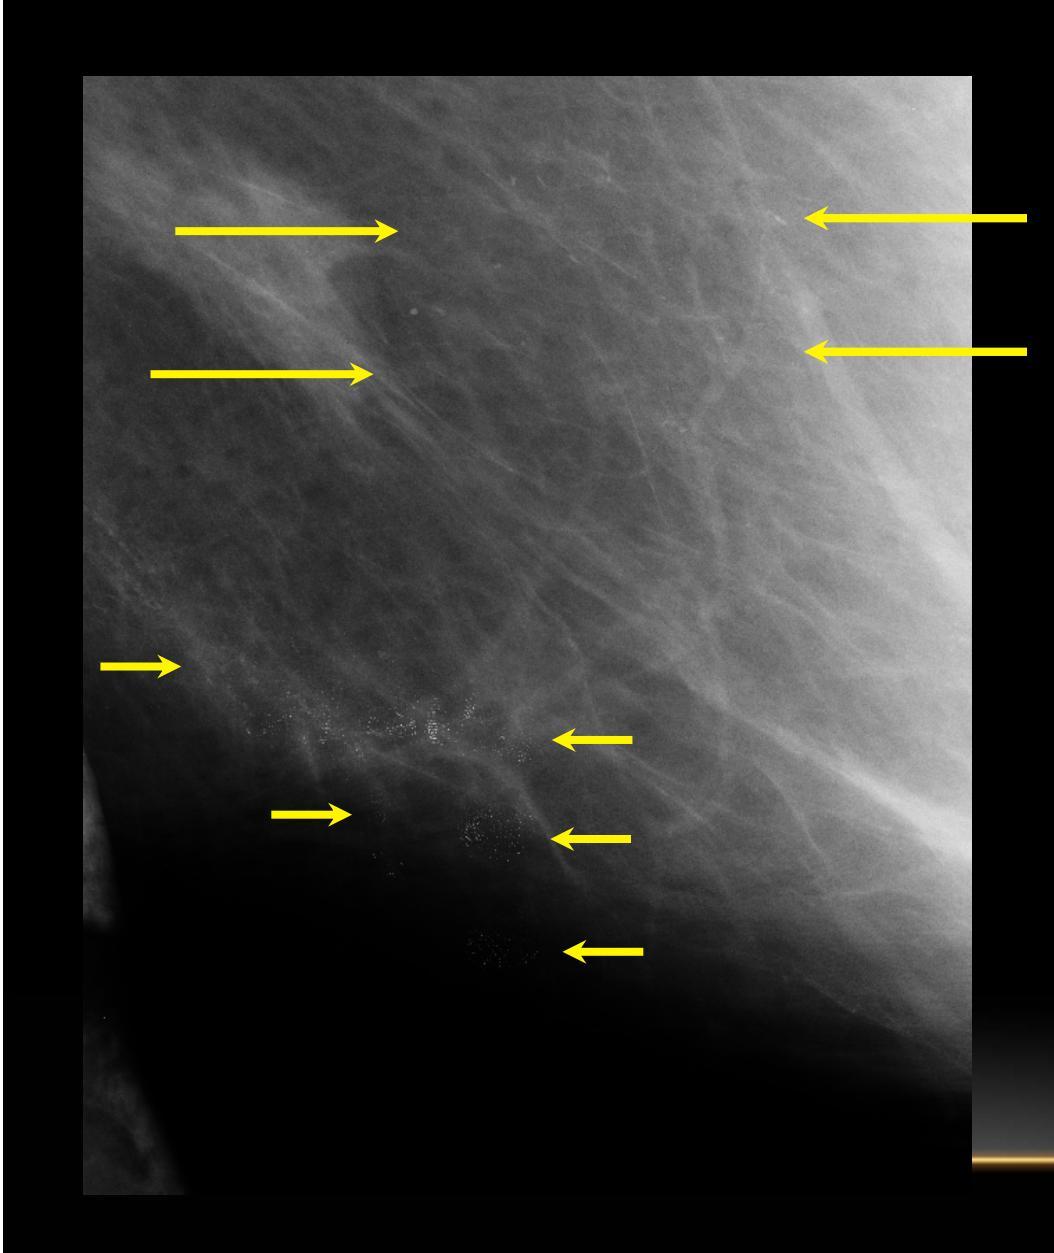
# Fingerprints (arrows).

Fingerprints (short arrows) and calcifications (long arrows). Fingerprints can obscure detail when evaluating mammograms for calcifications.

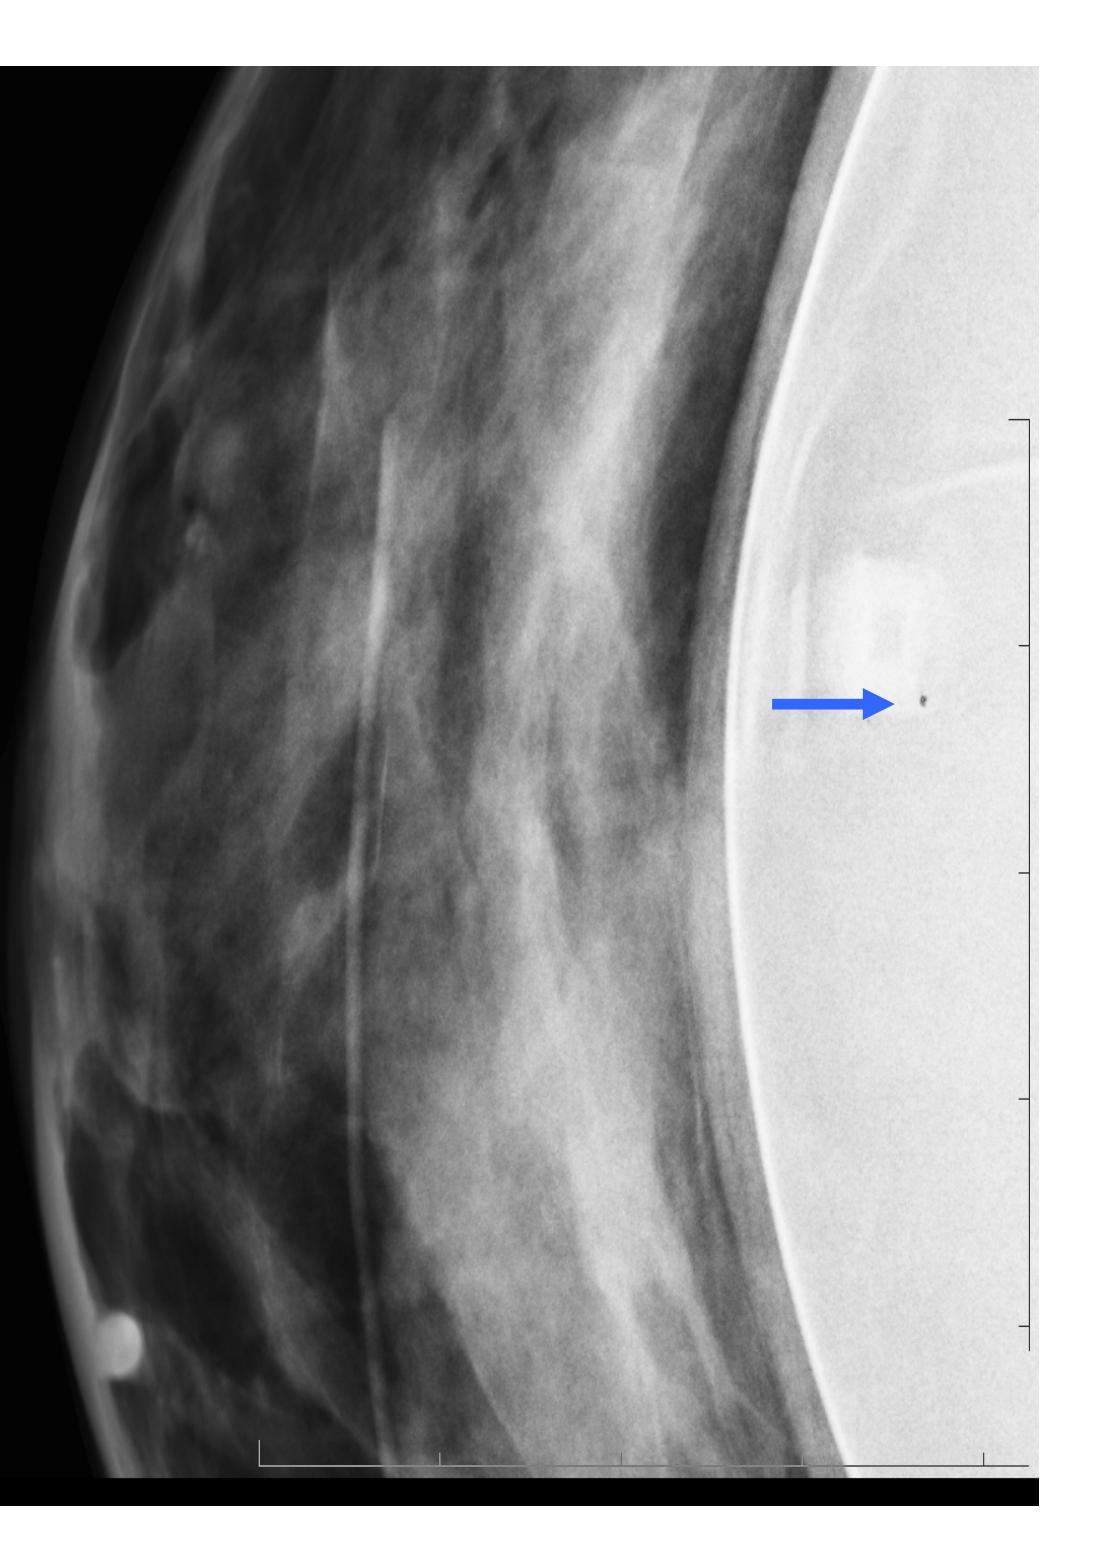
• Dead pixel group projecting over an implant.

- Not necessarily clinically significant
- Usually identified on weekly artifact evaluation images
- Requires service call to get detector element mapped out

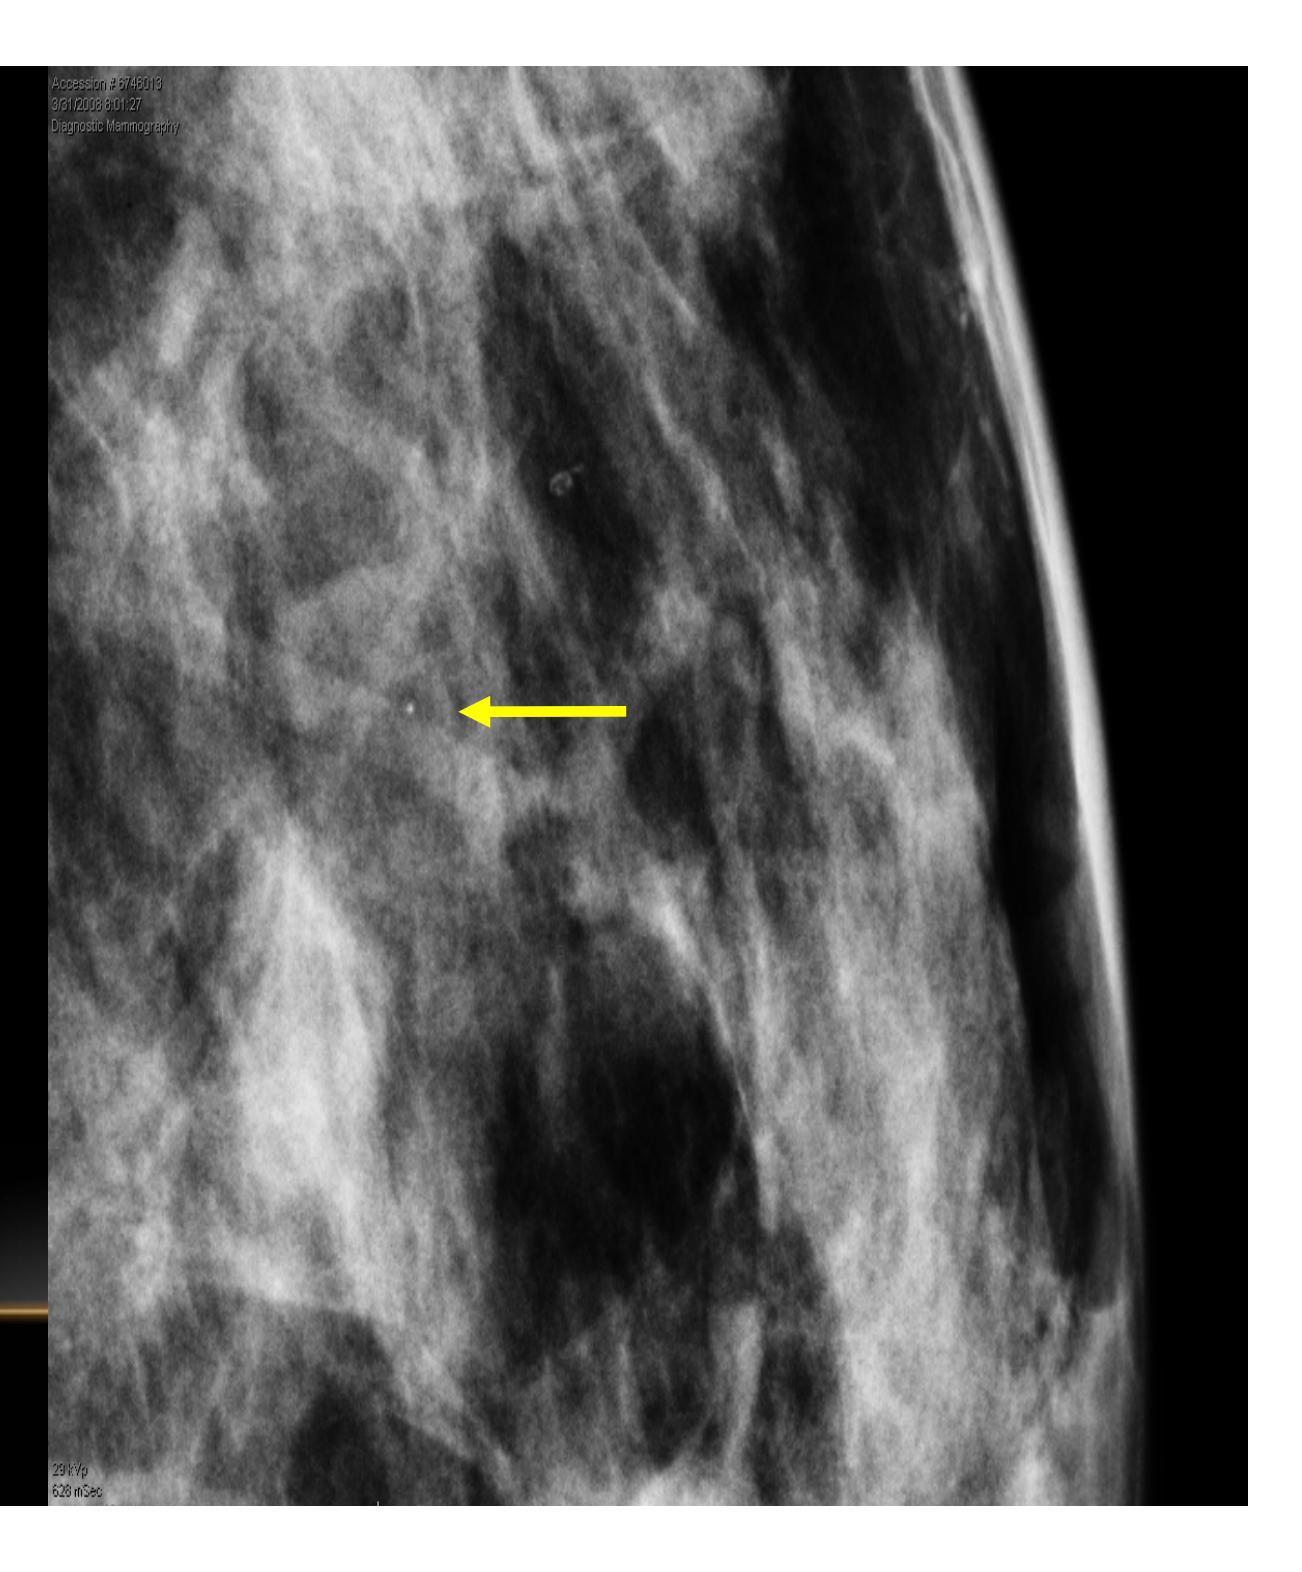
- The same dead pixel group seen in a standard LCC view.
- Individual dead pixels are mapped out by the service engineer.

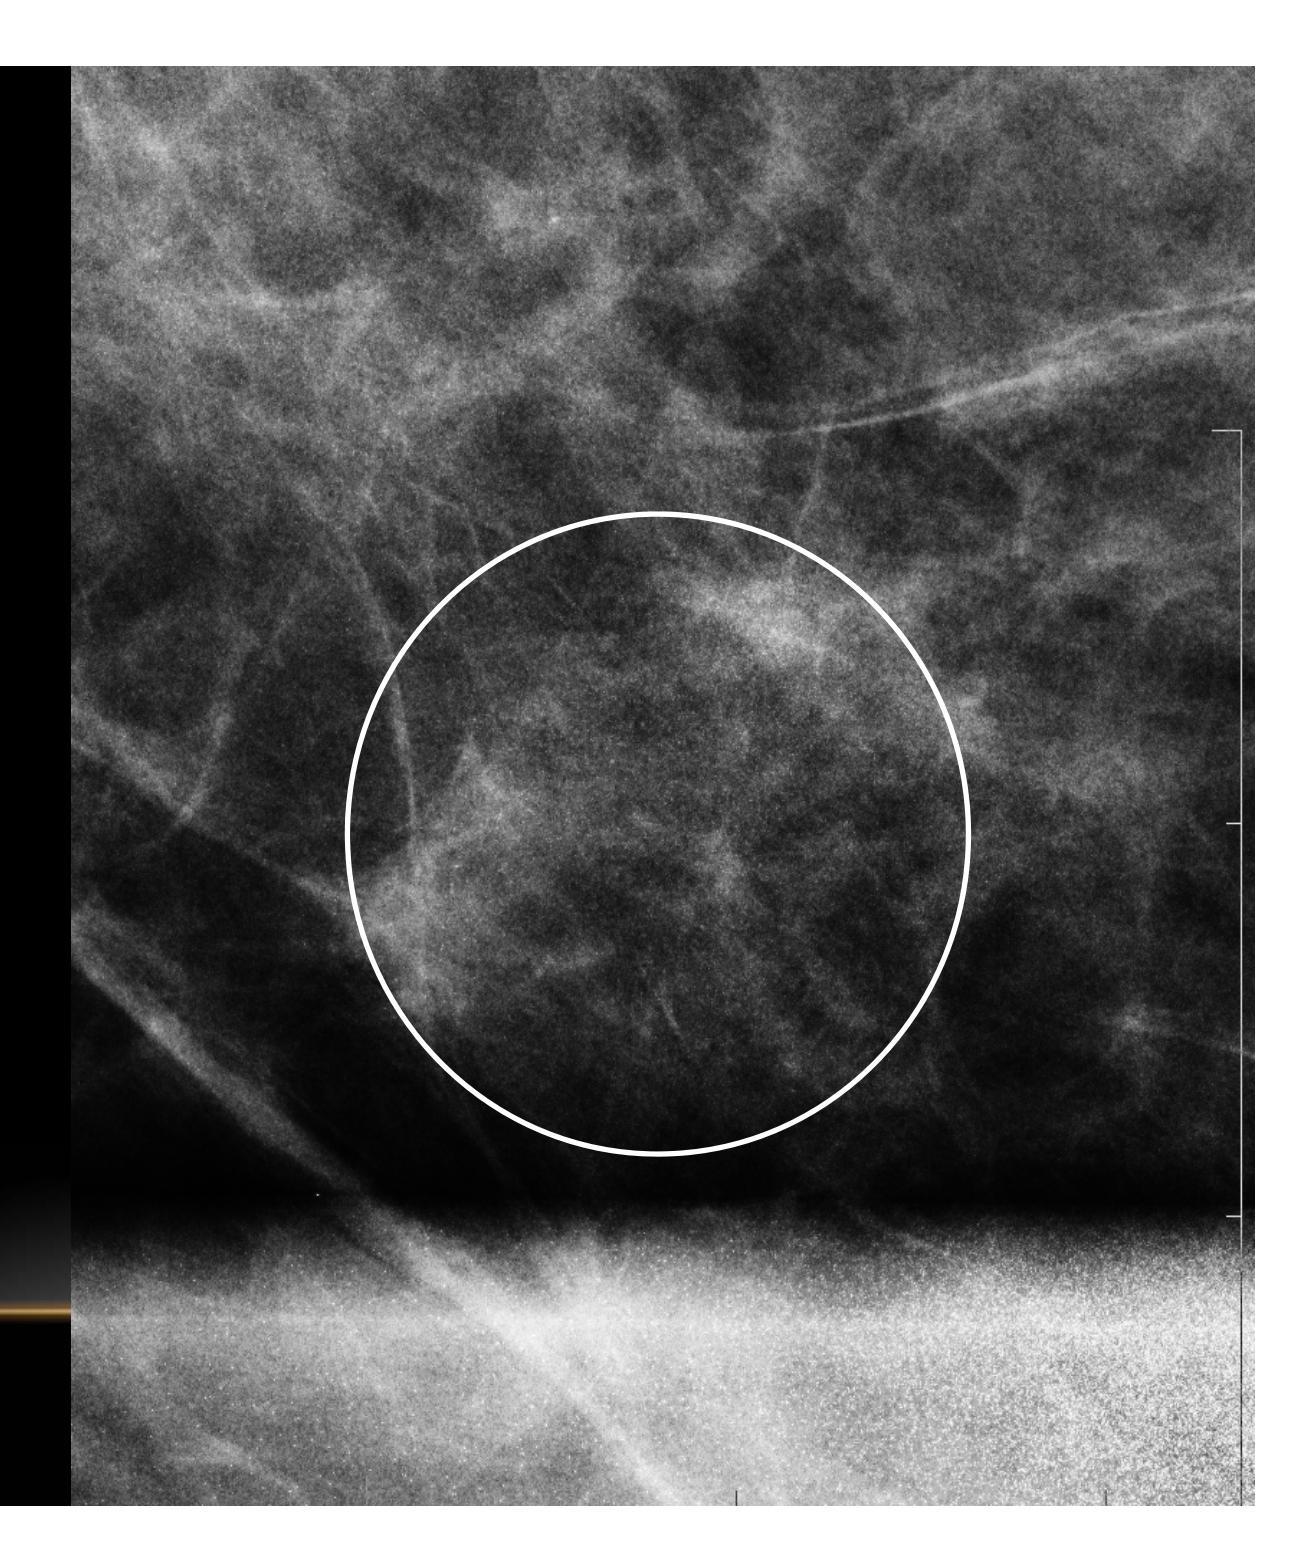
As a detector gets damaged by exposure to radiation, pixels begin to be damaged and no longer operate properly. The following images show a detector at the end of its useful life. Note the many dead pixels and how they look like small scattered calcifications. Subsequent testing using a flat field phantom and the ACR accreditation phantom showed the damage to the detector. This detector was replaced.  FFDM detector failure showing large numbers of misread or dead pixels. These can look like clusters of microcalcifications

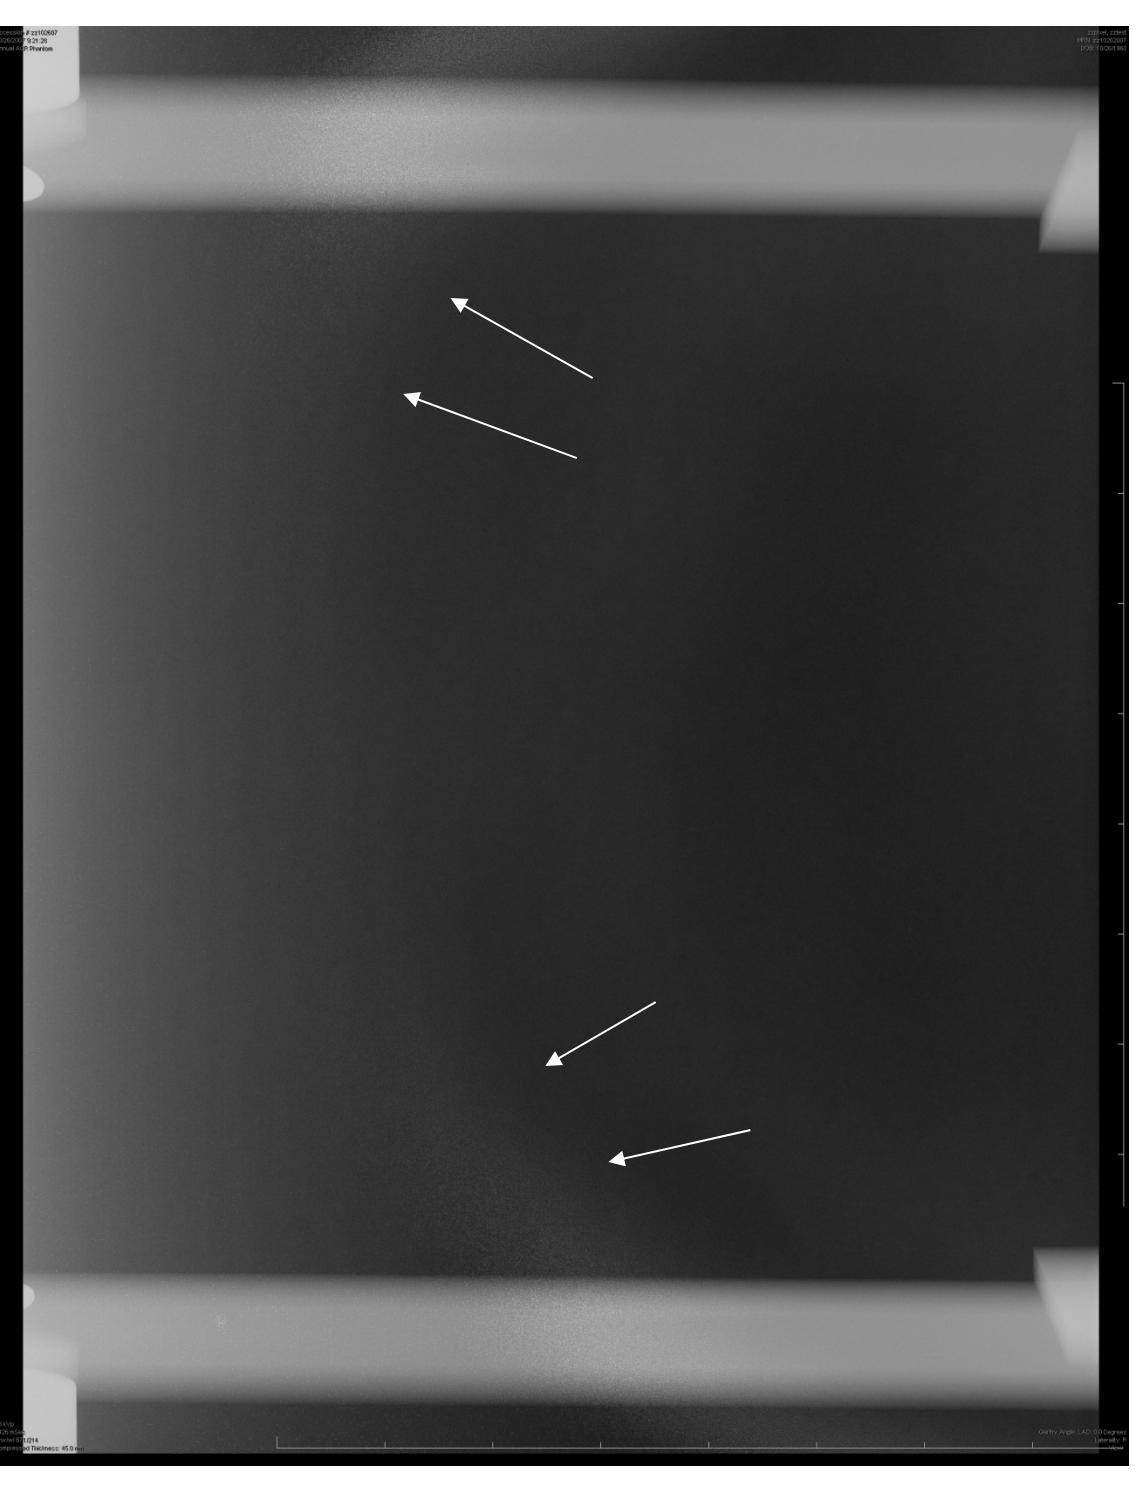
Flat field image of a detector as it starts to fail. Note the white band of dead pixels.

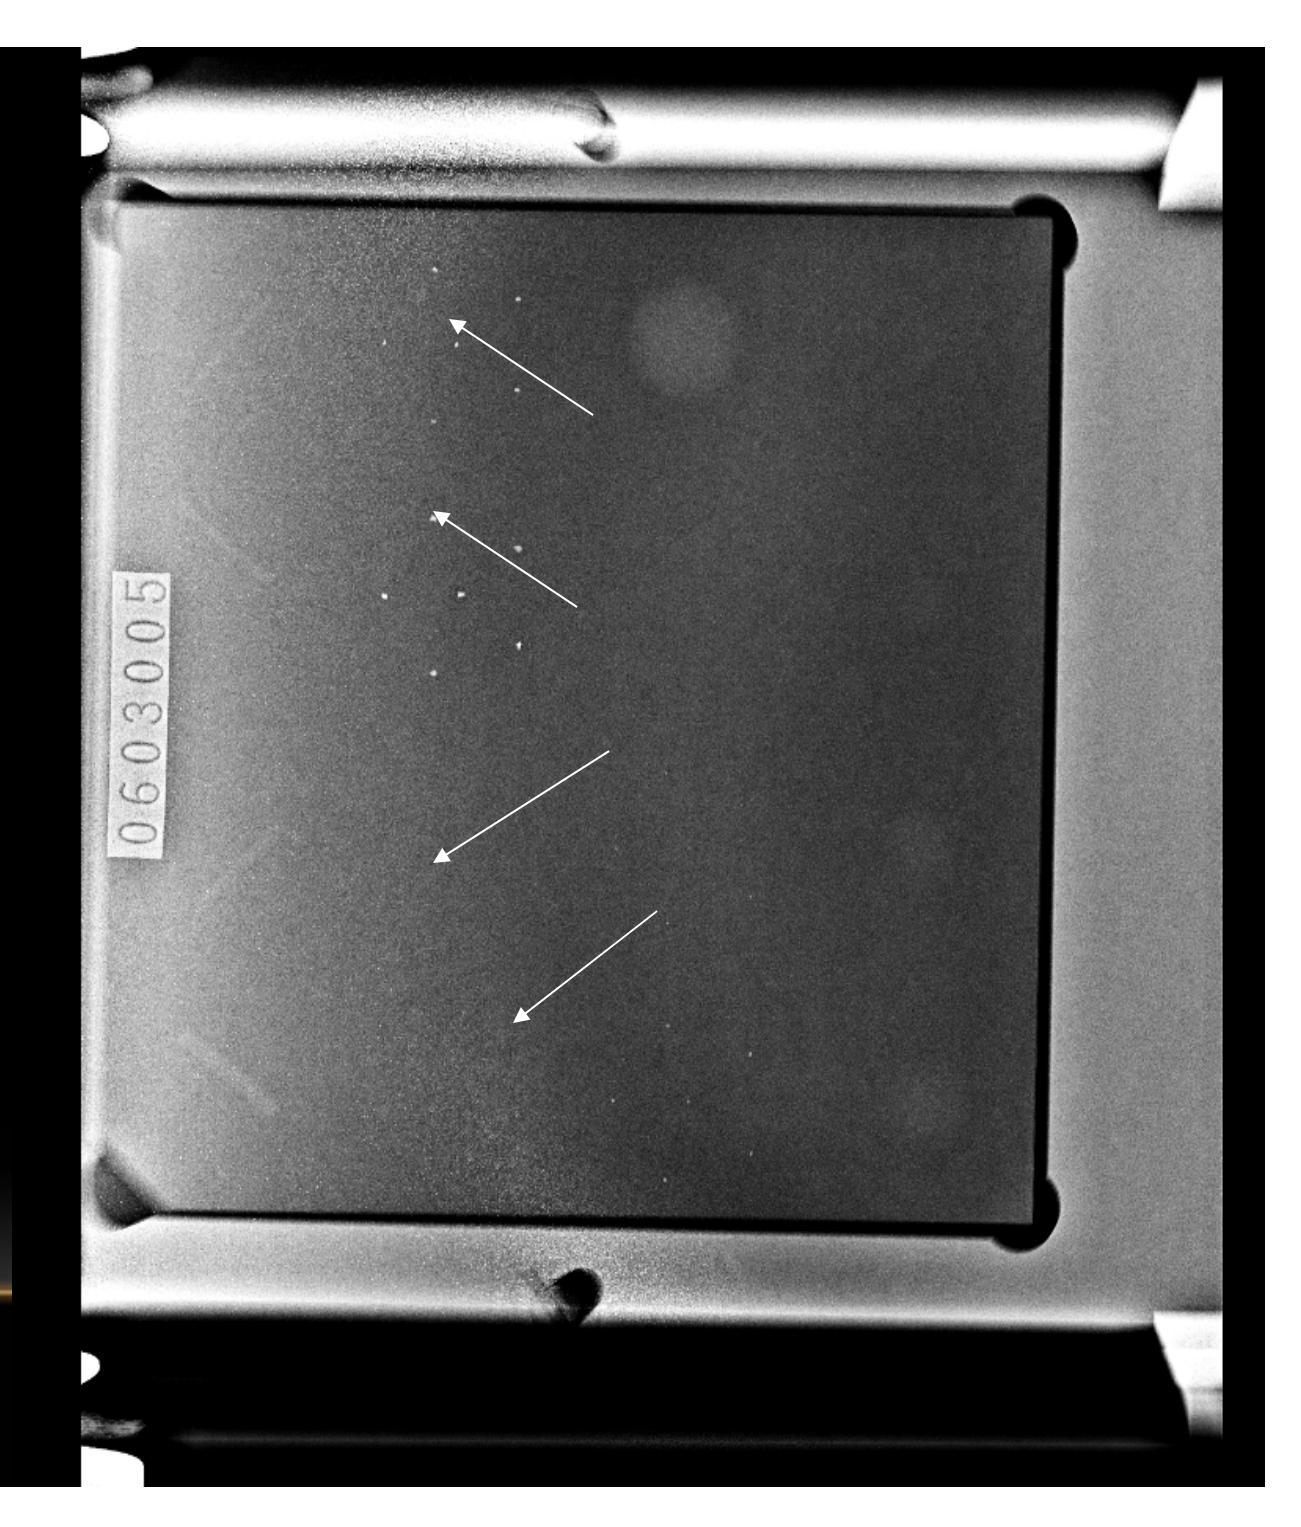
- Magnification image of the ACR Accreditation phantom on a detector as it starts to fail. Note the white band of dead pixels.
- This room was taken out of service immediately and the detector replaced within a couple of days

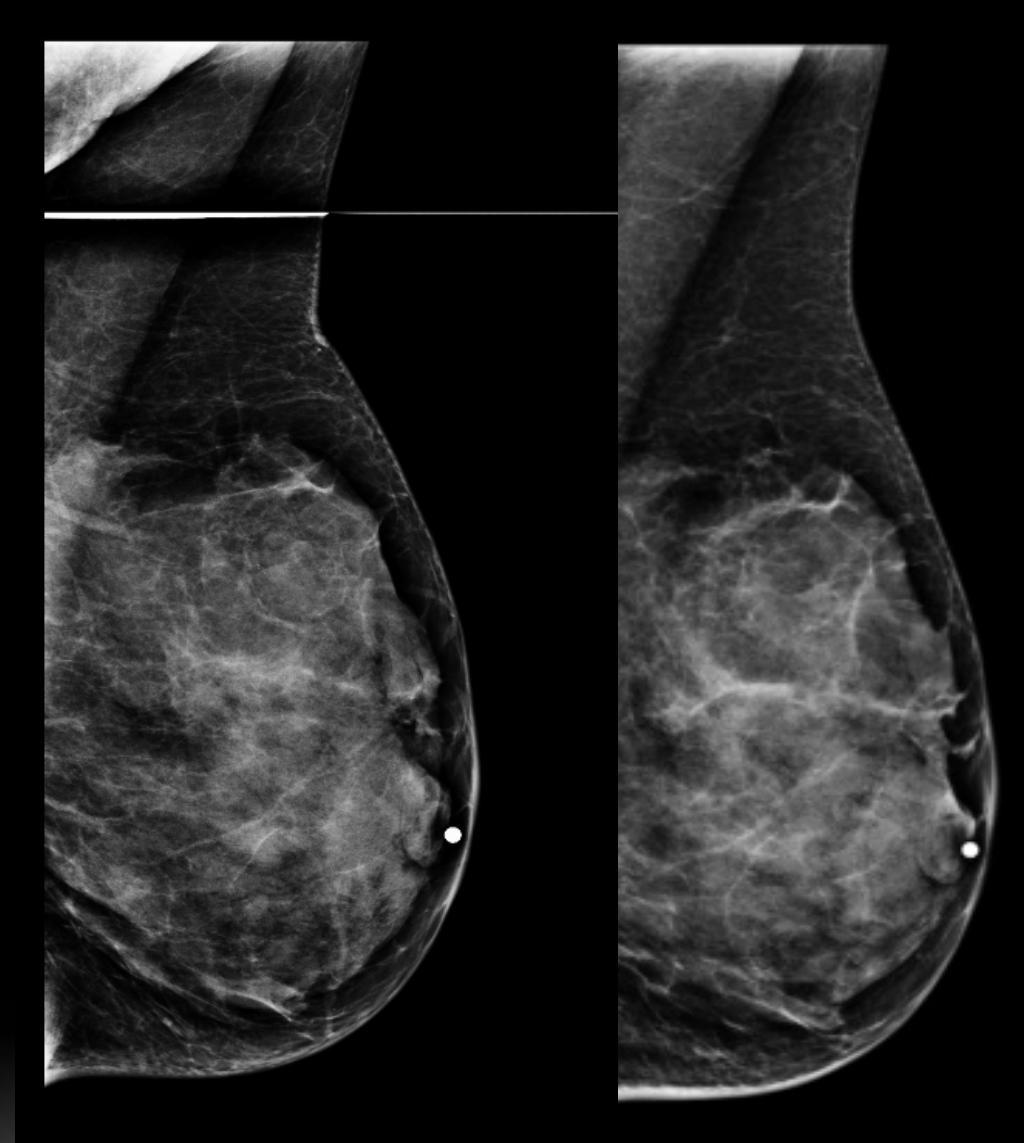
Failure of a line to read out during read out of the detector.

System corrected itself on repeat exposure.

- Technologist took image and noted an artifact
- Continued with exam
- Artifact disappeared on next image
- Retake of same projection was satisfactory
- Determined that gate line did not turn on
- Tech support had service engineer install new sequence file for readout

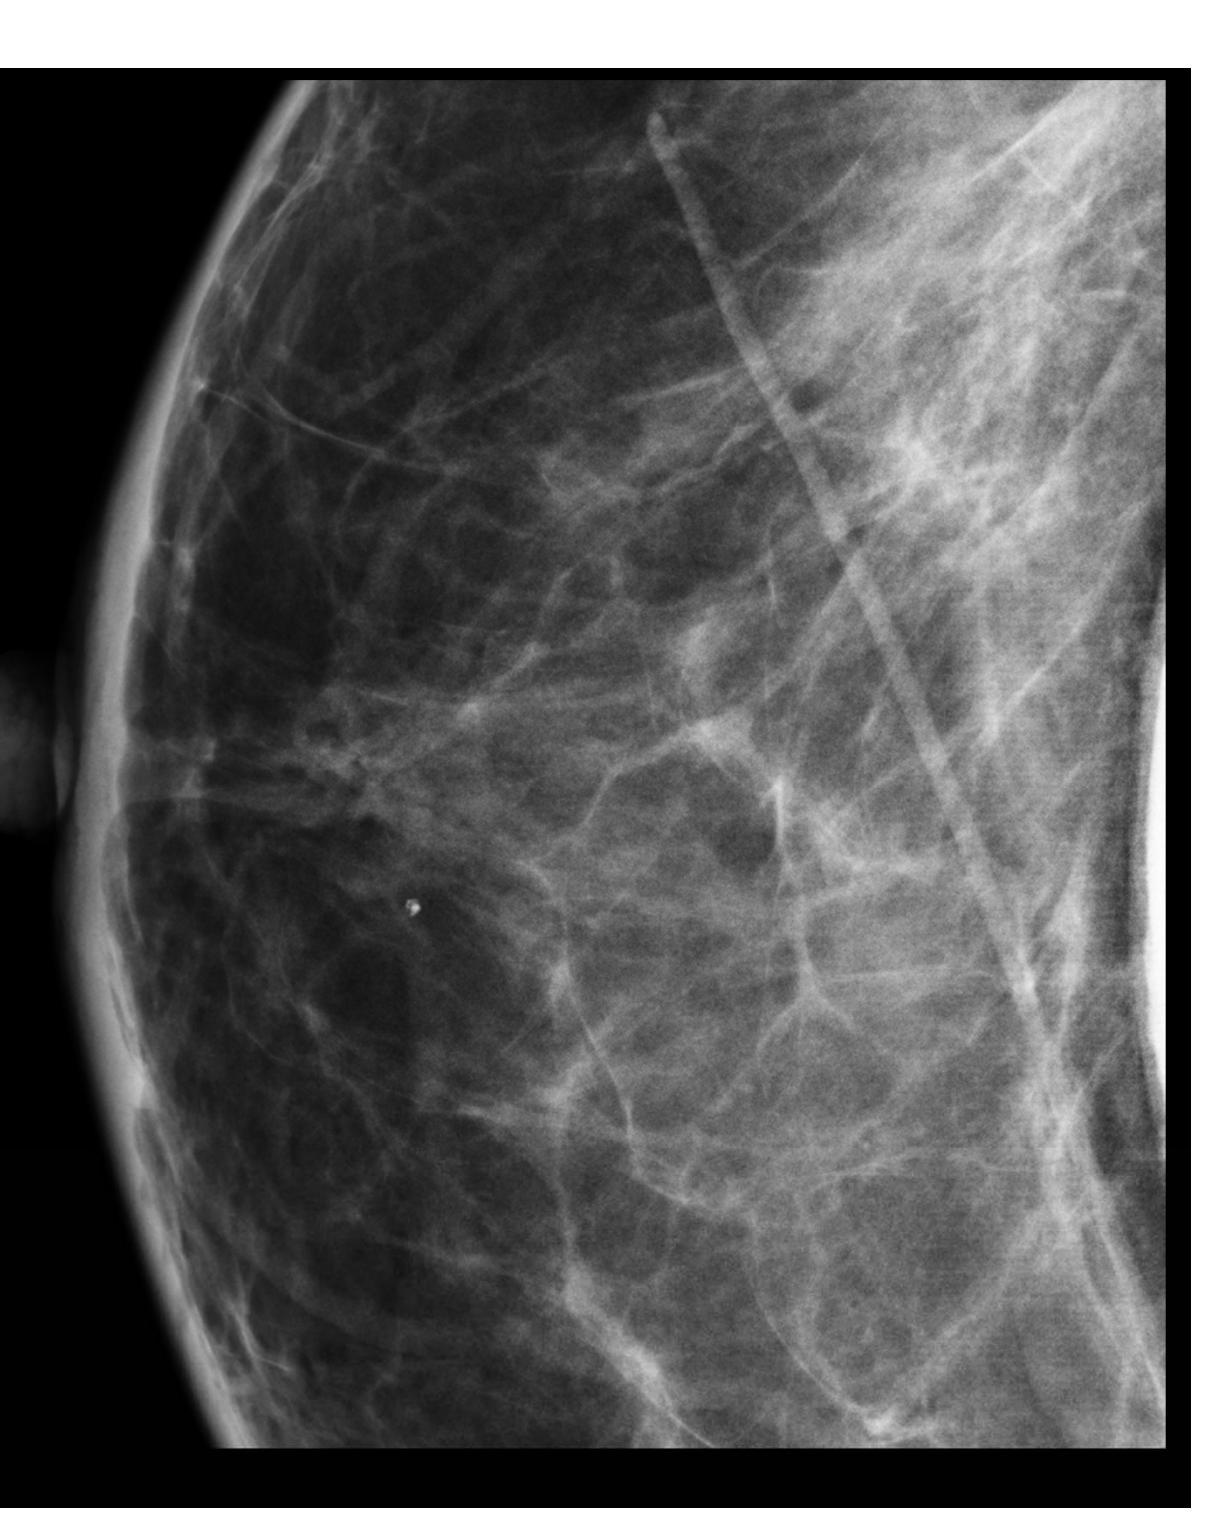
#### Banding Artifact

View: RCC kVp: 29 mAs: 65 Compressed Thickness: 7.9 cm Compression Force: <10 lbs

Cause: According to Hologic this artifact is caused by either a shock to the detector during the readout phase or a problem with a mismatch between the frequency of the power supply for the detector and the readout of the detector.

The fix: if the artifact is not seen on multiple images and does not interfere with diagnosis nothing needs to be done immediately. We just watch that system more closely to see if it becomes a common occurrence. If it starts showing up more frequently say one image per day then we have the power supply for the detector replaced.
