# THE ART OF THE IMAGE: IDENTIFICATION AND REMEDIATION OF IMAGE ARTIFACTS IN MAMMOGRAPHY

#### William Geiser, MS DABR

Senior Medical Physicist MD Anderson Cancer Center

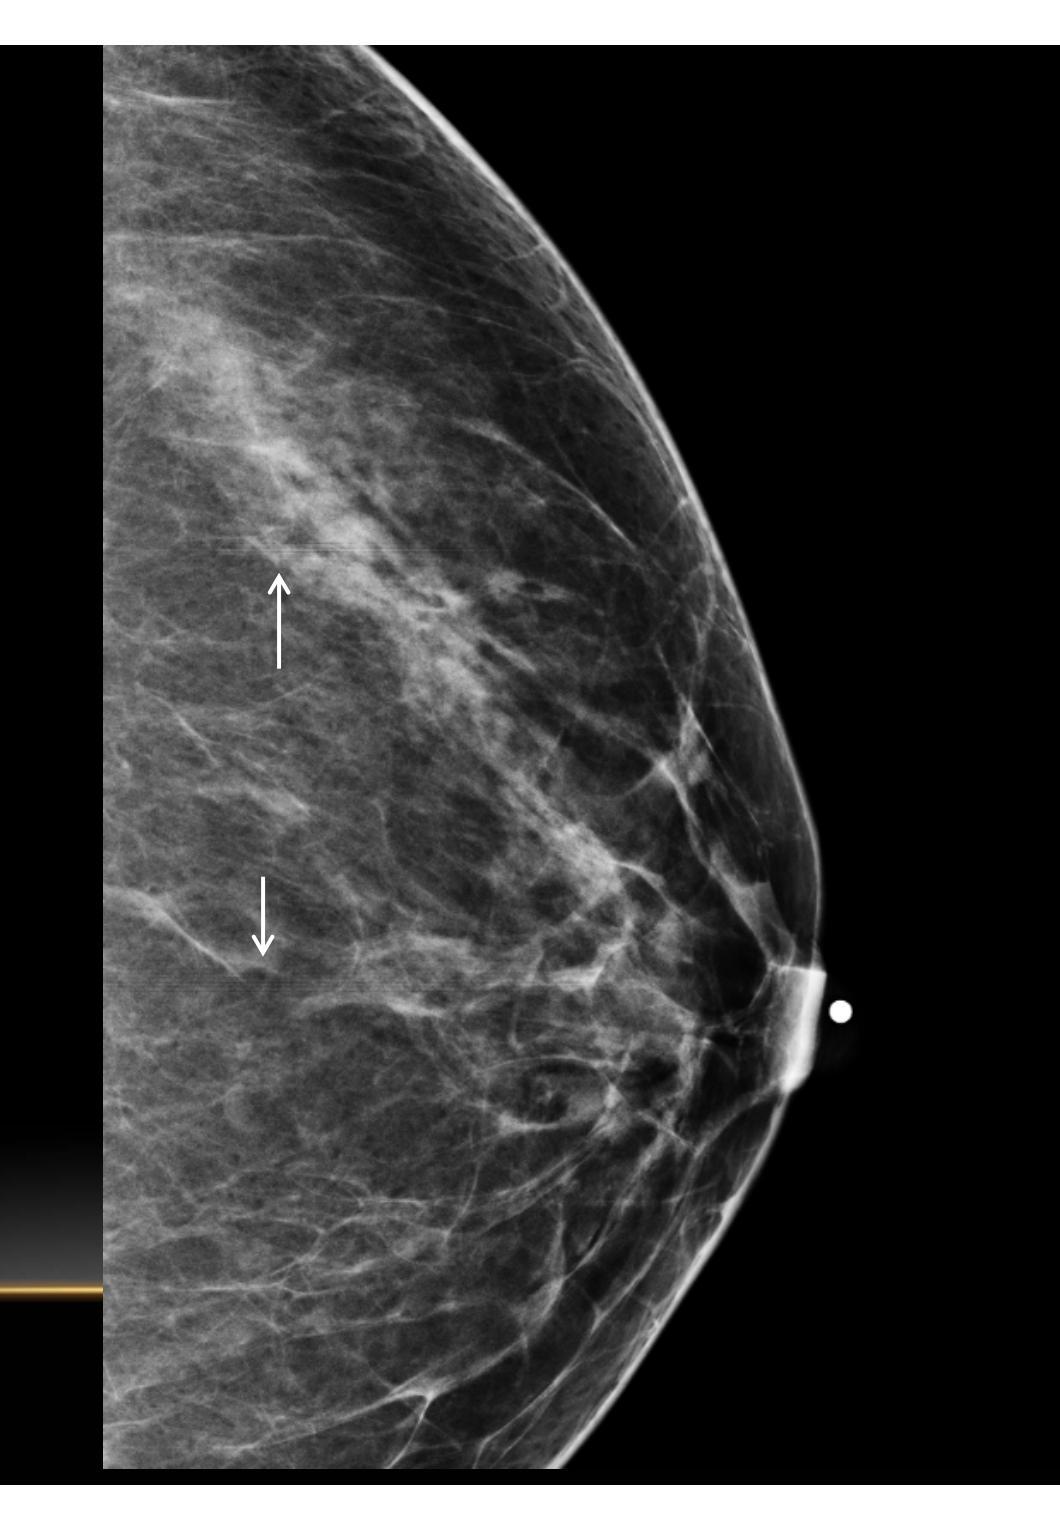
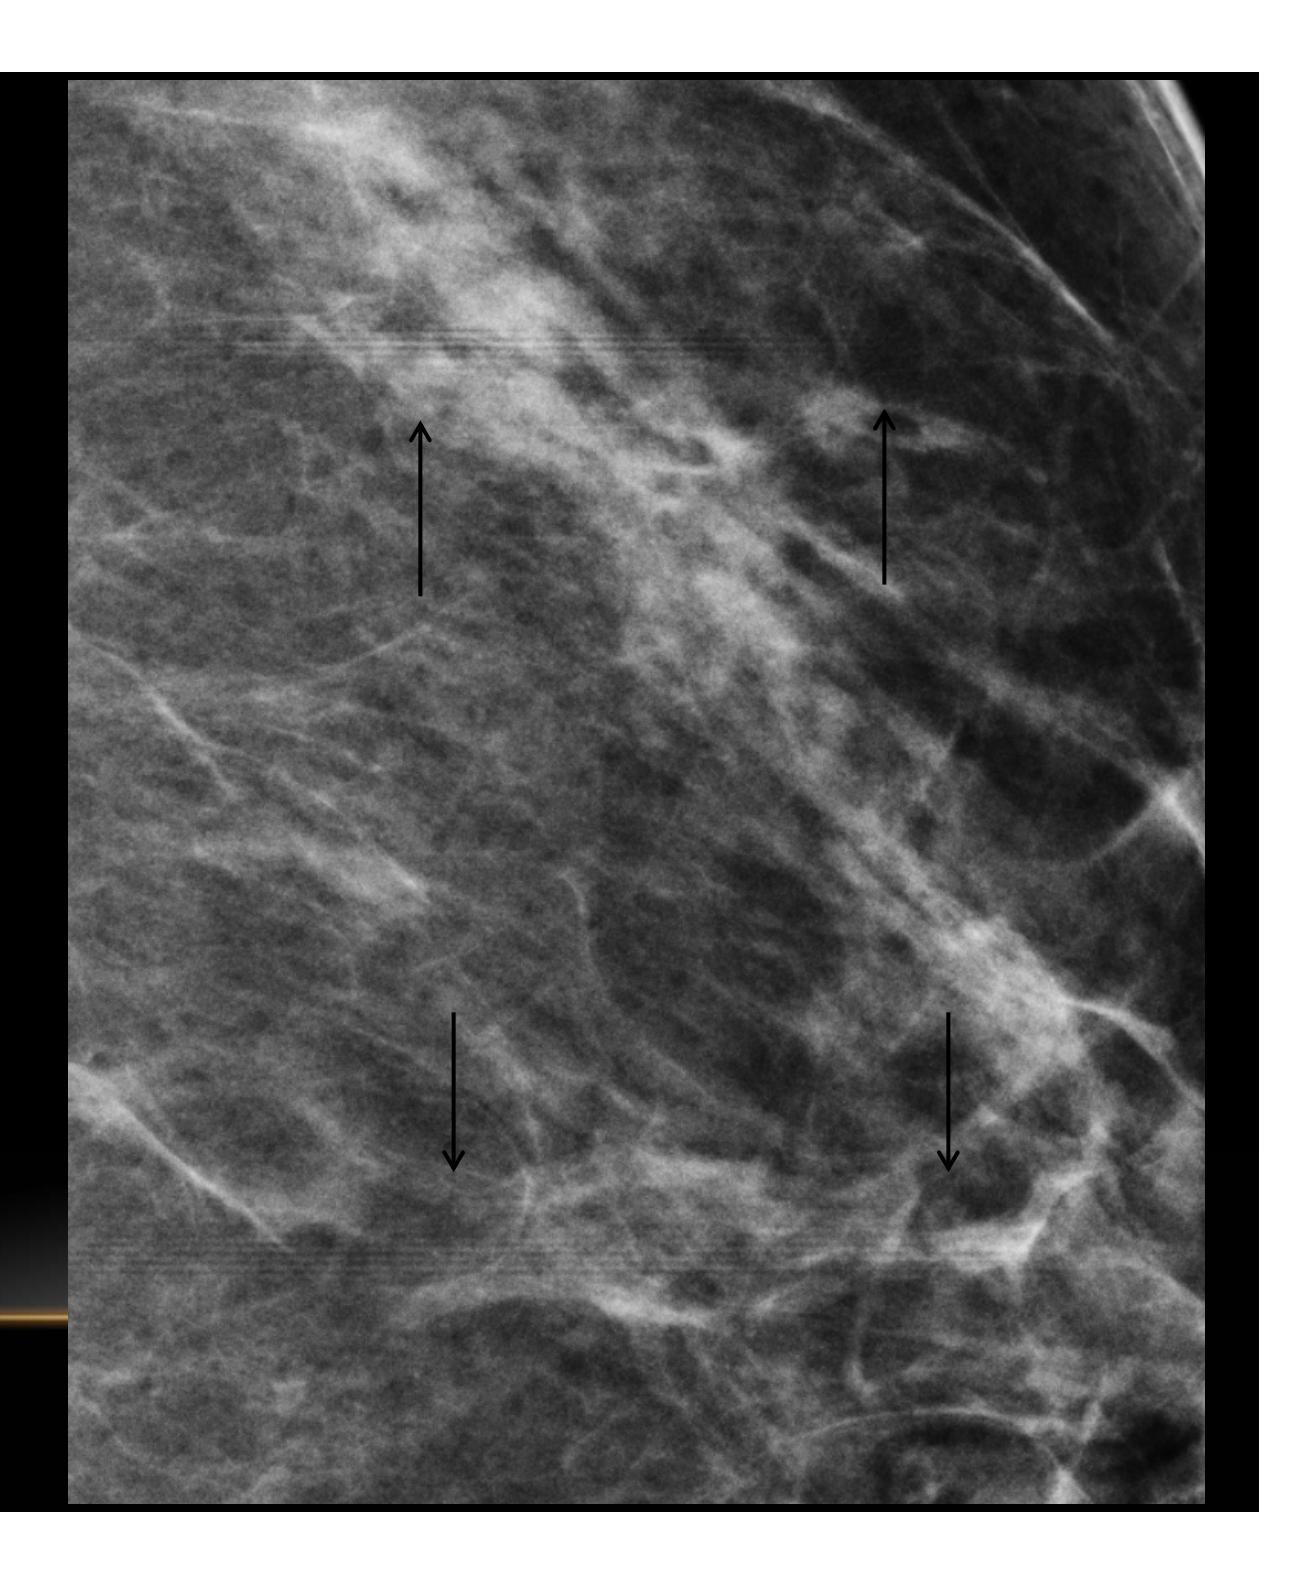
#### Tire Tracks

Caused by a shock to the detector during read out

Cause: According to Hologic this artifact is caused by either a shock to the detector during the readout phase or a problem with a mismatch between the frequency of the power supply for the detector and the readout of the detector.

The fix: if the artifact is not seen on multiple images and does not interfere with diagnosis nothing needs to be done immediately. We just watch that system more closely to see if it becomes a common occurrence. If it starts showing up more frequently say one image per day then we have the power supply for the detector replaced.

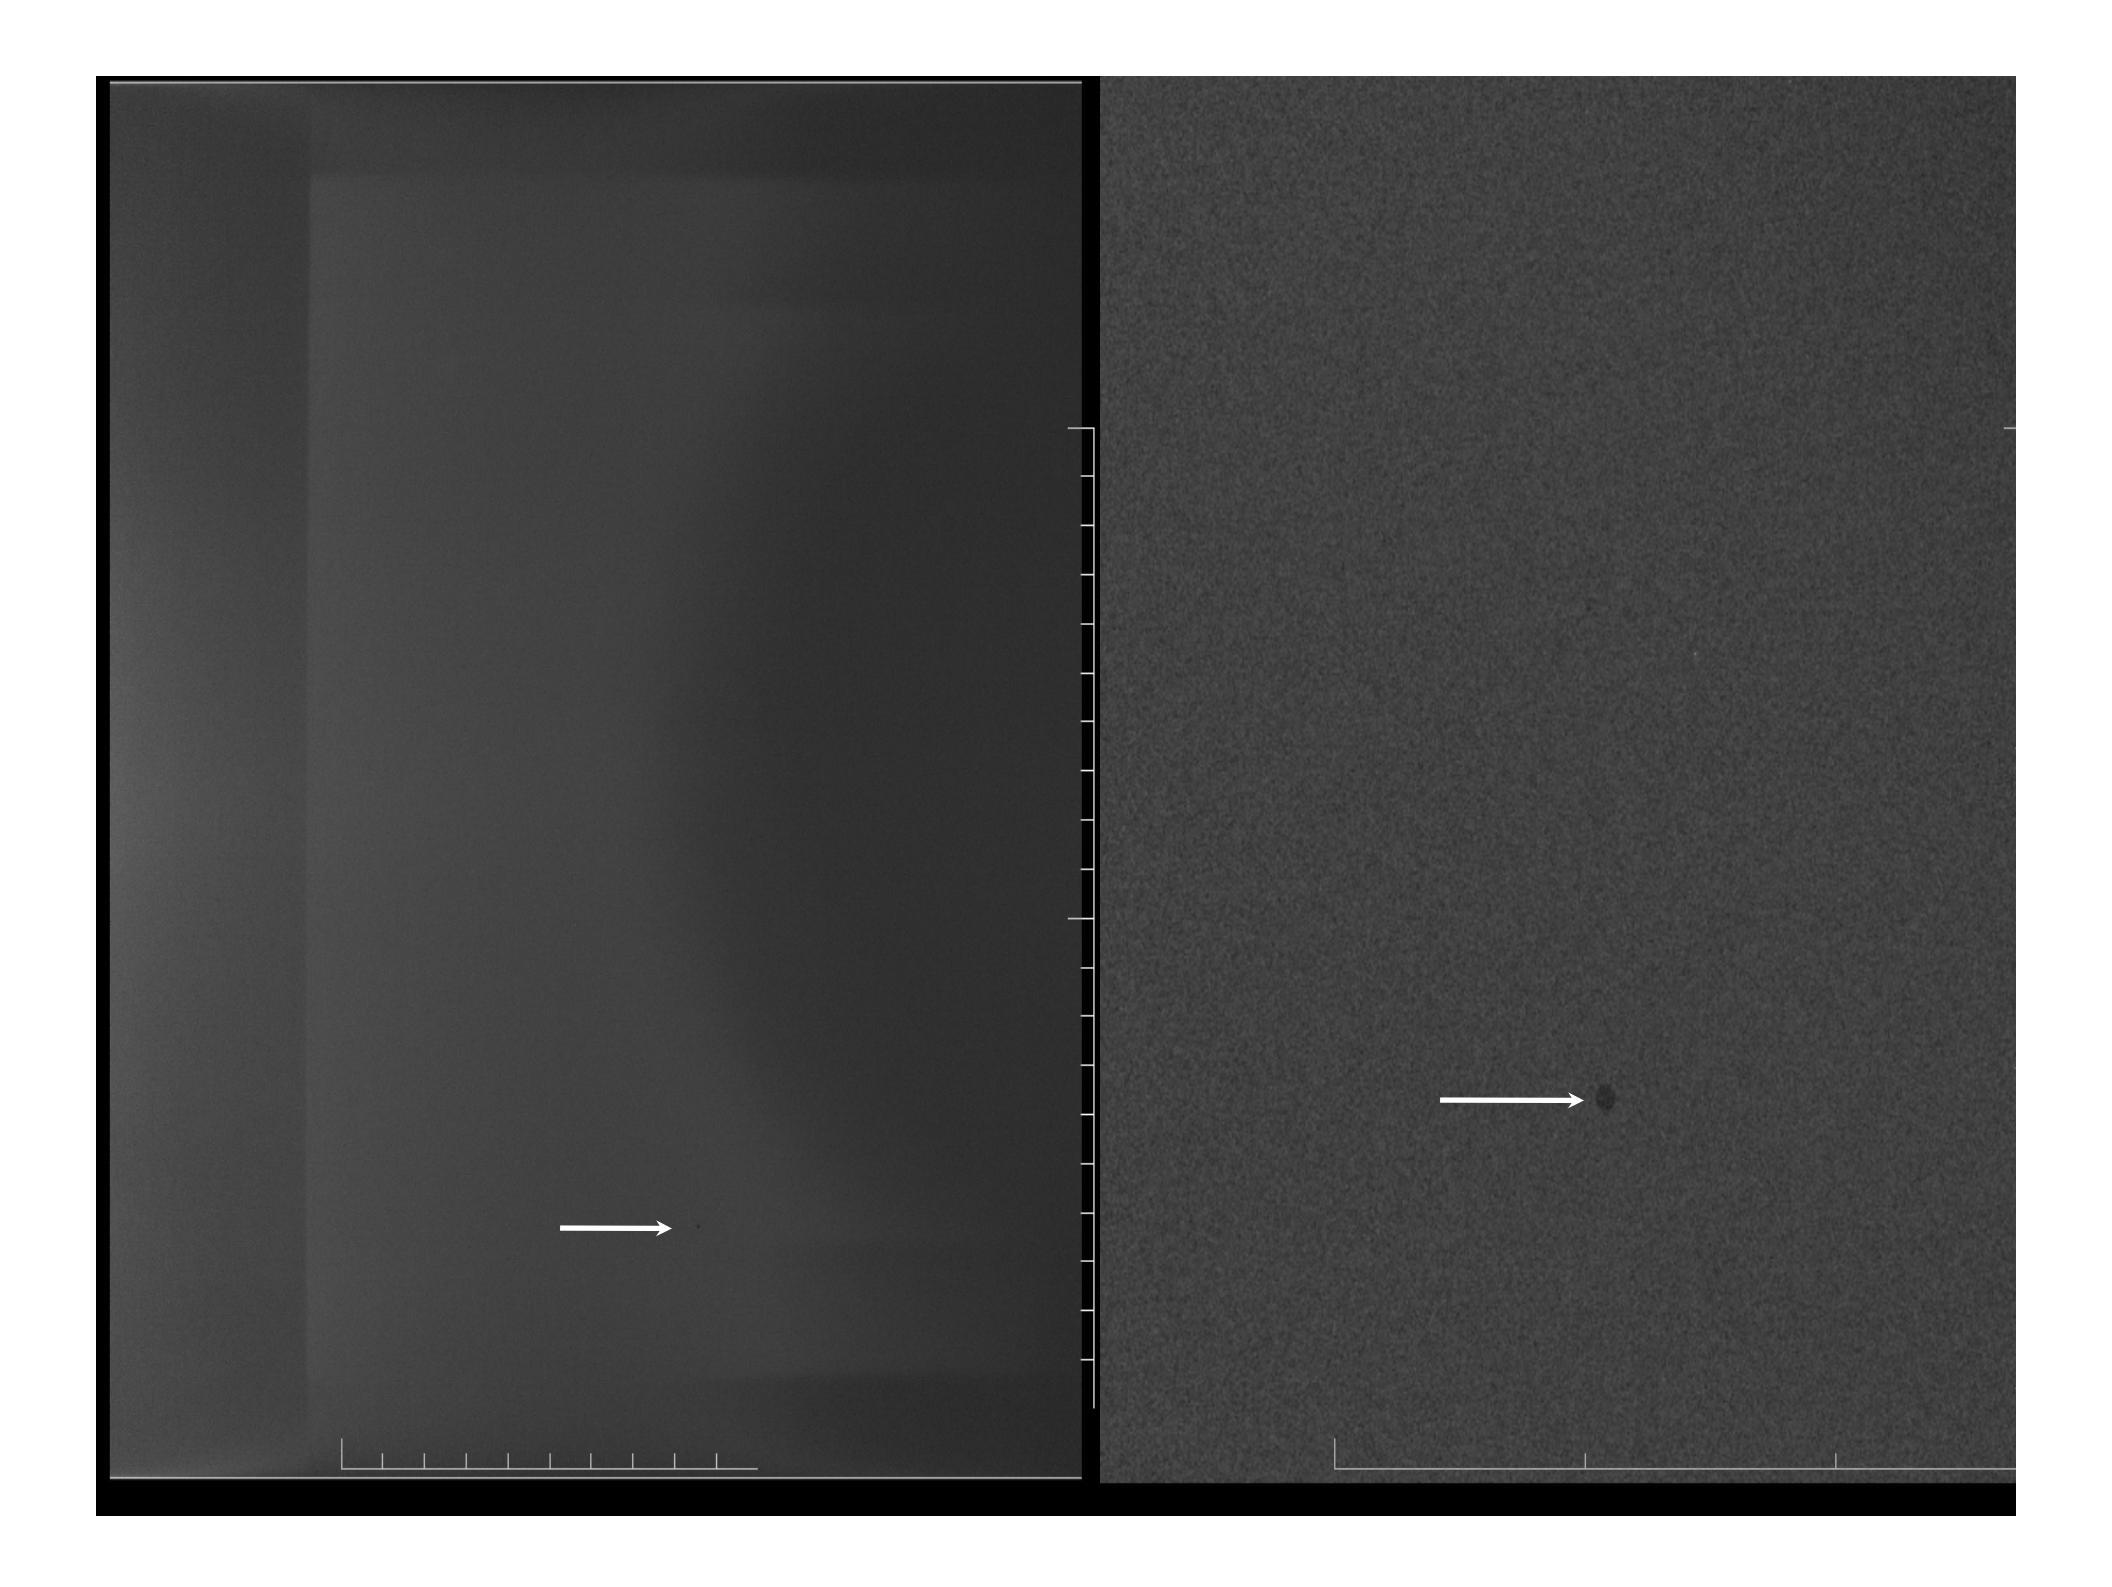
- Small dark spot
- Determined to be from detector
- Cannot be calibrated out
- Detector was replaced

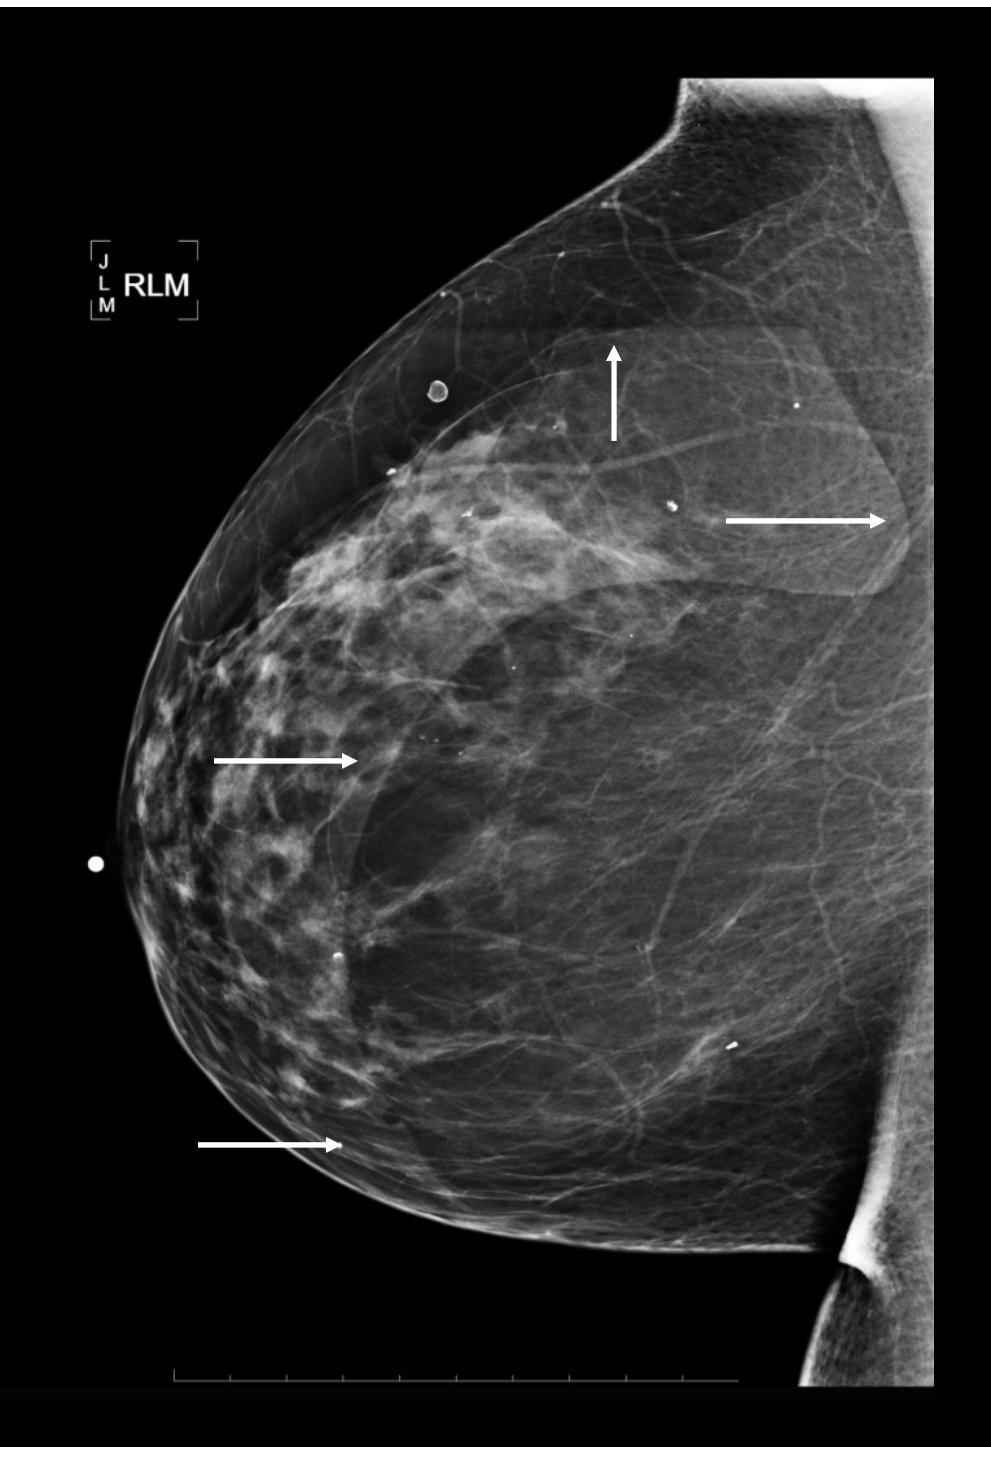
- Selenium detector technology had ghosting problems
- Temperature of detector plays large part
- Ensure that detector is at proper temperature to prevent ghosting

Ghost of the previous MLO image is visible on this RLM.

This ghost image was cause by incorrect detector temperature. Allowing the detector to warm up properly cleared the problem.

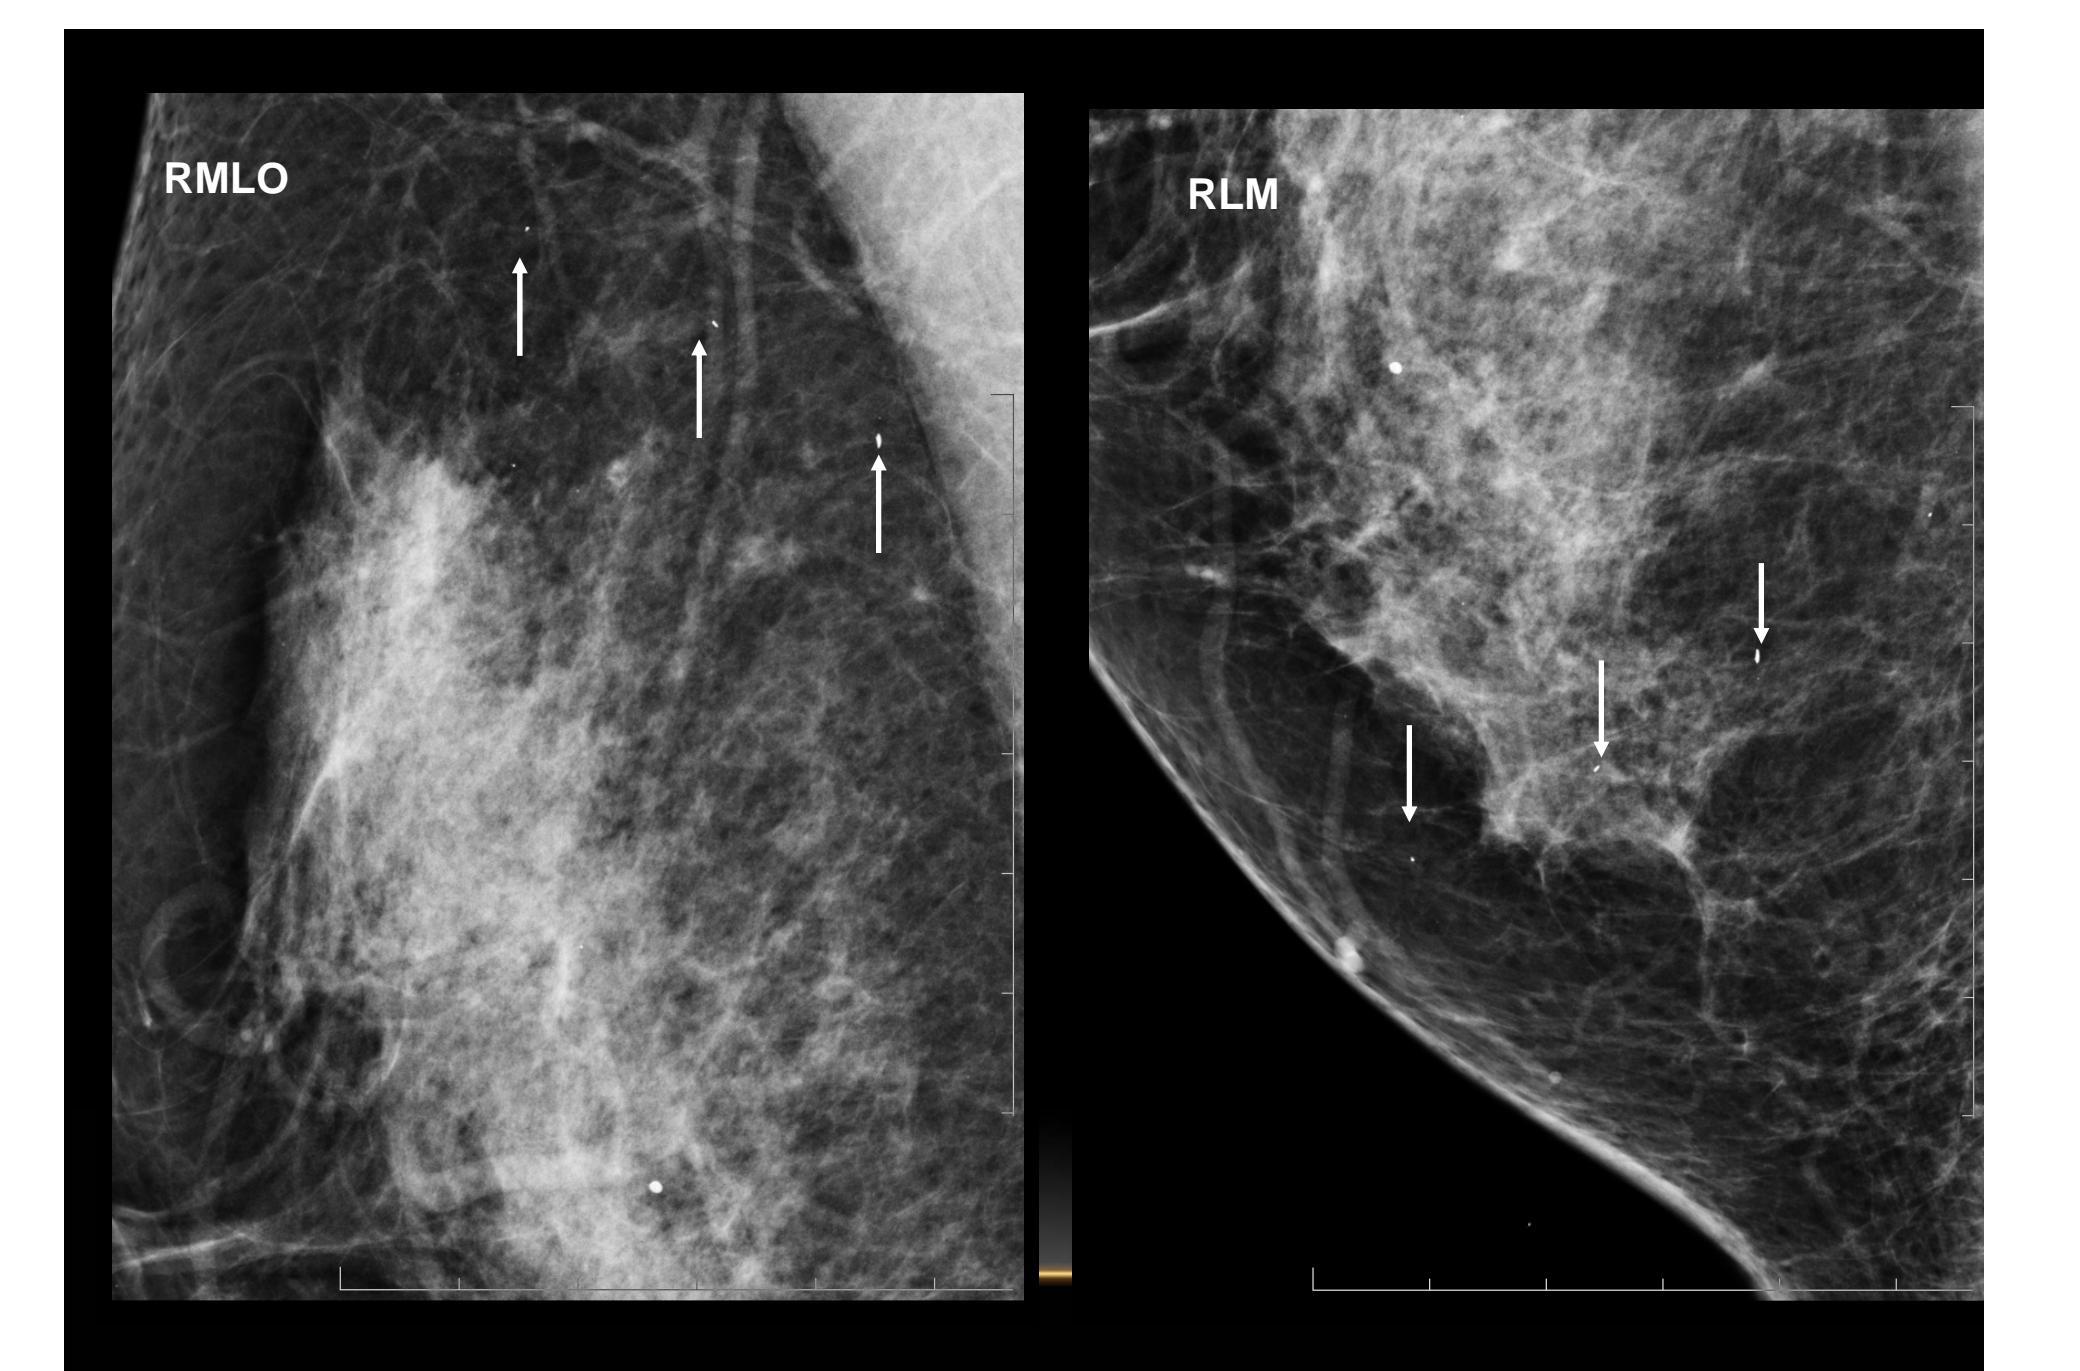
- Dust or dirt on the compression paddle may mimic calcifications or masses. Look for an artifact that is seen on two different images but in the same area of the detector (flipped and rotated).
- Regular cleaning of compression paddles will prevent this artifact
