# Estimation of Shielding Effectiveness for Electromagnetic Interference using an Infinite Plate Model

**David E Hintenlang, PhD<sup>1</sup>, Xia Jiang, PhD<sup>1</sup>, Kevin J Little, PhD<sup>1</sup>,**  
<sup>1</sup>Department of Radiology, Ohio State University Wexner Medical Center, Columbus, OH 43210

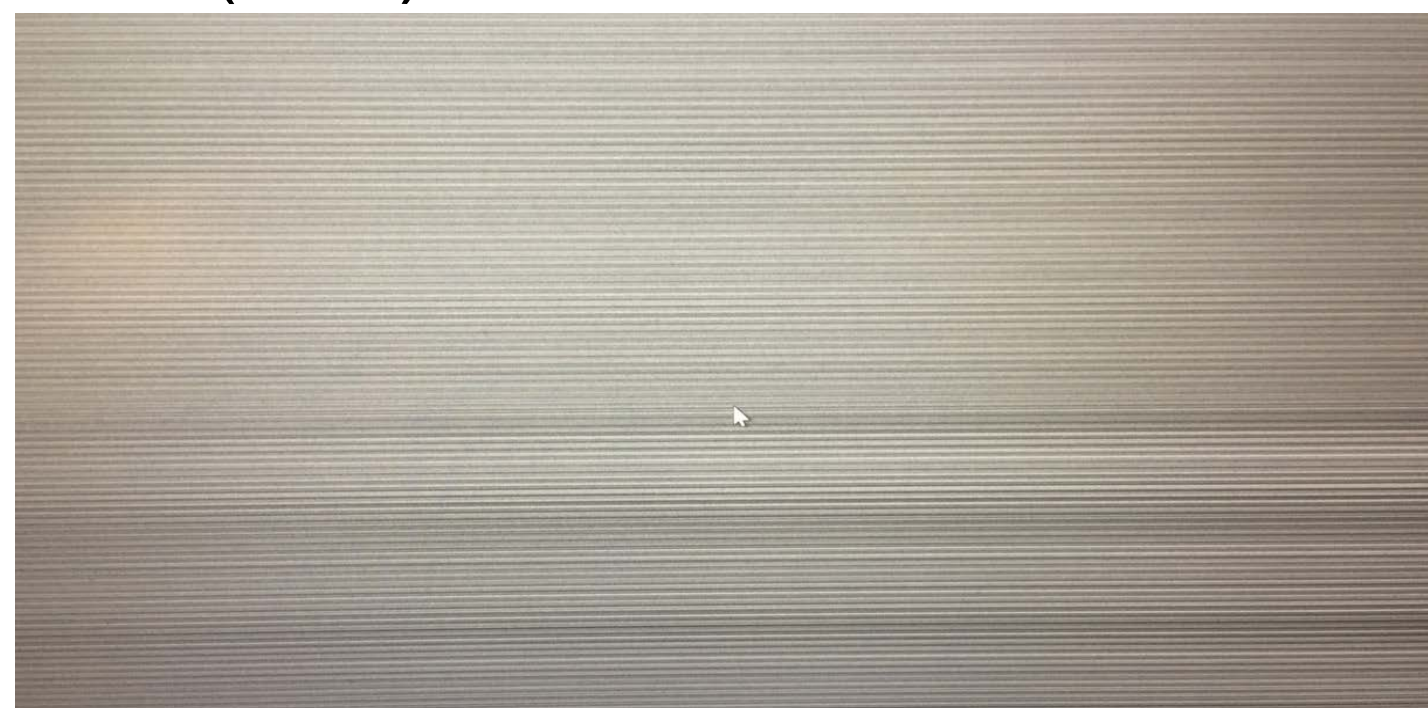
Horizontal line artifacts produced by AC magnetic fields on a digital mammography detector

- AC magnetic fields from electrical utility services have been observed to induce artifacts in images from high-sensitivity digital detectors used in mammography systems<sup>1</sup>.
- The site of a new mammography facility was observed to have AC magnetic fields of magnitudes great enough (>2 mG) to raise serious concerns that artifacts may be present in clinical images after installation was complete.
- A shielding design was implemented to attenuate AC magnetic fields and potential electromagnetic interference (EMI).

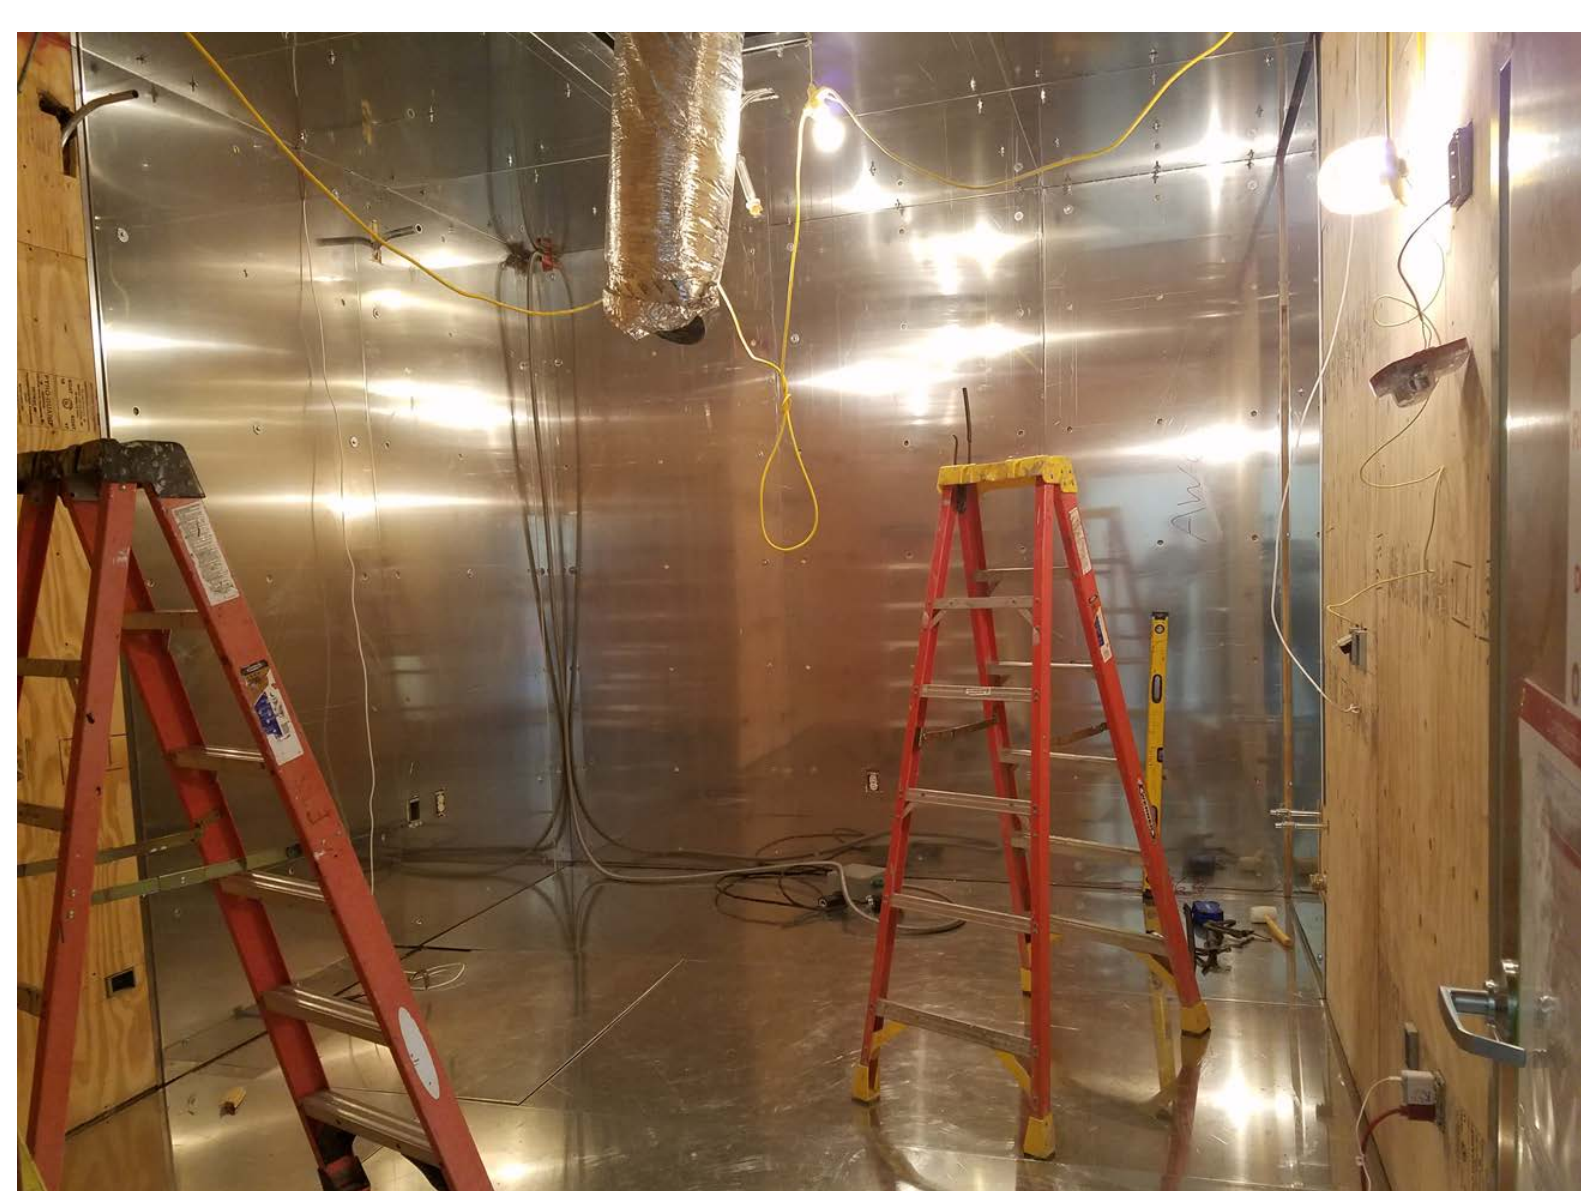
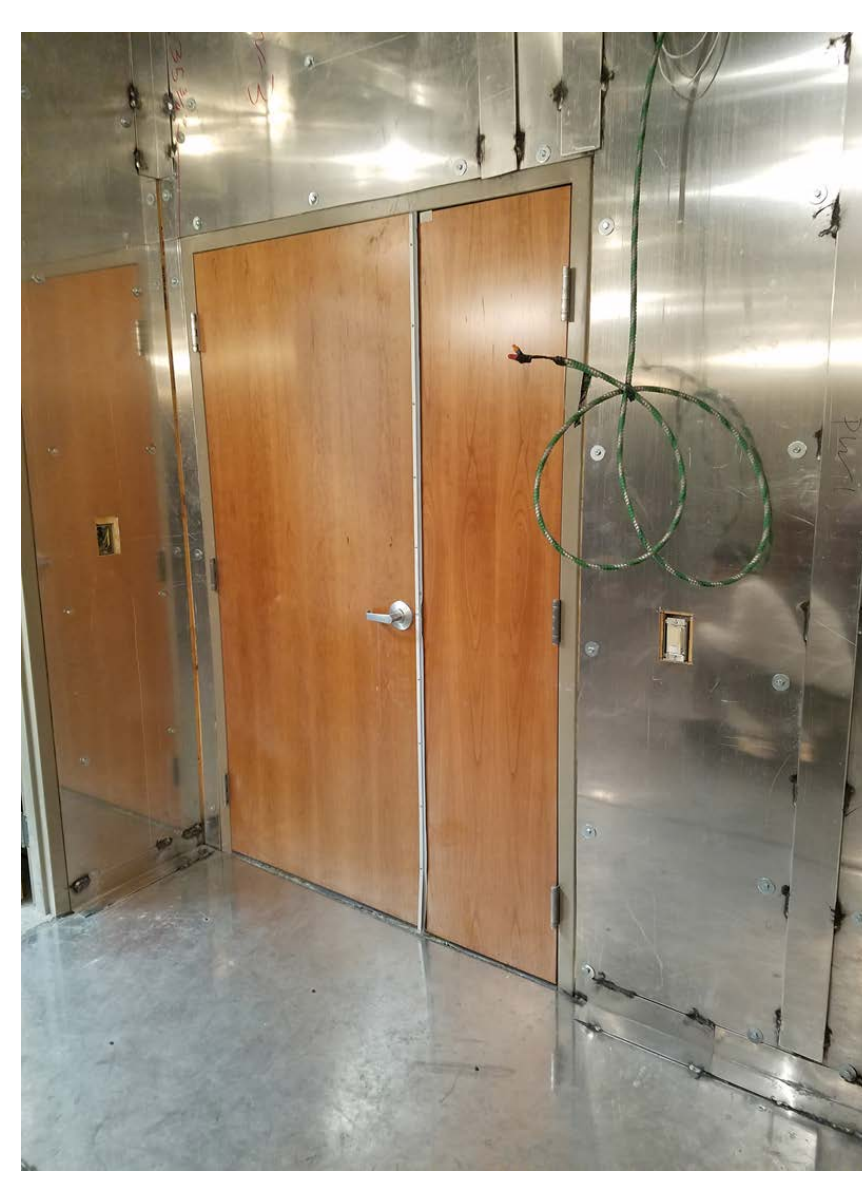
All interior surfaces of the room were shielded with 6.25 mm (1/4") plate aluminum (walls, ceiling and floor)<sup>2</sup>.

The floor incorporated an additional 6.25 mm (1/4") Si-Steel

The existing wooden doors were not shielded

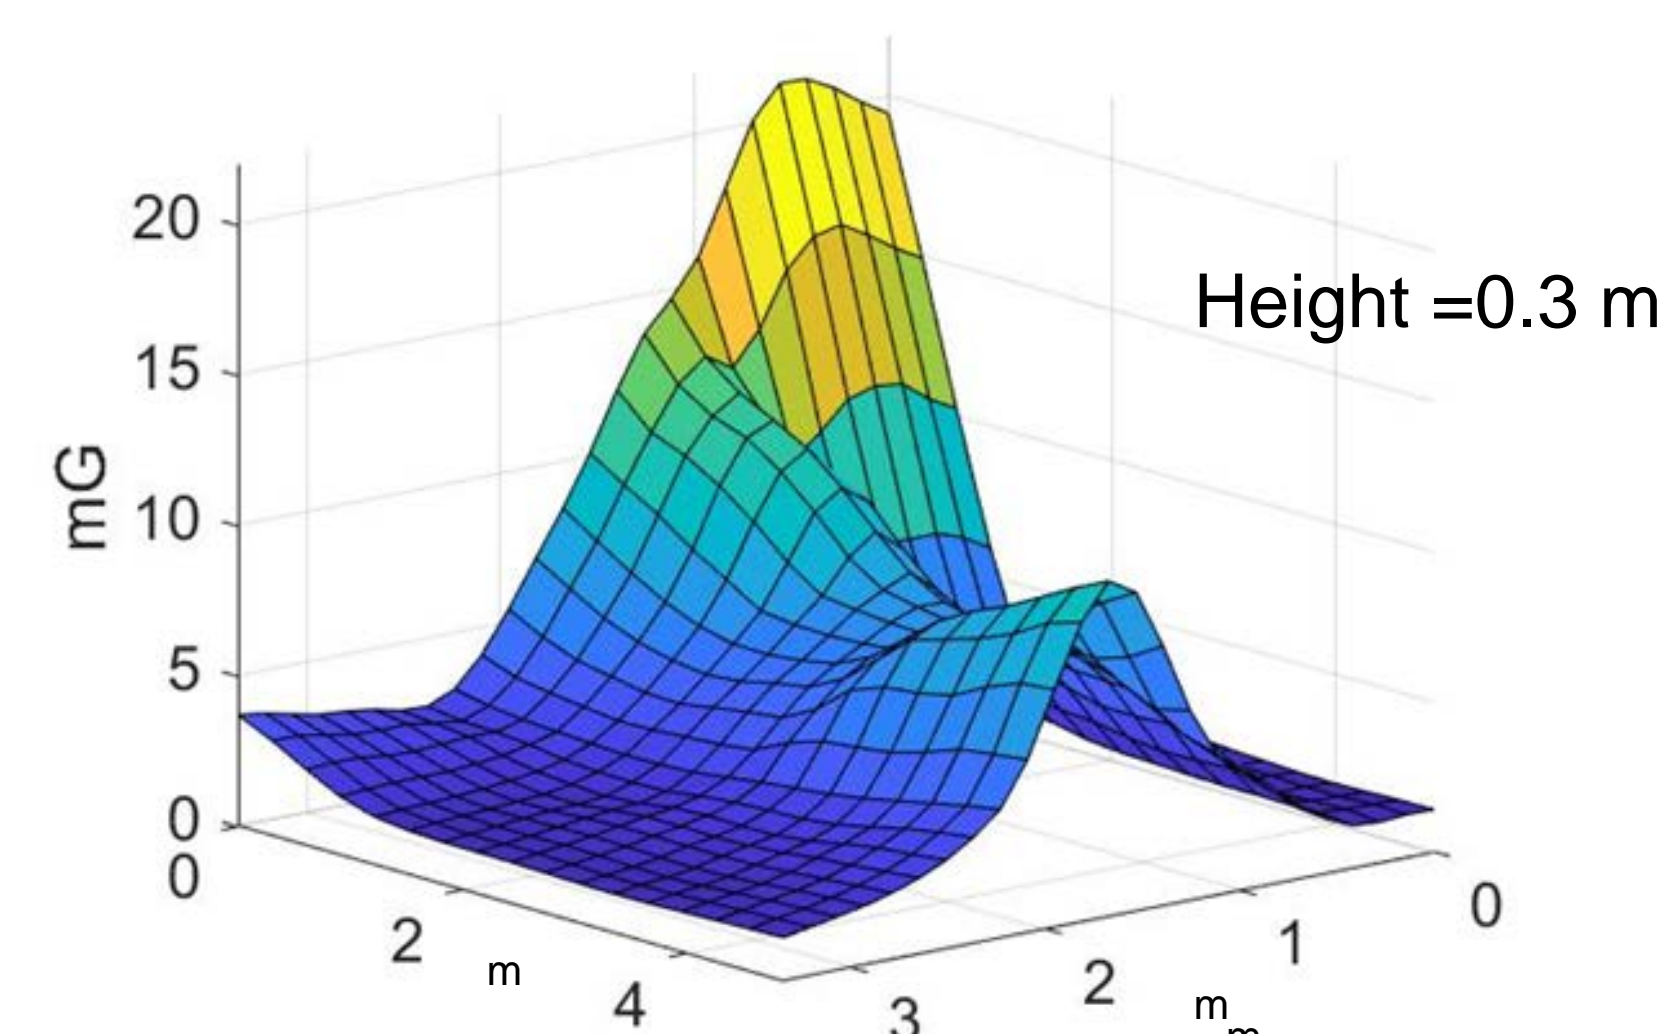
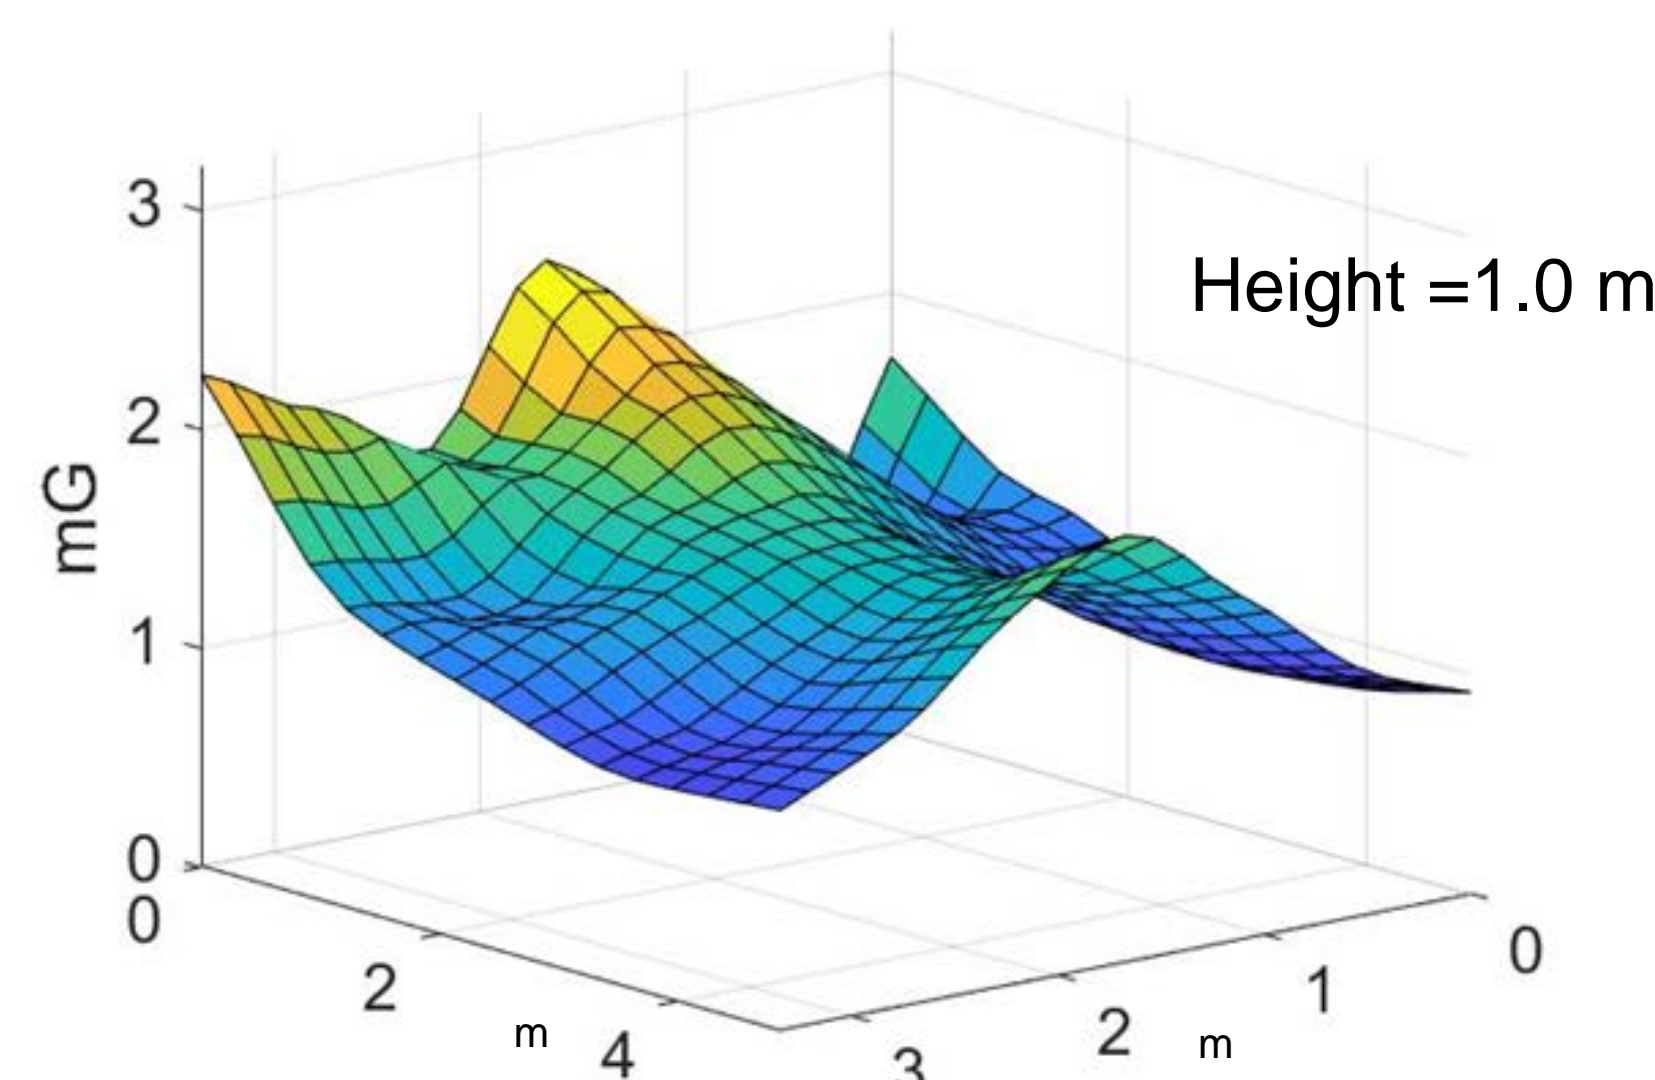
- AC Magnetic fields were mapped across the room at four different heights<sup>2</sup>: 0.3 m, 1m (detector position) 1.5 m and 2.4 m.
- The intensity decreased with distance from a neighboring electrical supply room and the floor, where a sub-slab electrical conduit is located.

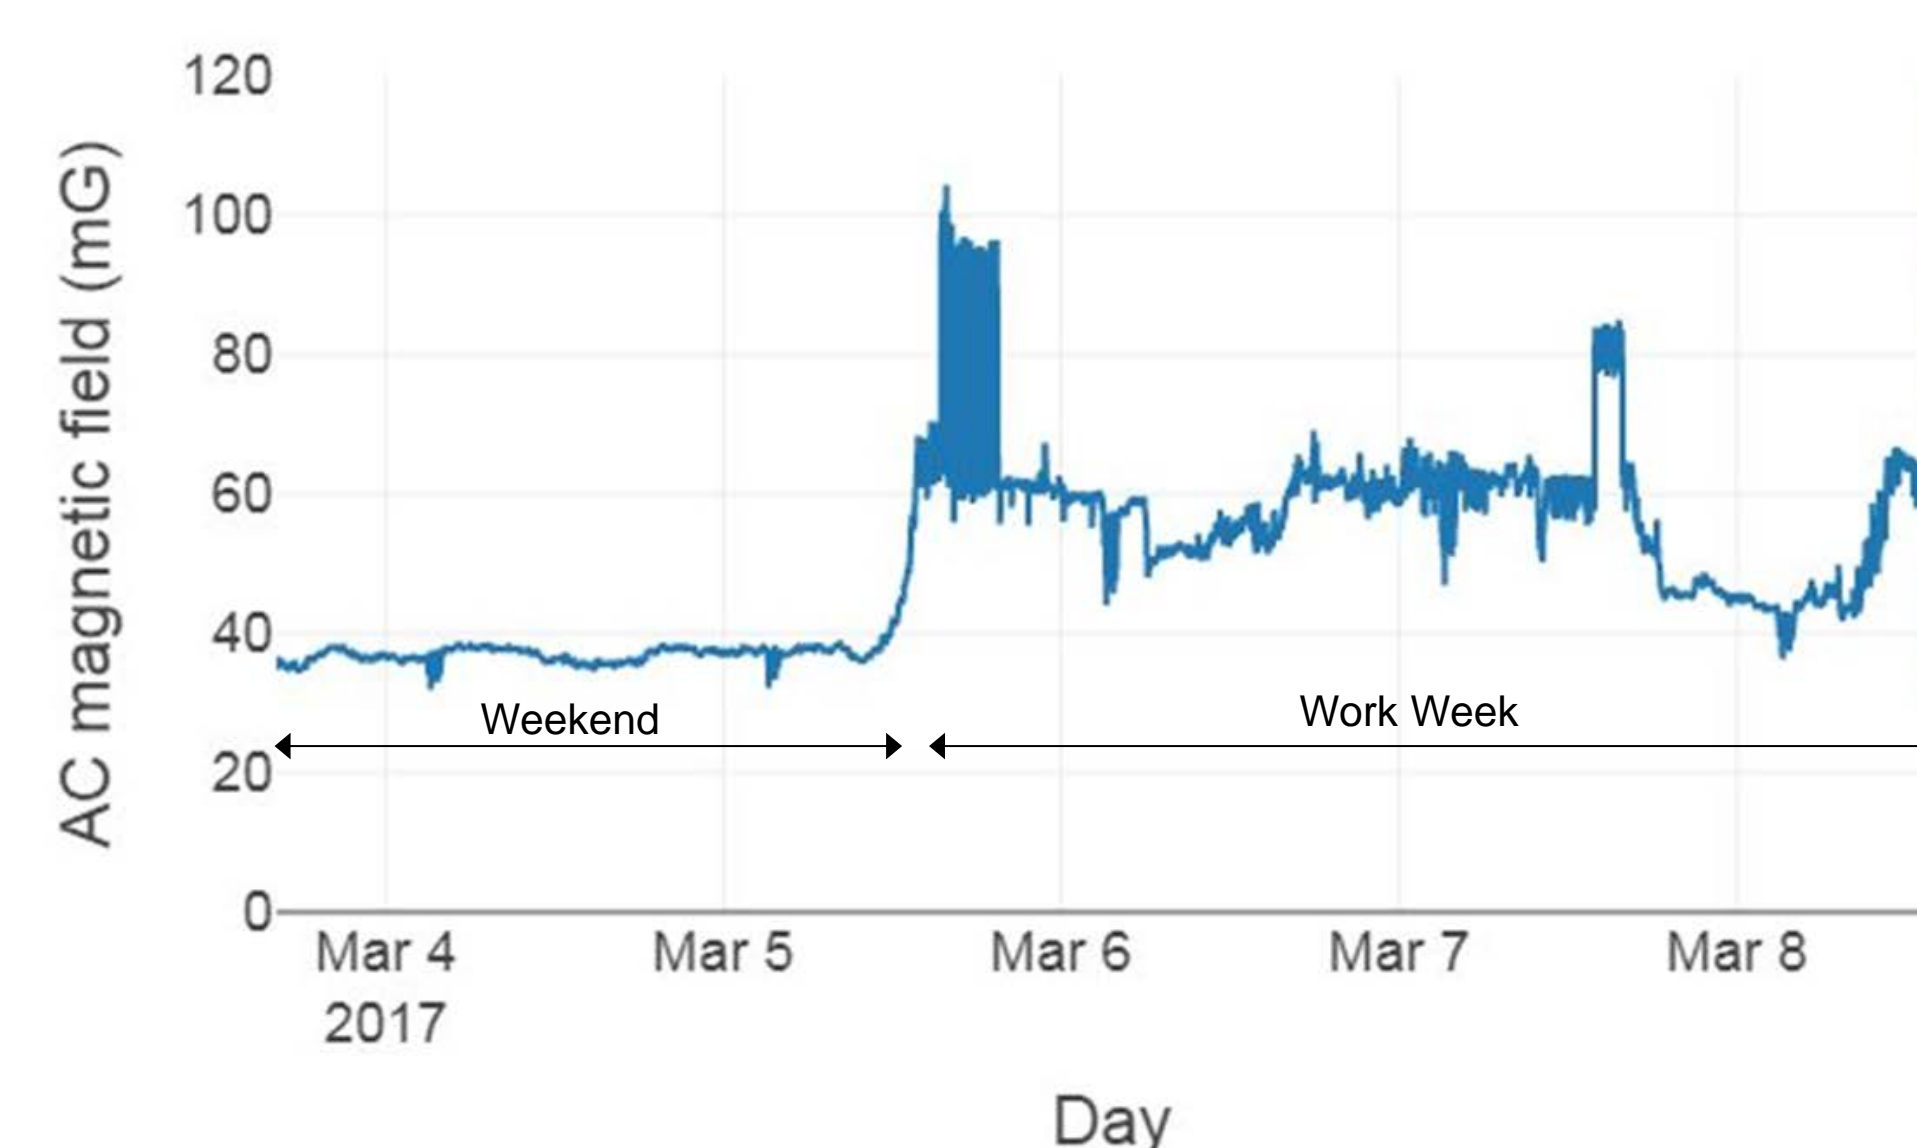
Continuous measurements showed large variations in the magnitudes of the AC magnetic field.

- March 4-5: weekend days of low building electrical loads.
- March 6 begins work week with increased building electrical loads.

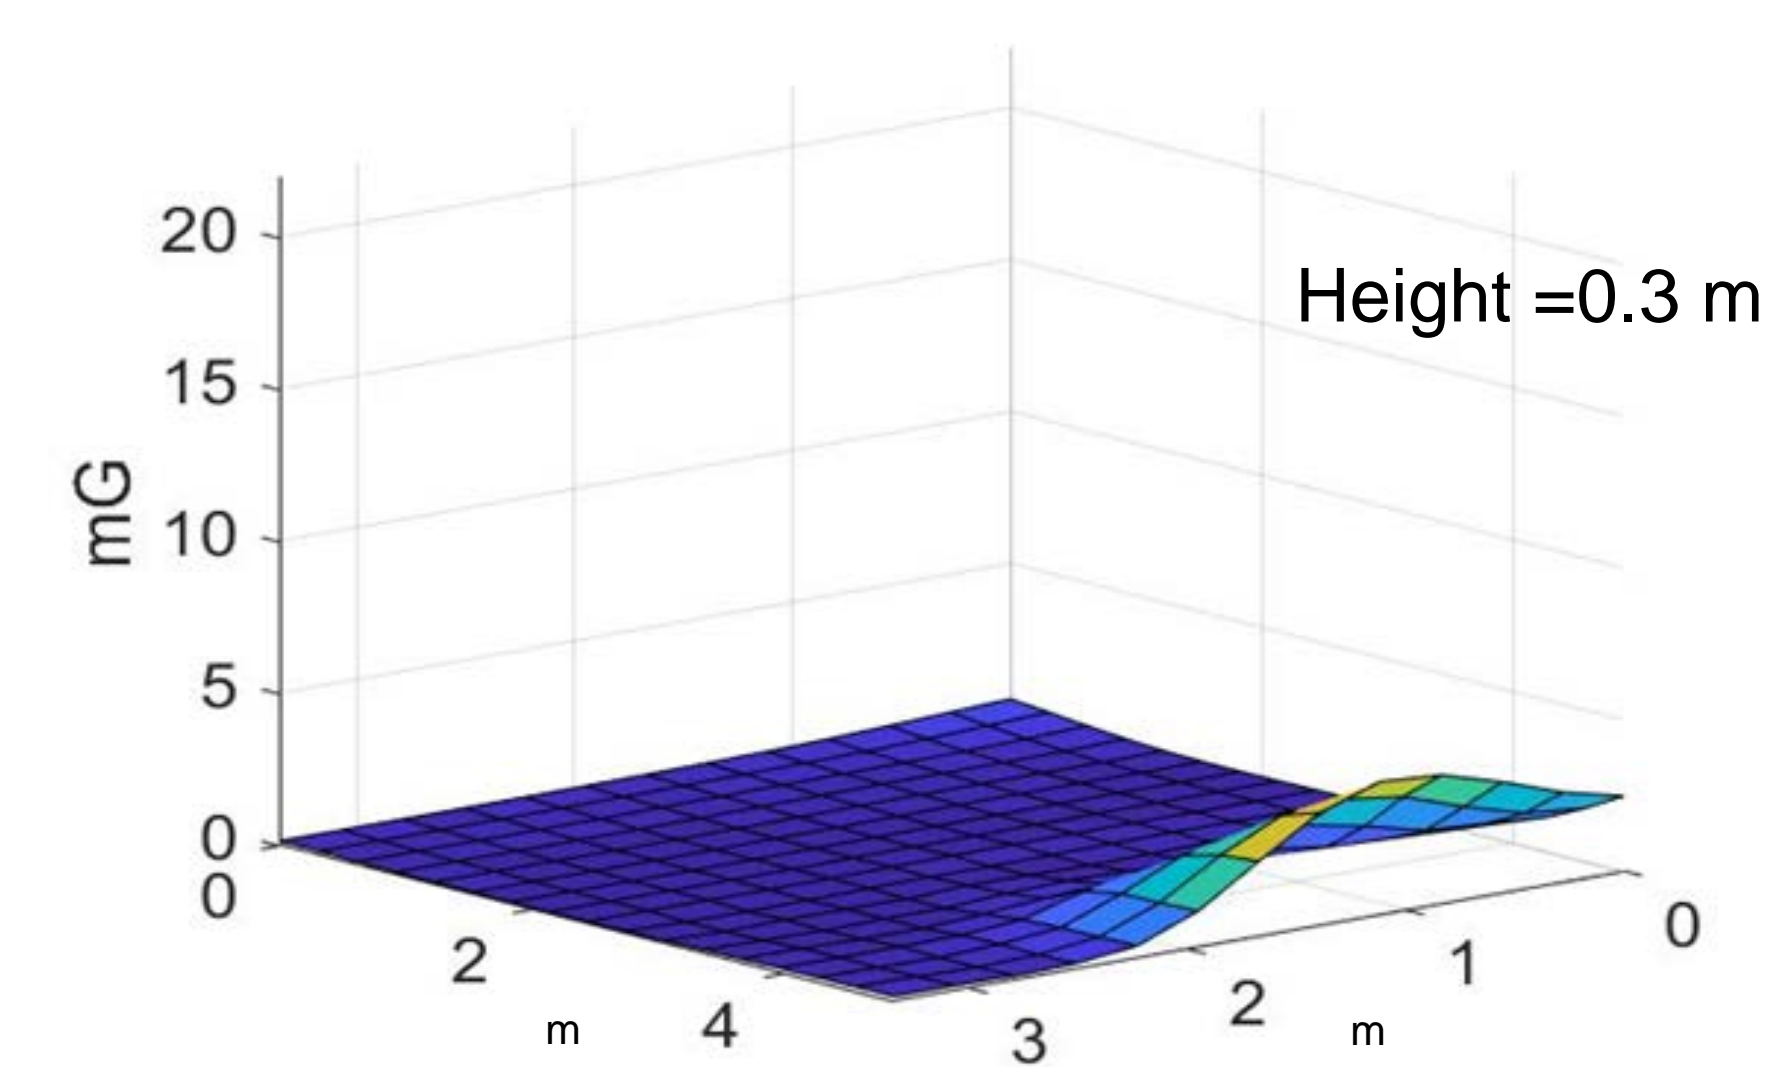
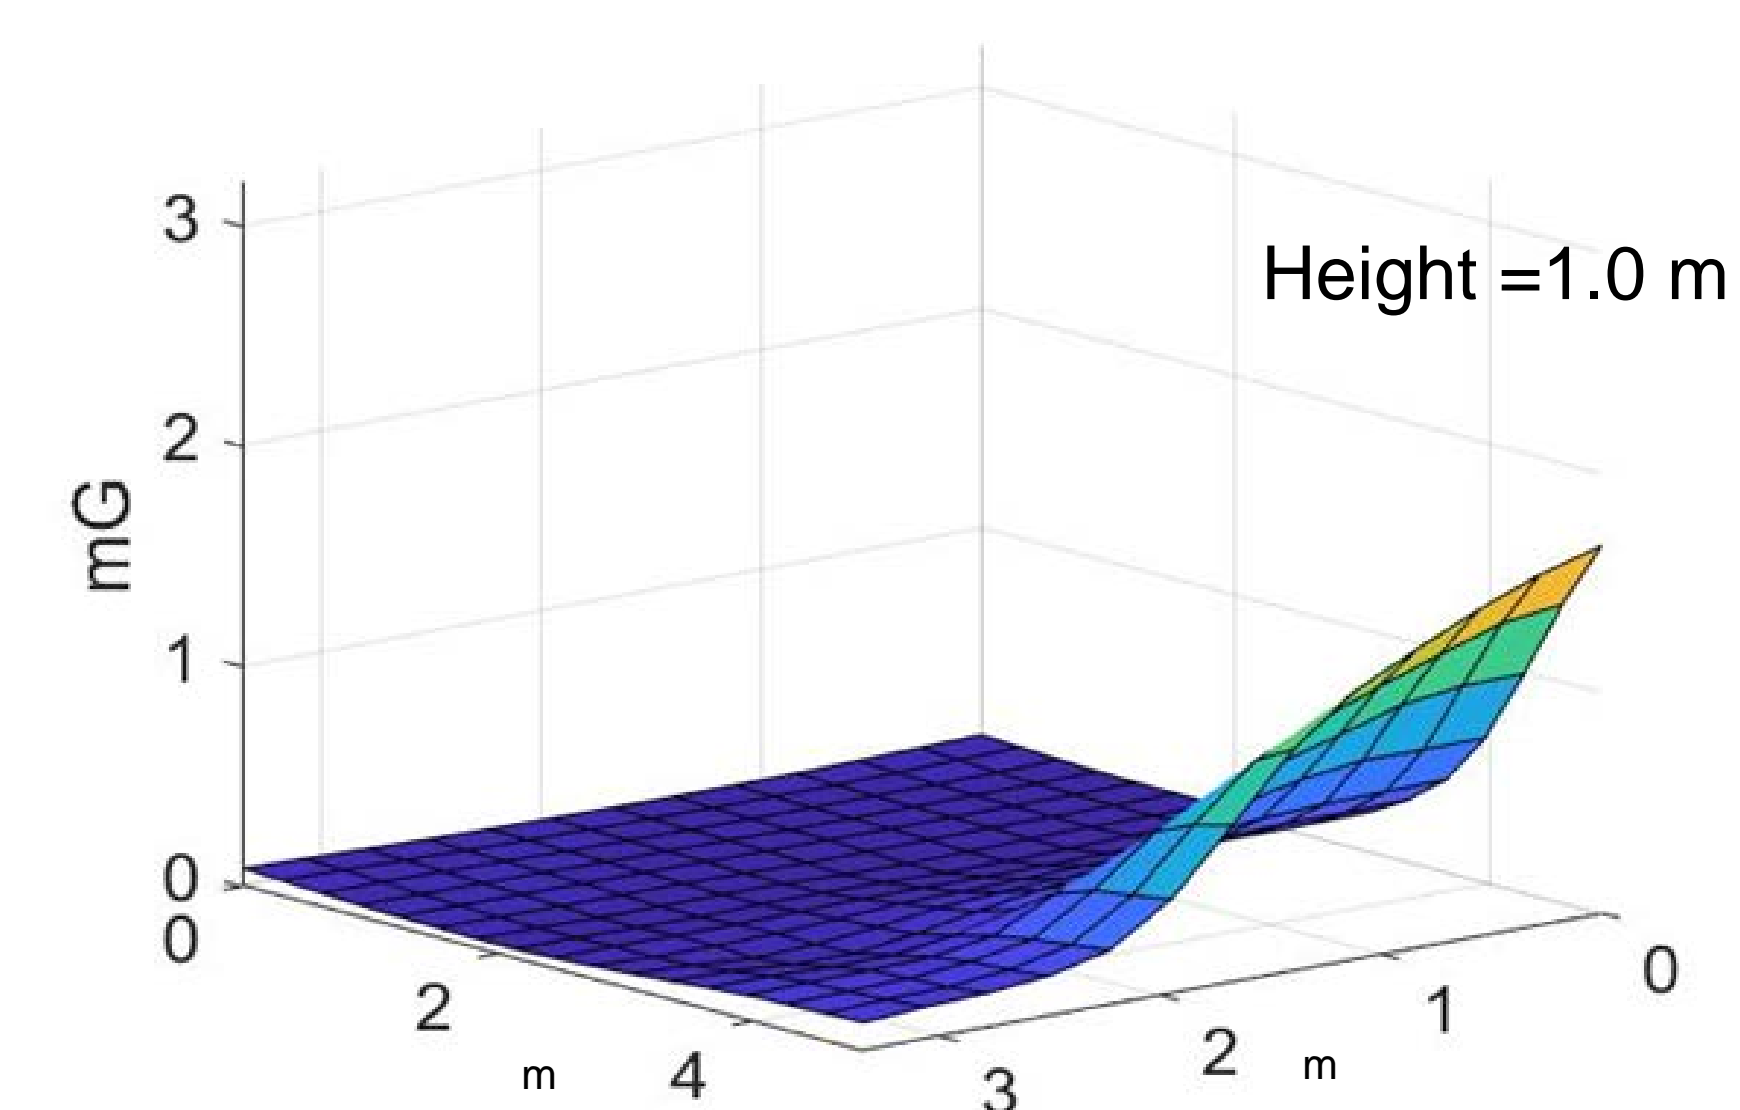
- After the shielding was installed AC magnetic fields decreased to below the design goal of 0.5 mG at the detector location.
- The greatest residual fields are observed around the unshielded doorways.

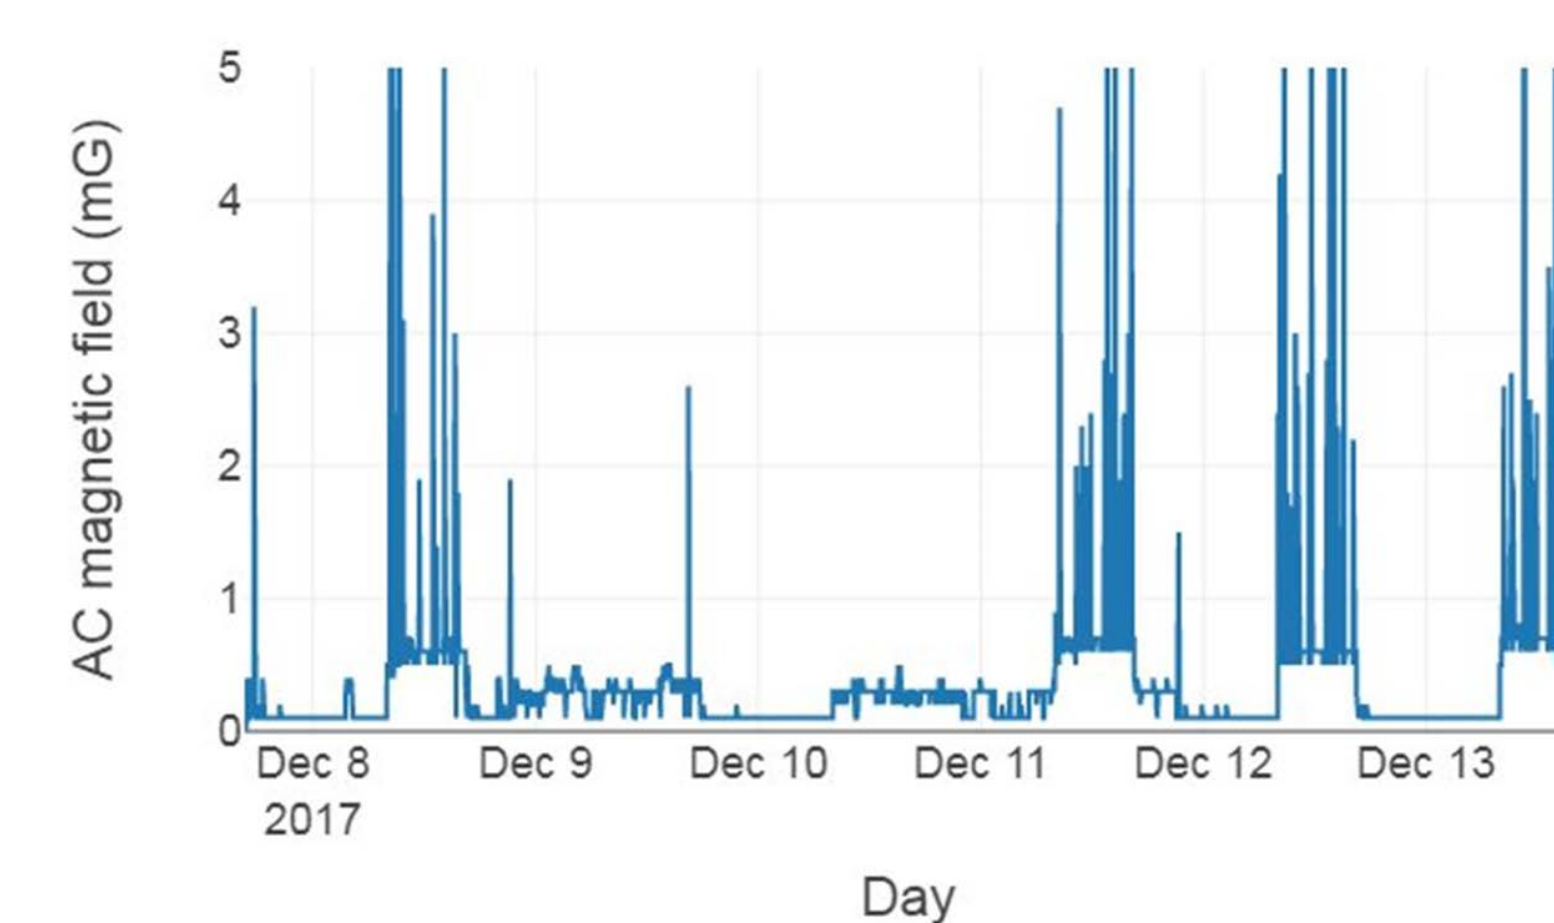
- Continuous measurements showed the externally generated AC fields were attenuated below the design goal of 0.5 mG inside the room.
- Elevated baselines during the work-day correlate with operation of the mammography system
- The large spikes correlate with x-ray exposures by the mammography system and have not generated image artifacts.
