A Case Based Review of Implant Safety in Pediatric MRI

Christina L. Sammet PhD DABR, Nicole Murphy MS,
Tim Harkensee RT(R) MR, Andrada Popescu MD,
Maura Ryan MD, Cindy Rigsby MD

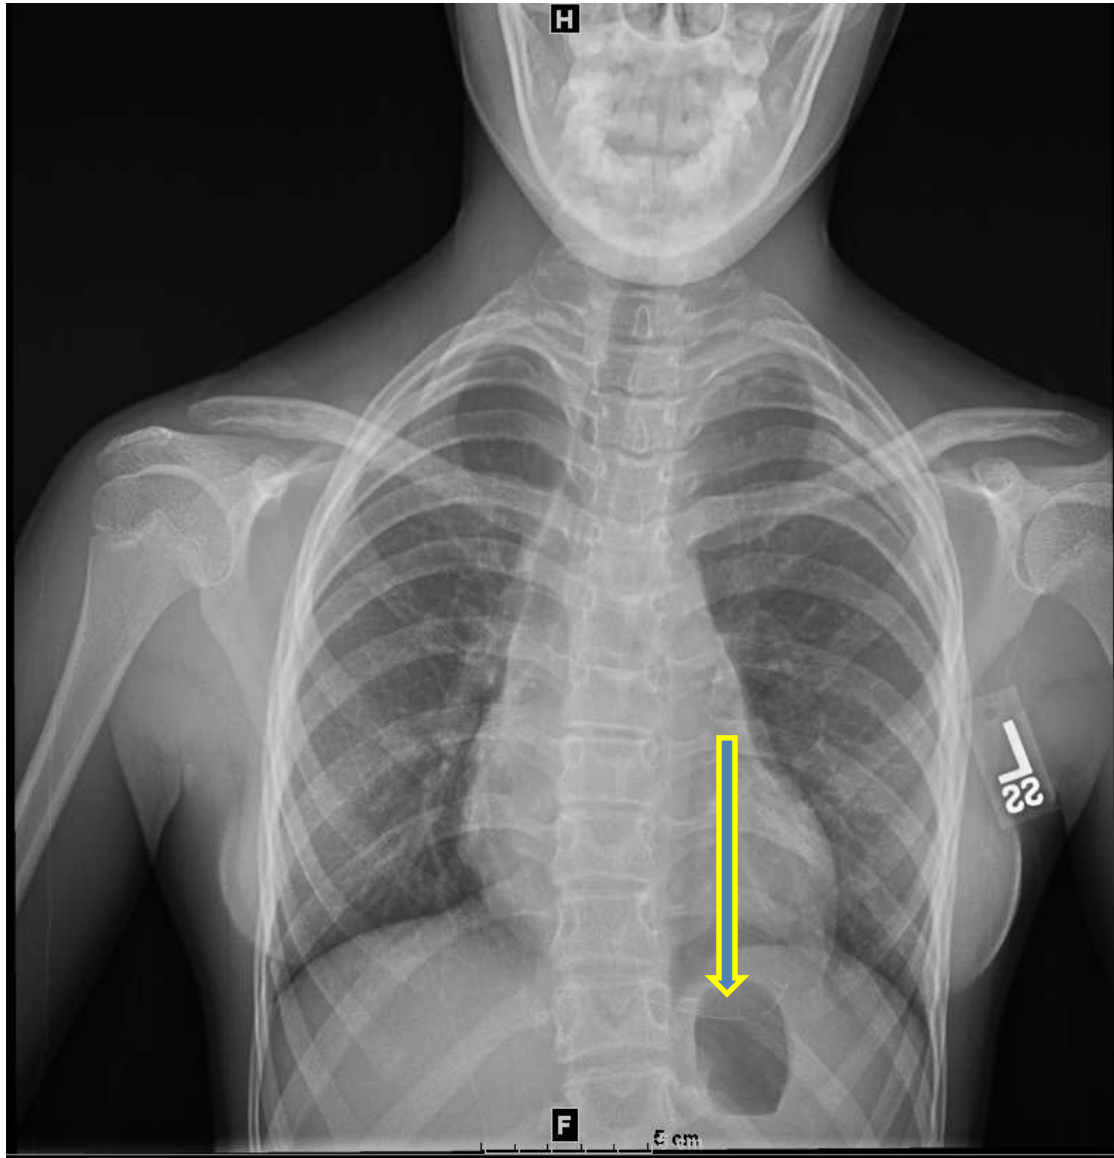
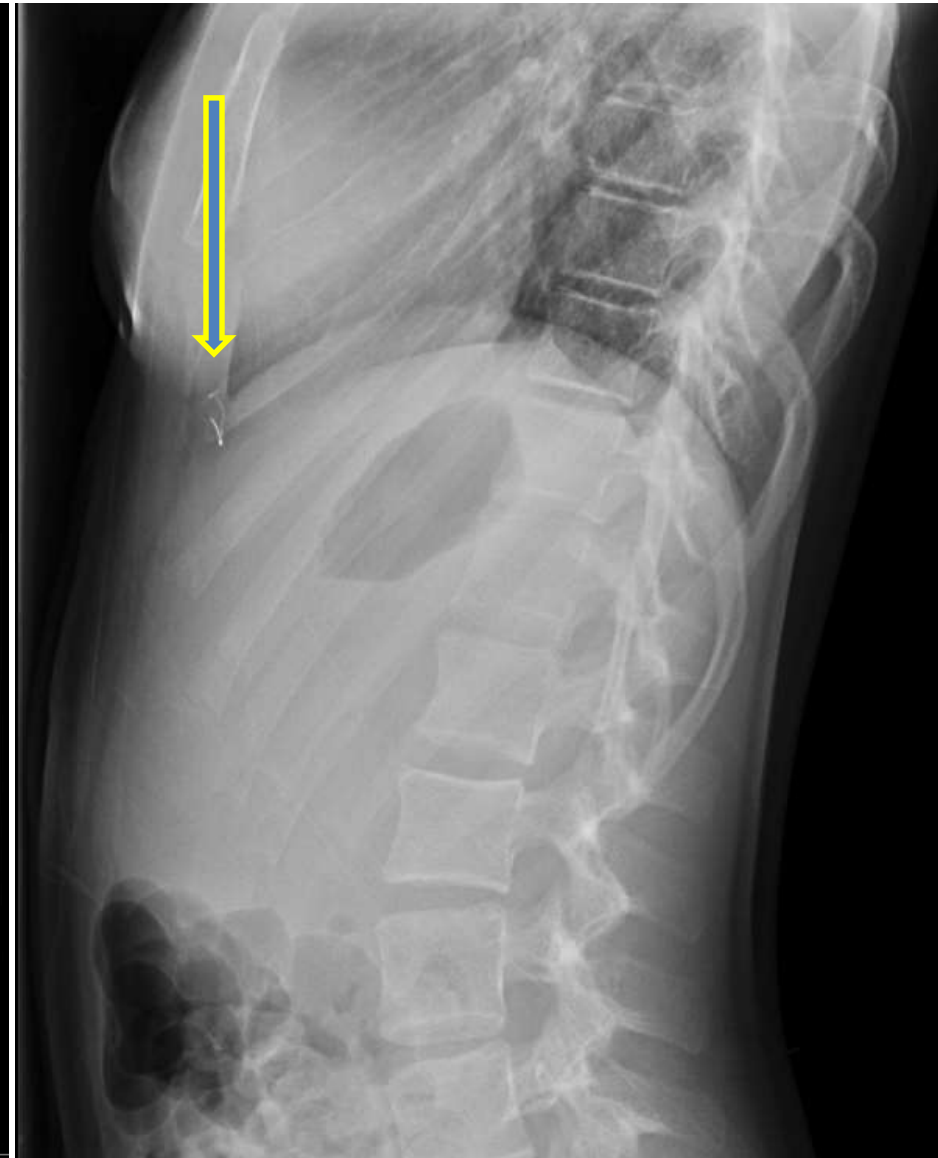
2 View Chest X-ray

Conclusion: Remnant/Orphaned Pacer Wire

- The attending radiologist informed us that the wire is a remnant/orphaned pacer wire.
- Temporary pacer wires are sometimes placed during cardiac surgery in order to prevent the need for a second open heart surgery if the patient develops the need for a pacemaker.
- If the patient's heart rate is steady after surgery, the pacer wires are mechanically removed.
- During the removal process, it is possible that a piece of the pacer wire can break off and remain as an orphaned/remnant wire.

- Remnant/Orphaned pacer wires are MR Unsafe.
- The MR examination was cancelled as the wires are in close proximity to the heart and within superficial soft tissues so there was a risk of local soft tissue & myocardial/pericardial heating and patient discomfort.
- The attending radiologist decided to cancel the MRI exam and ordered a CT exam to assess the scoliosis.
- The family was made aware of the orphaned pacer wires for future MR examinations.

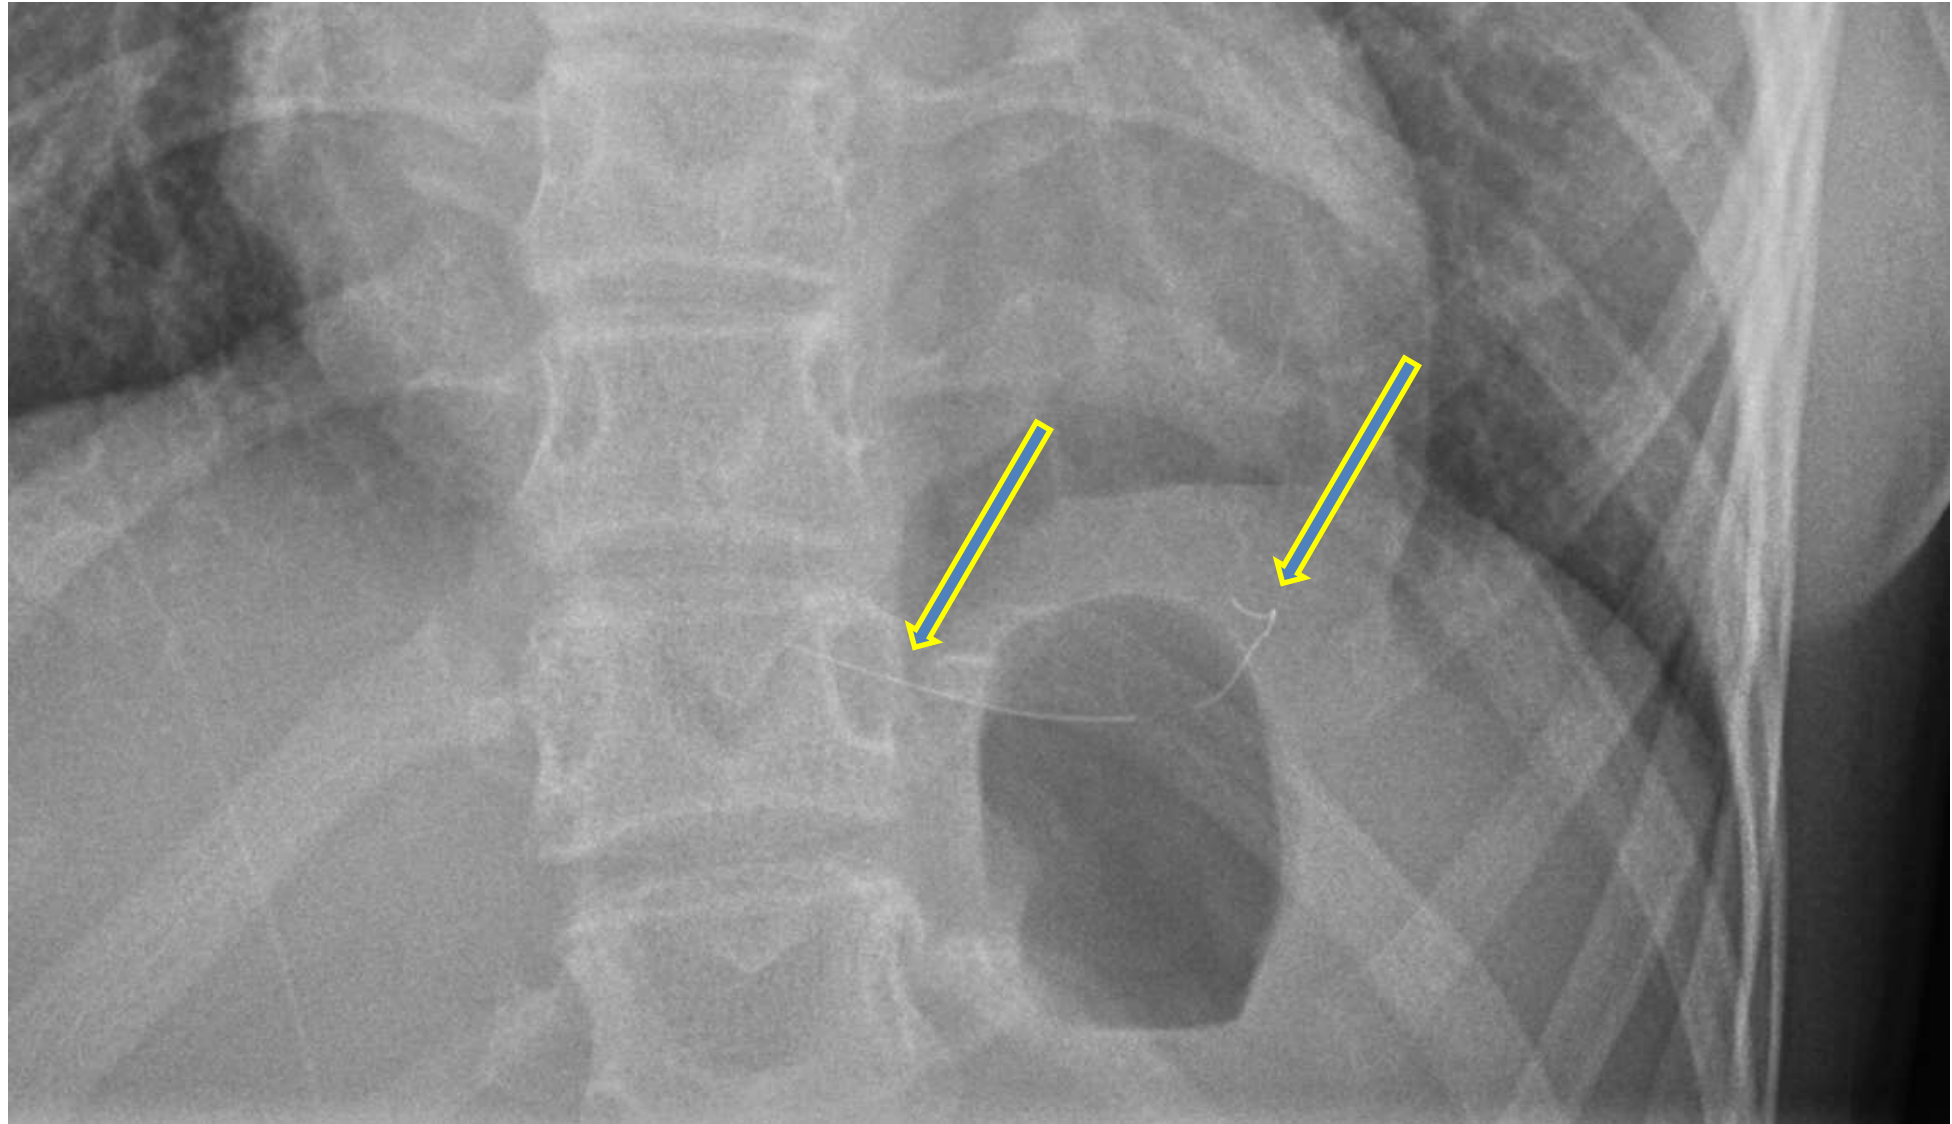
Conclusion: Remnant/Orphaned Pacer Wire

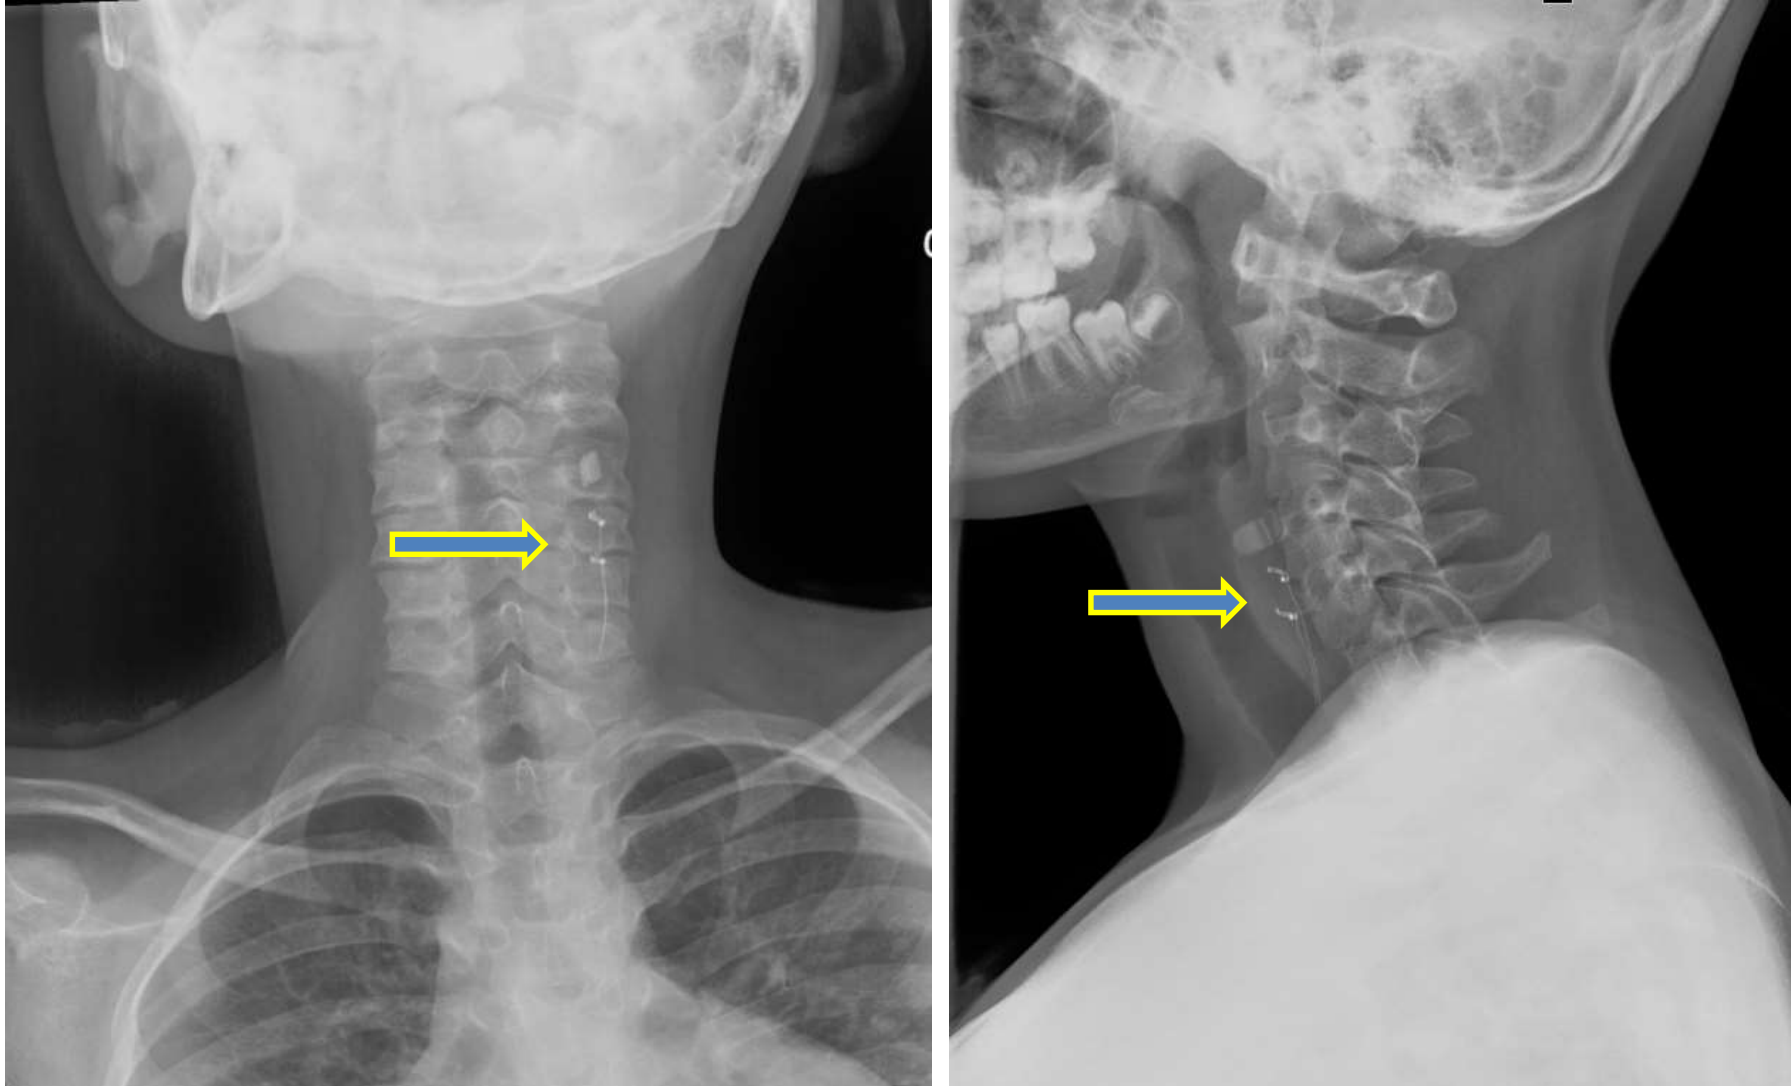
2 View Cervical X-ray to Assess Lead Length

- The remnant lead length measured on the x-ray was approximately 2 cm making the decision somewhat subjective.
- We decided to cancel the MRI due to the because of the risk of potential heating and because patient was delayed/non-verbal and required general anesthesia (and therefore could not communicate discomfort).
- A CT abdomen with contrast was ordered as an alternative to the MR abdomen.

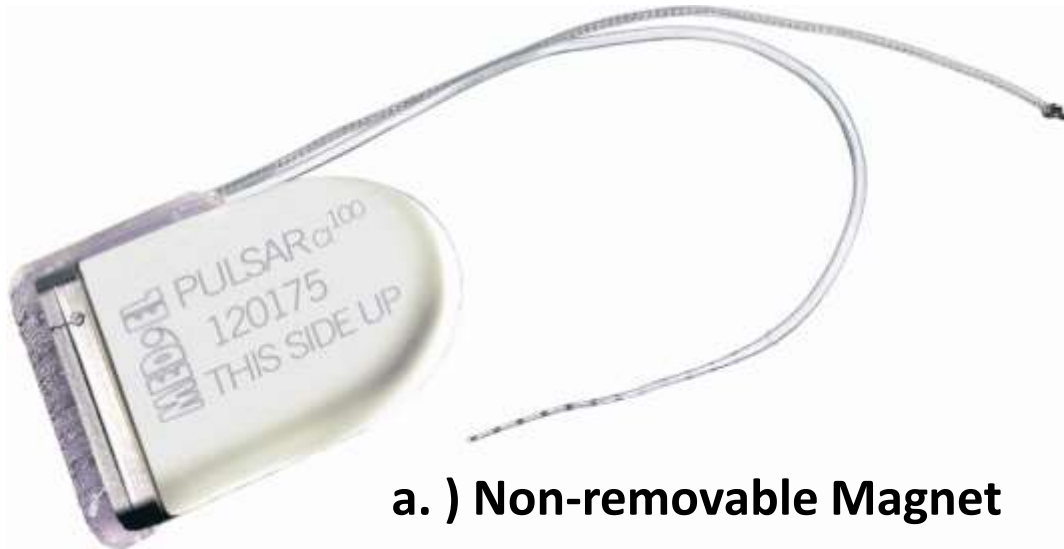
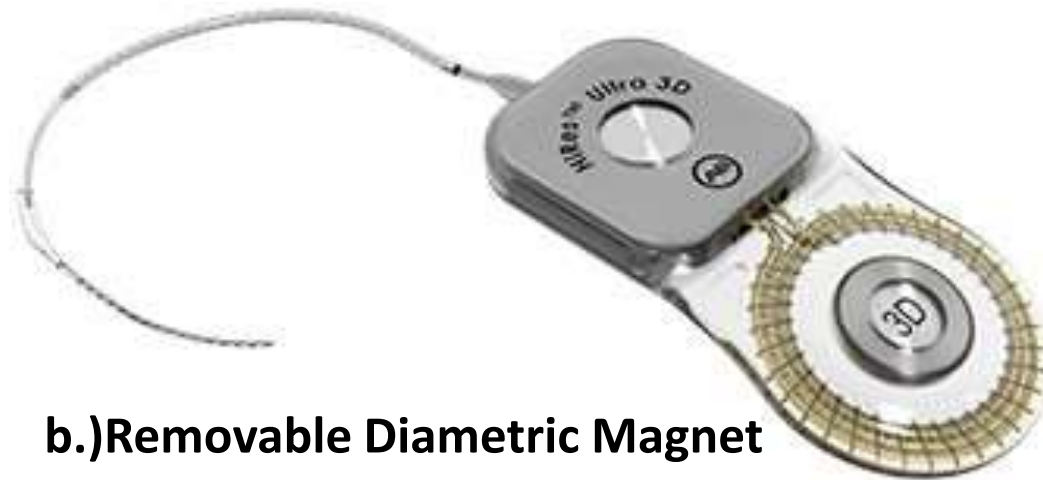
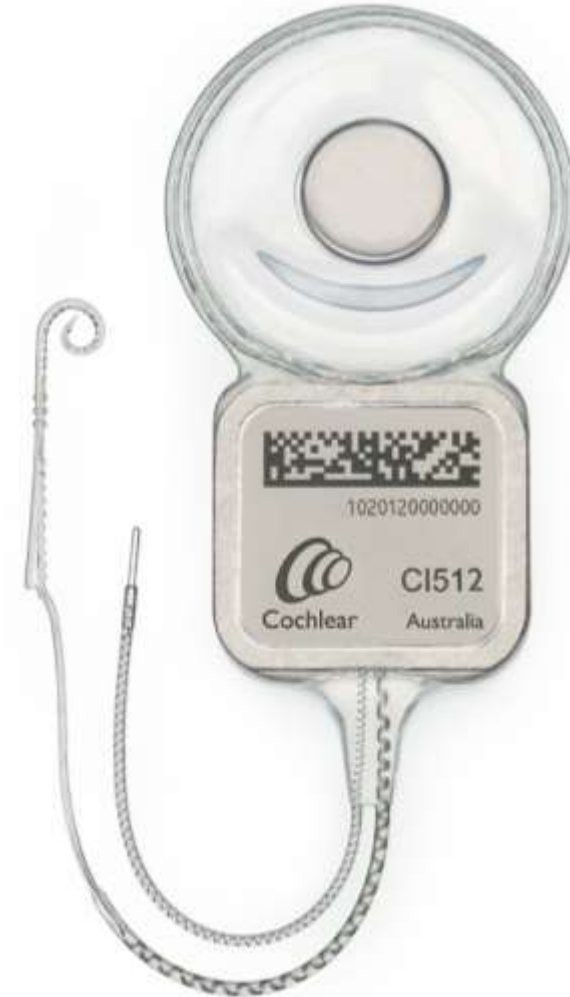
Cochlear Implant Design (3 principle types)

a.) Non-removable Magnet

b.) Removable Diametric Magnet

c.) Removable Axial Magnet

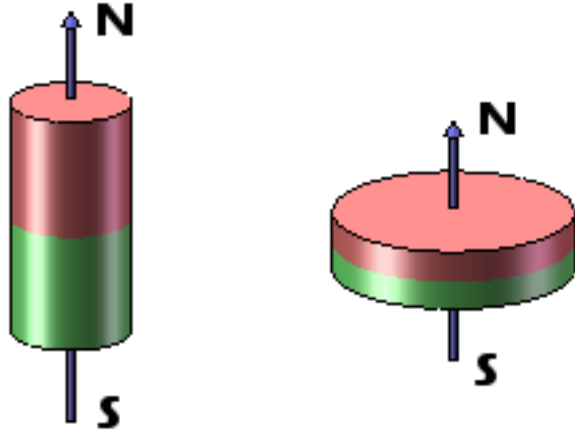
Axial Magnet Pole Orientation

If the north and south pole of the magnet is oriented along the cylinder axis, it is more likely to torque when the patient is put in or out of the MRI. Therefore, these designs require head wraps to restrict them from moving.

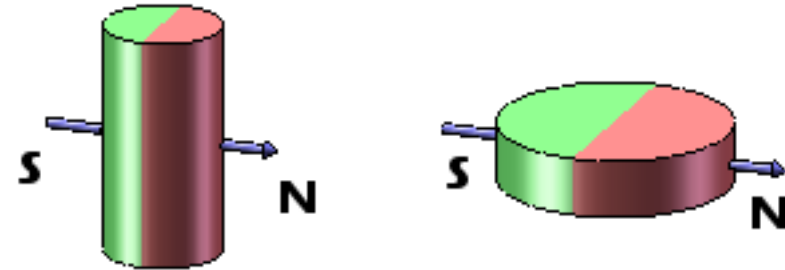
Diametric Magnet Pole Orientation

If the north and south pole of the magnet is oriented along the cylinder diameter, it is more likely to rotate along its axis when it is placed in the MRI and not transfer pressure to the patient. Therefore, these designs do not require head wraps.

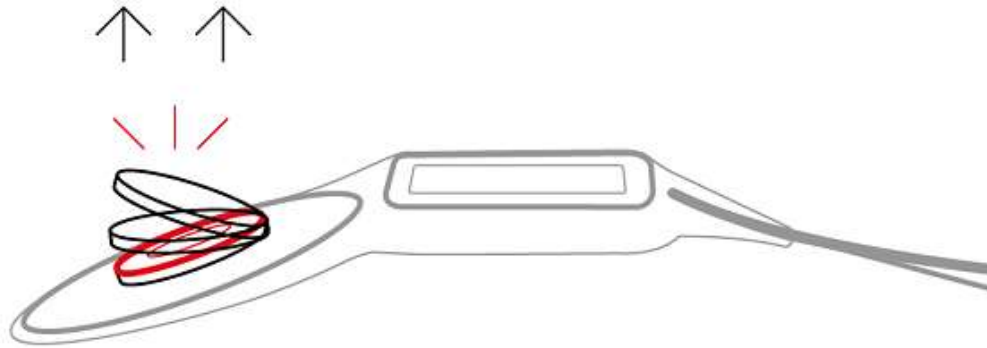
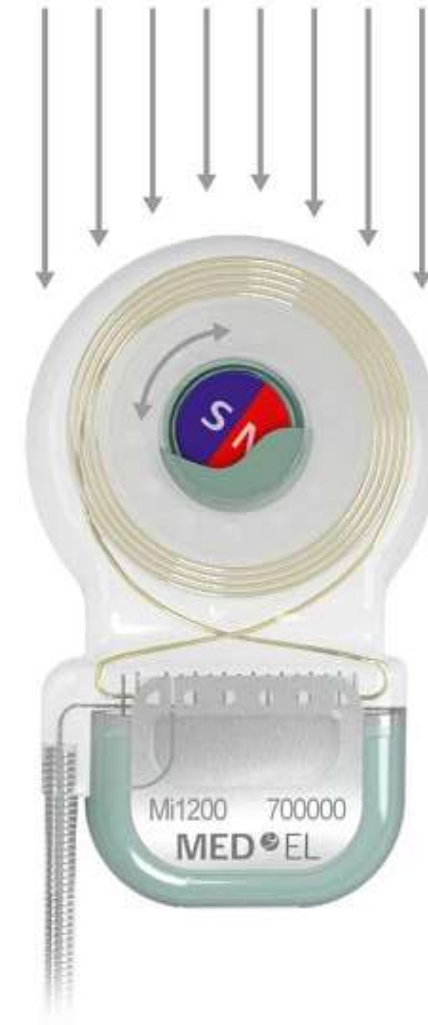
Magnet Dislocation

Non-secure axial magnet in soft silicone pocket

Axial Magnets Torque in MRI field

Diametric Magnet "Spin" in MRI field

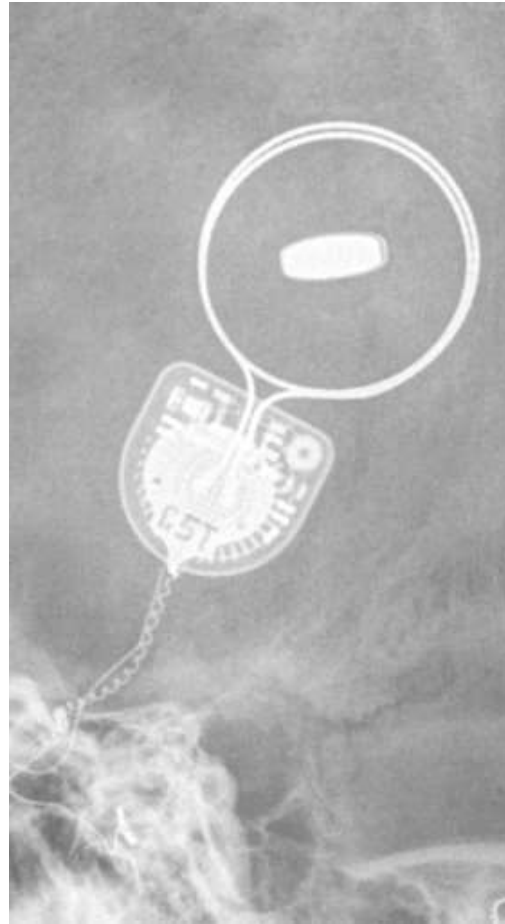
Normal Orientation

Example of Cochlear Implant Magnet Displacement after MRI

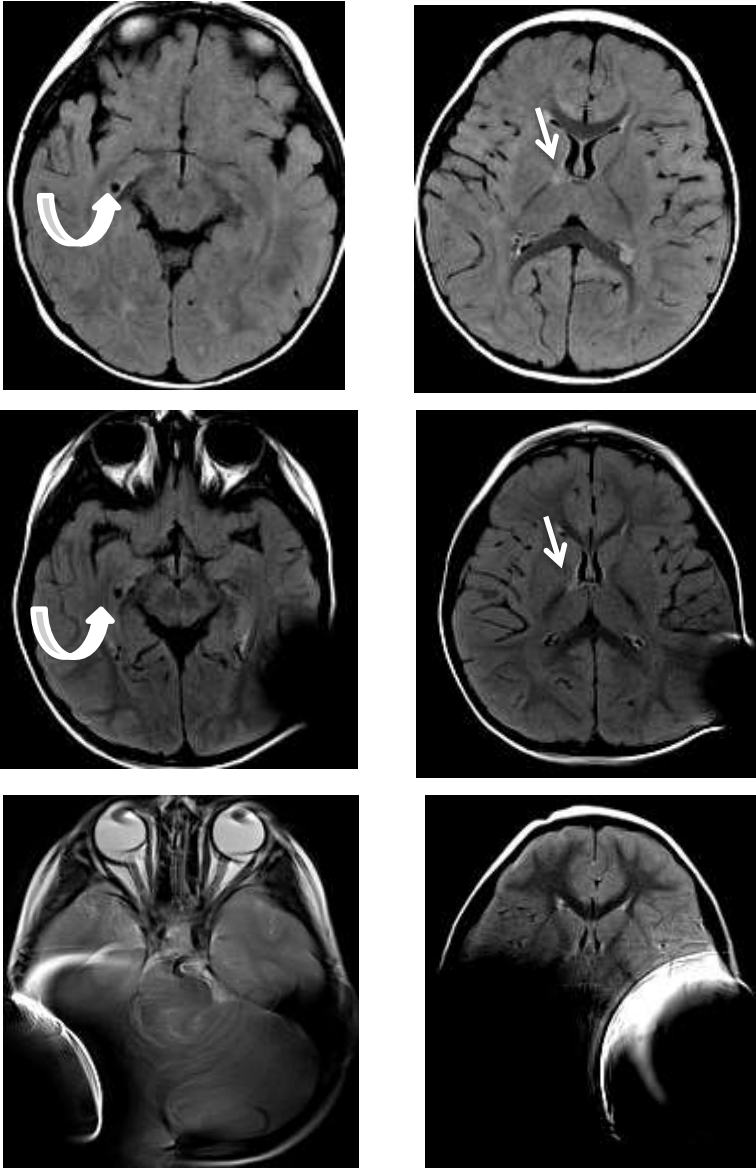
T2 FLAIR IMAGES

Cochlear Implant Effect on MRI Image Quality

Pre-implantation MRI: small choroid fissure cyst (curved arrow) and presumed gliosis in the basal ganglia (straight arrow)

MRI after implantation of the left cochlear implant contralateral to the region of interest – The pre-implantation findings are still identifiable.

MRI after implantation of bilateral cochlear implants which produces non-diagnostic images for the purposes of evaluating the previous findings. Consideration is then made whether to remove the magnets and repeat MRI imaging.
