Software Bugs or Features - Troubleshooting the Black Box: Part 1

Tom Oshiro, Ph.D., DABR
Associate Professor – Radiological Sciences
UCLA David Geffen School of Medicine

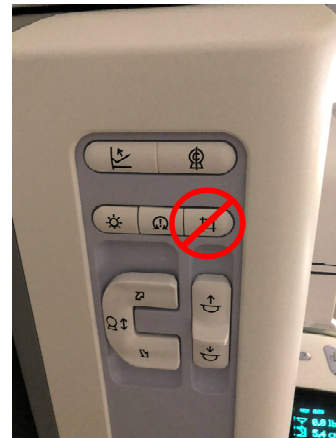
Software issue

- Programming of collimation button
- Prior models had deactivated this button (tomo)
- New version was not disabled - allowed beam restriction in tomo
 - When the field size was set smaller - the beam opened up anyway

Troubleshooting

- Escalated through the vendor
 - Showed difference in operation on systems
 - Acknowledged the 'bug' & issued a patch
- Workaround
 - Advised techs to not to push the collimation button during tomo exposures
 - Same patient dose compared to normal operation (less clinical impact)
