Review of Basic MRI Artifacts in the Clinical Realm

Trevor Andrews, PhD, DABMP(MRI), MRSE(MRSC™)
Associate Professor of Radiology
Mallinckrodt Institute of Radiology
Washington University in St Louis School of Medicine
trevor.andrews@wustl.edu

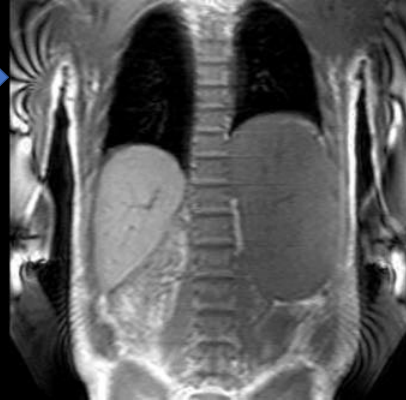
Cause:

The static magnetic field far from the isocenter of the magnet (often near the end of the bore for large FOVs).

All MR physics falls apart here!

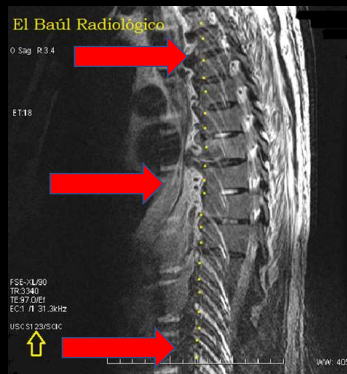
Variation on an Annefact Artifact

Fix: Turn off coil elements away from your slices

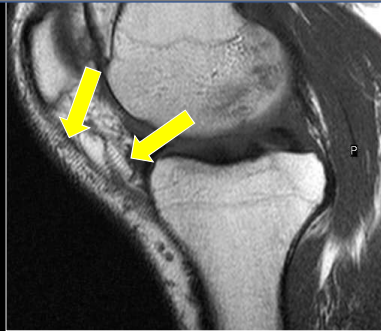
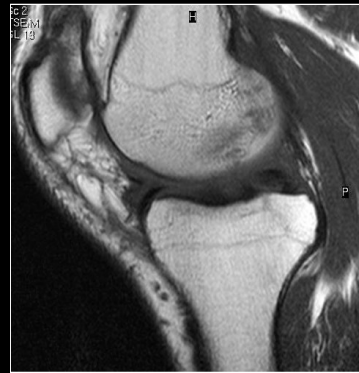
FID Artifact (focal stripes)

Most apparent with T1/PD TSE

Cause: Flip angle inaccuracy leads to **stimulated echoes** (which after the reconstruction look like fine structure)

- 1) Use 2 "real" NEX
- 2) Increase signal crushing gradients around refocusing pulse (possibly by turning on flow compensation gradients).

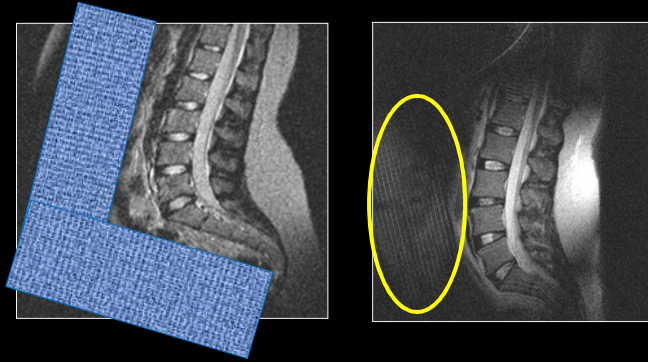
Cause: Intersecting Saturation Bands (AKA: REST slabs)

- Not to be confused with corduroy artifacts caused by spikes
- Those caused by REST tend to be localized
- Often associated with 3D FSE/TSE
