## Enhancing Our Safety Culture by Understanding Recent Mishaps (Part 2): Brachytherapy

Bruce Libby, PhD  
Associate Professor and Chief of  
Clinical Brachytherapy Physics  
University of Virginia Health System

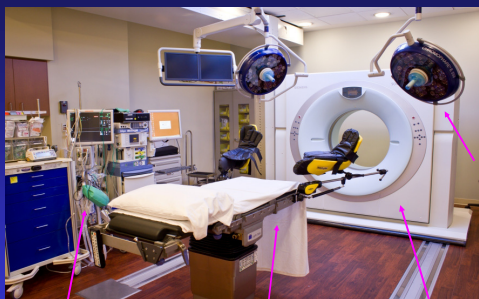
Image Guided Brachytherapy Suite at the University of Virginia

Anesthesia

Trumph OR couch (w/ carbon fiber insert)

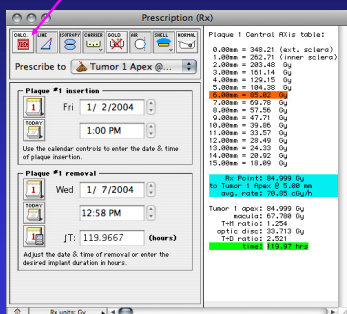
Easy to overlook changing calculation protocol  
(USC protocol is default, CANNOT change the default to COMS protocol)

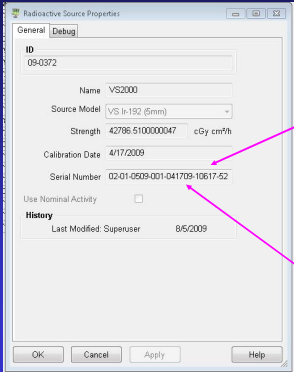
### BrachyVision Source Properties

Activity (mCi)

Calibration Date
