New Comprehensive and Practical Guidelines for Managing Radiotherapy Patients with Cardiac Devices---TG203

**Dimitris Mihailidis, PhD.,
Charleston Radiation Therapy Consultants
Charleston, WV 25304**

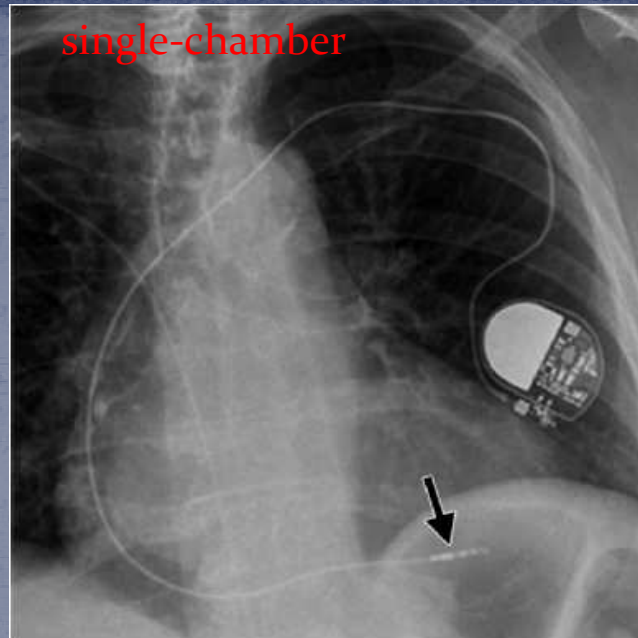
a.

Figure 2. Three types of cardiac pacemakers. (a) Frontal chest radiograph shows a single-chamber pacemaker with a single lead in the right ventricle (arrow). (b) Frontal chest radiograph shows a dual-chamber pacemaker, which has leads in the right atrium (arrowhead) and right ventricle (arrow). (c) Frontal chest radiograph shows a biventricular pacemaker with one right ventricular lead (arrowhead) and one left ventricular lead (arrow). A biventricular pacemaker may also have a right atrial lead.

Different types of pacemakers are placed depending on the cause of bradycardia (Fig 2). A single-chamber pacemaker has one lead that paces either the right ventricle or right atrium. Most commonly, this lead is placed in the apex of the right ventricle and is used to pace the heart when there is a problem with the conduction pathways (Fig 2a). Uncommonly, a single lead may be placed in the right atrium when an atrial dysrhythmia due to sinoatrial node dysfunction or an aberrant additional sinoatrial node pacemaker focus is present. In this case, the conduction tissues are normal; once the

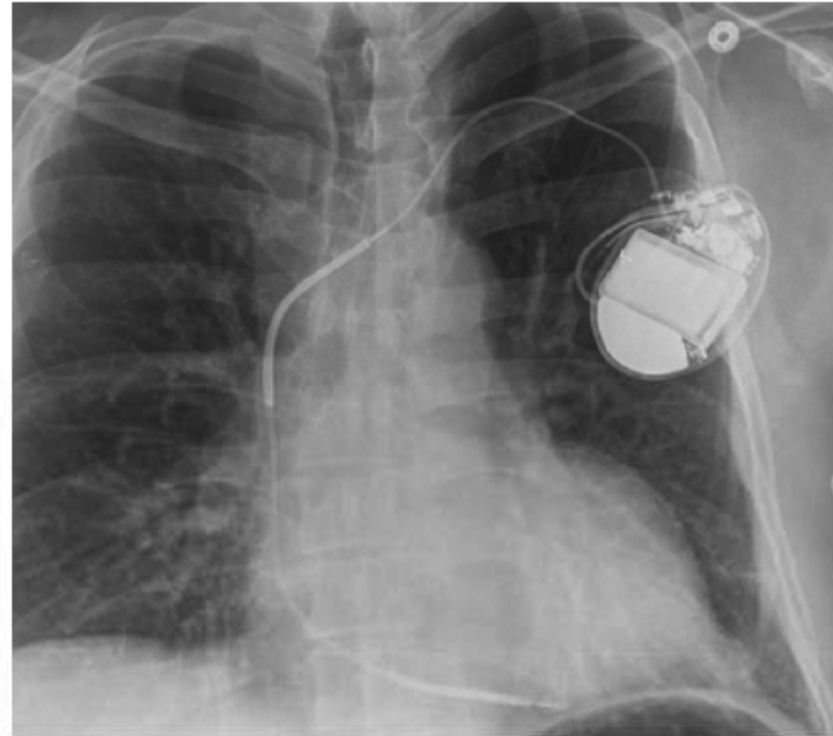
Figure 4. Normal radiographic appearance of an ICD. On a frontal chest radiograph, the shock coils of an ICD lead appear as sections of thickened metallic opacity that terminate in the regions of the superior vena cava and right ventricle.

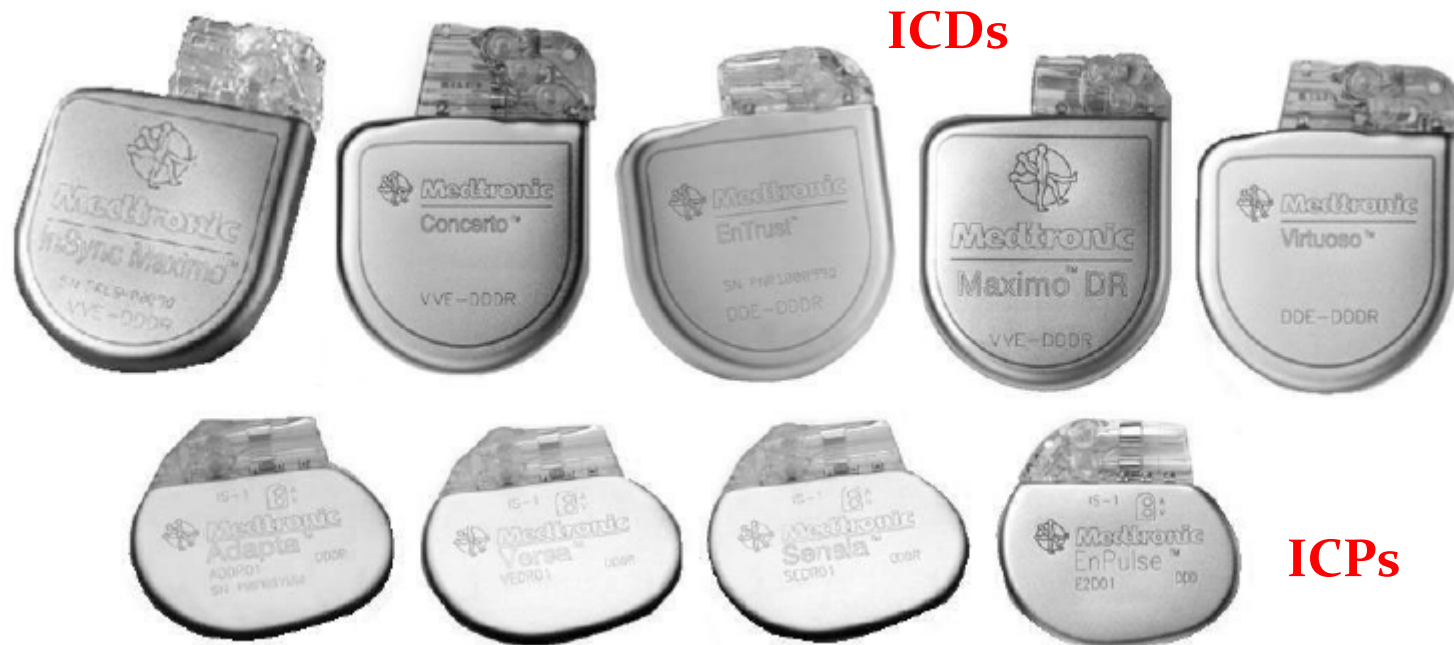
FIG. 3. [Top]: Five ICDs [Left to Right]: InSync Maximo model 7304, Concerto model C154DWK (VVE-DDDR), Entrust model D154ATG, Maximo DR model 7278, and Virtuoso model D154AWG; [Below]: four implantable pacemakers: Adapta model ADDR01, Versa model VEDR01, Sensia model SEDR01, and EnPulse2 model E2DR01.

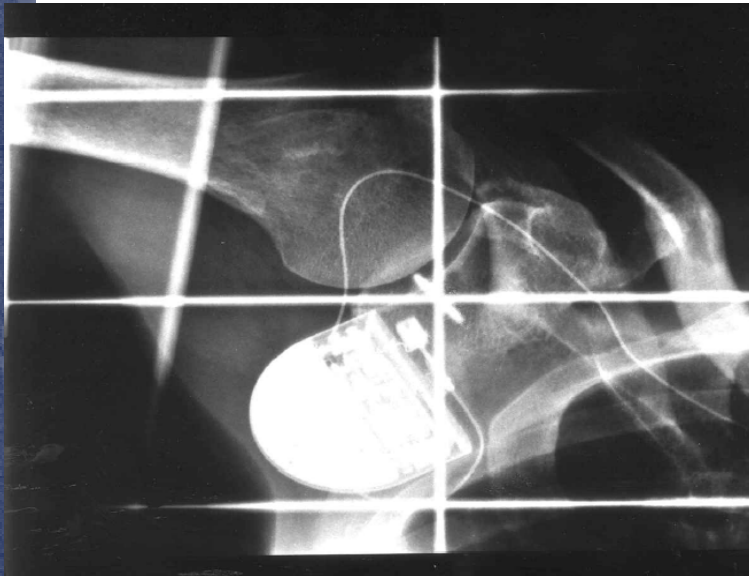
Radiotherapy course. The patient received radiotherapy as an inpatient. Figure 1 shows the pacer in the treatment field. During each fraction we performed an ECG and observed the rhythm on a monitor outside. The cardiologist was with us during the first fraction, and on stand-by for the further fractions. Pacer-function analyses were completed before, in the middle (3 weeks later) and after the radiation course. We irradiated the lymphatic nodes in the right axilla up to a dose of 50.4 Gy without problems. At a fractionation of 5×1.8 Gy per week, it took us about 6 weeks. The pacemaker functioned without failure during every fraction, but the magnetic frequency of the pacer, which is usually an indicator of the battery load, began to decrease.

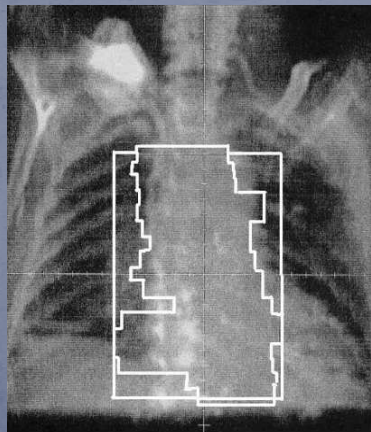
Figure 1. Simulation of the 2-field irradiation technique.

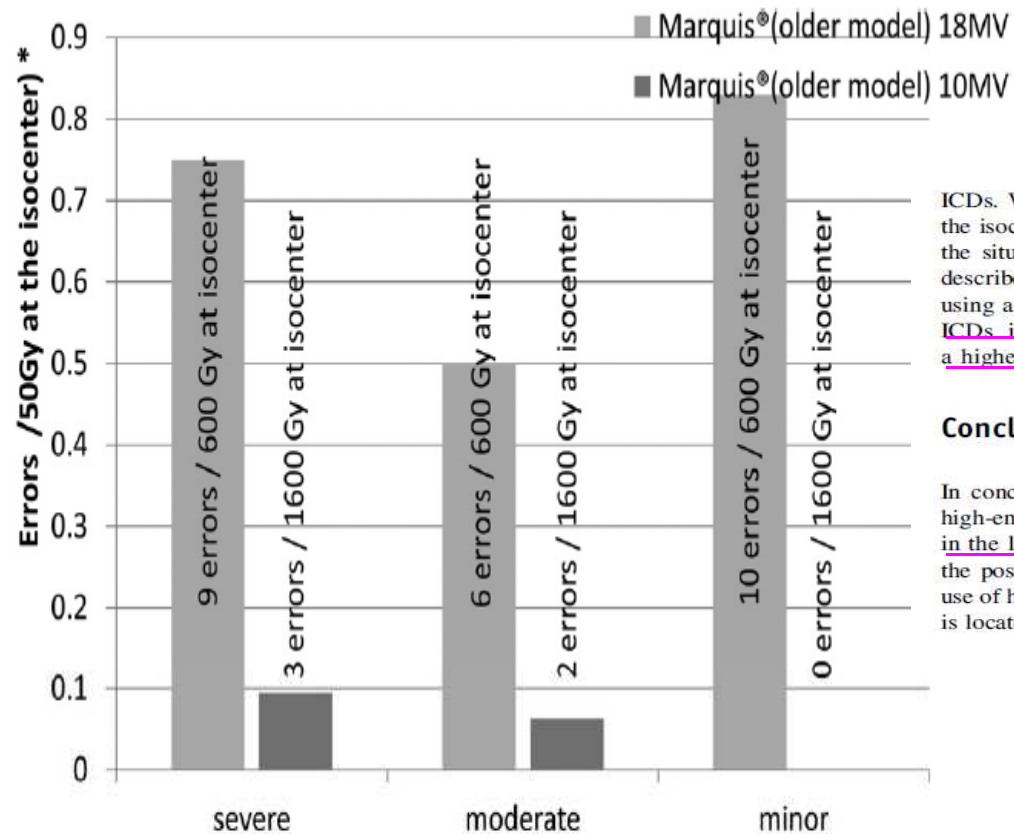
*The axis are scaled differently in figures 3 and 4.

Fig. 3. Comparison of the 2 irradiation energies, showing that 18-MV irradiation caused more frequent errors in the ICDs.

Results: Hard errors were not observed. For the older ICD model, the incidences of severe, moderate, and minor soft errors at 18 MV were 0.75, 0.5, and 0.83/50 Gy at the isocenter. The corresponding data for 10 MV were 0.094, 0.063, and 0.150 Gy. For the newer ICD model at 18 MV, these data were 0.083, 2.3, and 5.8/50 Gy. Moderate and minor errors occurred at 18 MV in control ICDs placed 140 cm from the isocenter. The error incidences were 0, 1, and 0/600 Gy at the isocenter for the newer model, and 0, 1, and 6/600Gy for the older model. At 10 MV, no errors occurred in control ICDs.

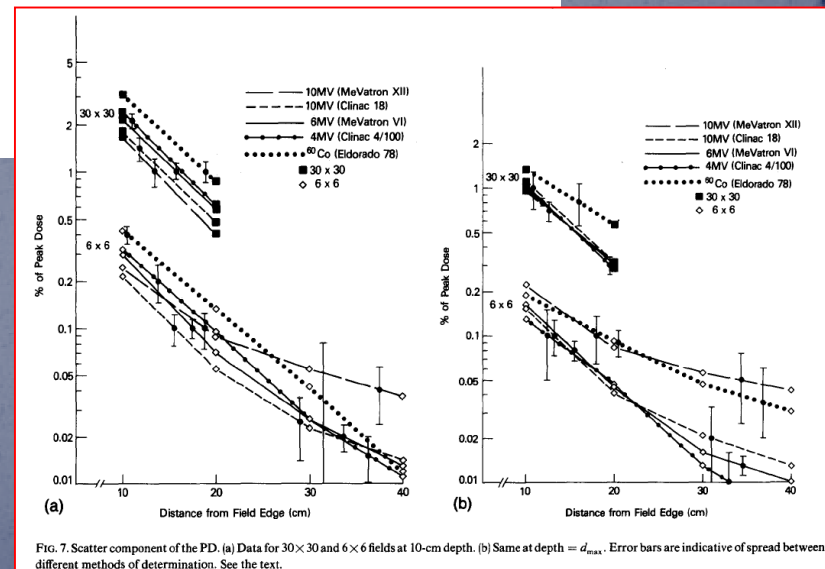
FIG. 7. Scatter component of the PD. (a) Data for 30 x 30 and 6 x 6 fields at 10-cm depth. (b) Same at depth = d_{max} . Error bars are indicative of spread between different methods of determination. See the text.

The peripheral dose (PD), defined as the dose outside of therapeutic radiation beams, has been investigated for ⁶⁰Co, 4-, 6-, and 10-MV x-ray machines. The measurements have been carried out down to dose levels of about 0.1% of the peak dose in the beam, since that dose level may be of clinical importance in some situations. The PD measurements for the various machines are qualitatively similar, which allows the identification of a simple basic data set which can characterize the PD for any particular machine. The PD has been separated into two components: in-phantom scatter dose and transmission (leakage) dose. Knowledge of the two components is important clinically when shielding is considered.

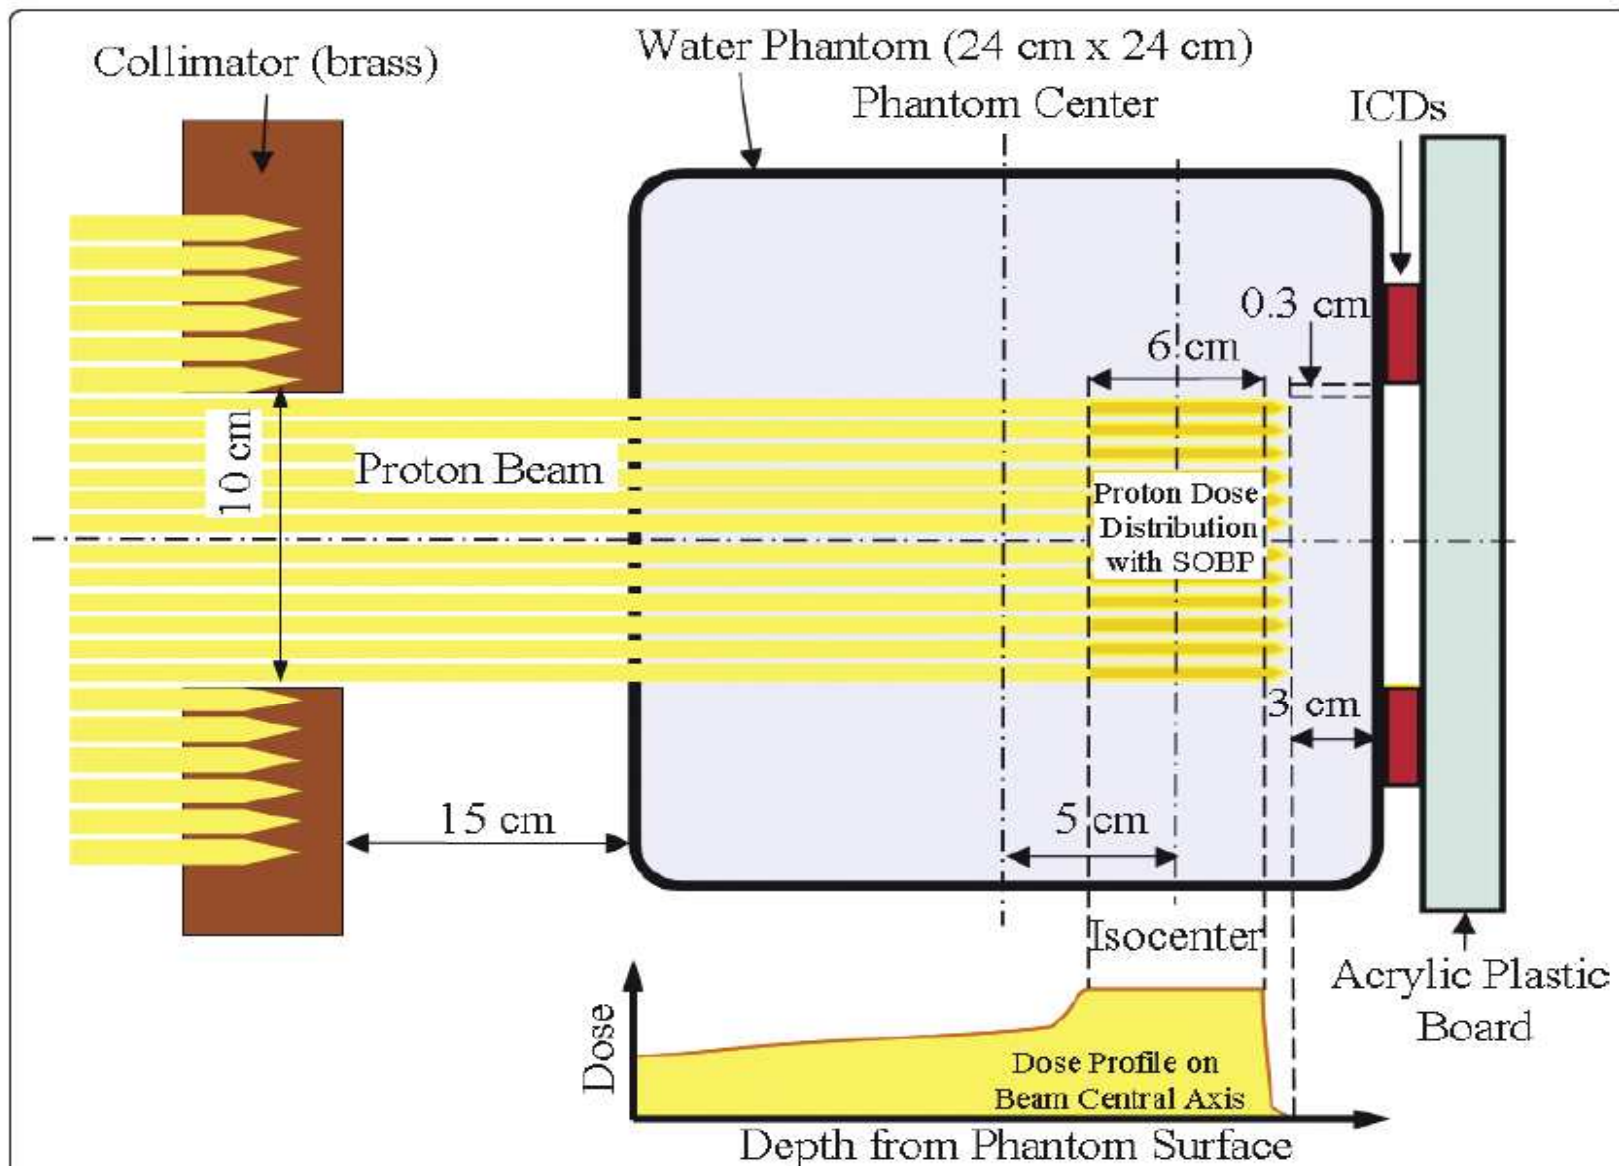
Figure 2 View of the experimental set-up of proton irradiation to the phantom with implantable cardioverter defibrillators (ICDs) on the central axis of the proton beam. Four ICDs were placed on the contralateral side of the phantom. Proton beams entered the water phantom laterally, and an acrylic plastic board was set behind the ICDs to provide backscatter conditions. Calculated spread-out Bragg peak (SOBP) curves in water and experimental values are included.

Conclusions: With the present experimental settings, the probability was approximately 1 power-on reset per 50 Gy, which was below the dose level (60-80 Gy) generally used in proton radiotherapy. Further quantitative analysis in various settings is needed to establish guidelines regarding proton radiotherapy for cancer patients with ICDs.

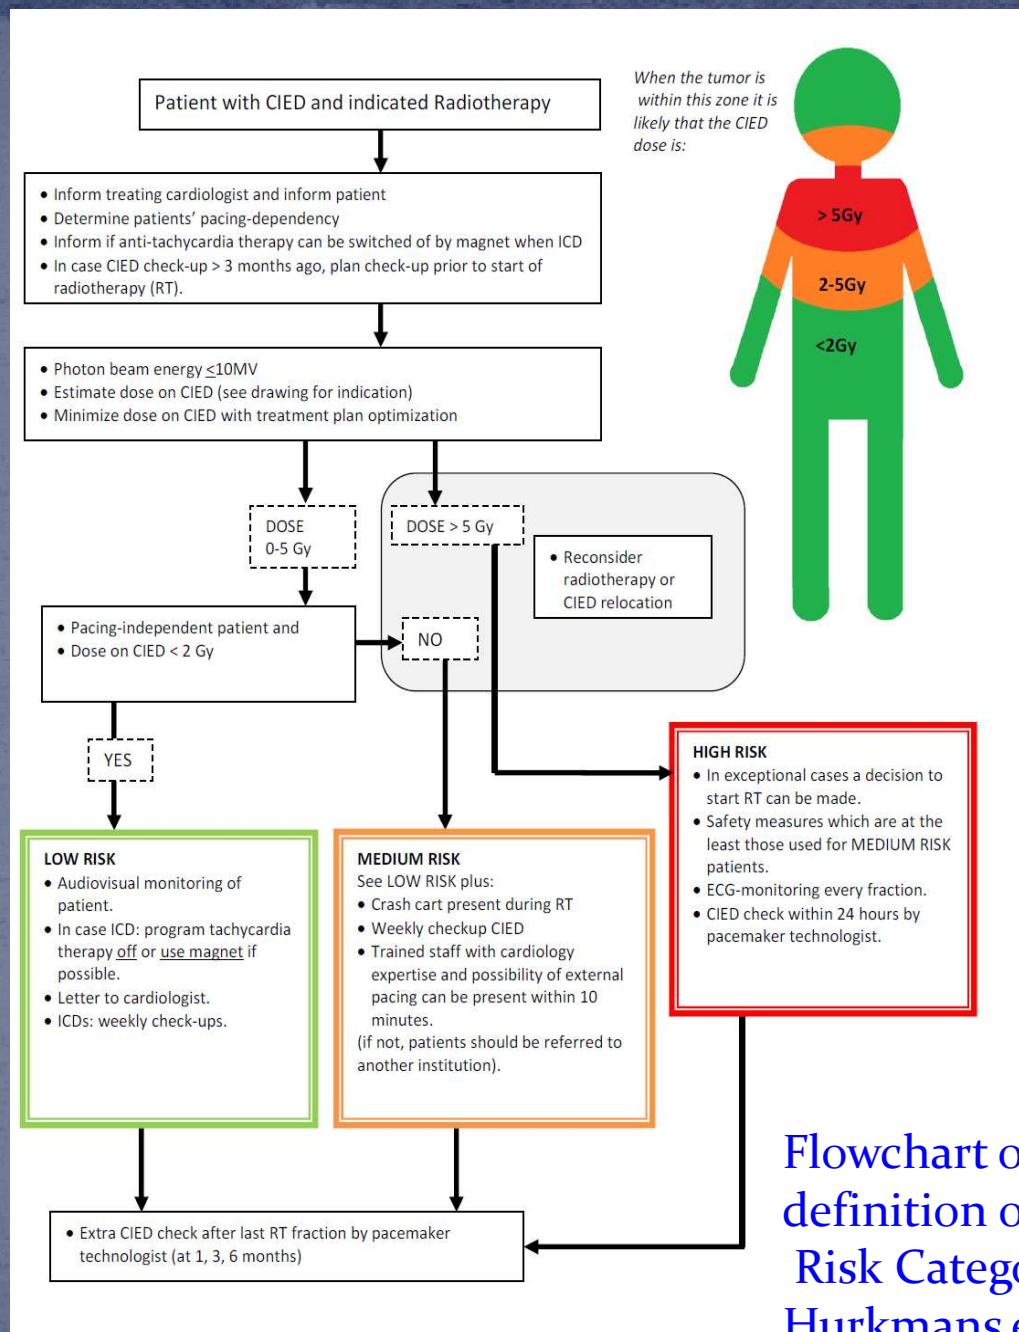
Flowchart or recommended guidelines, definition of patient Risk Categories (adapted and modified from Hurkmans et al. (2012))

Patient	Risk Category (Dose Region)		
	< 2 Gy	2-5 Gy	> 5 Gy
Pacing-independent	Low Risk	Medium Risk	High Risk
Pacing-dependent	Medium Risk	Medium Risk	High Risk
