### Outline: Artifact Identification, Cause, How to Fix

- Motion / ghosting
- Flow
- Aliasing / wrap
- Radiofrequency interference
- Metal
- Corduroy

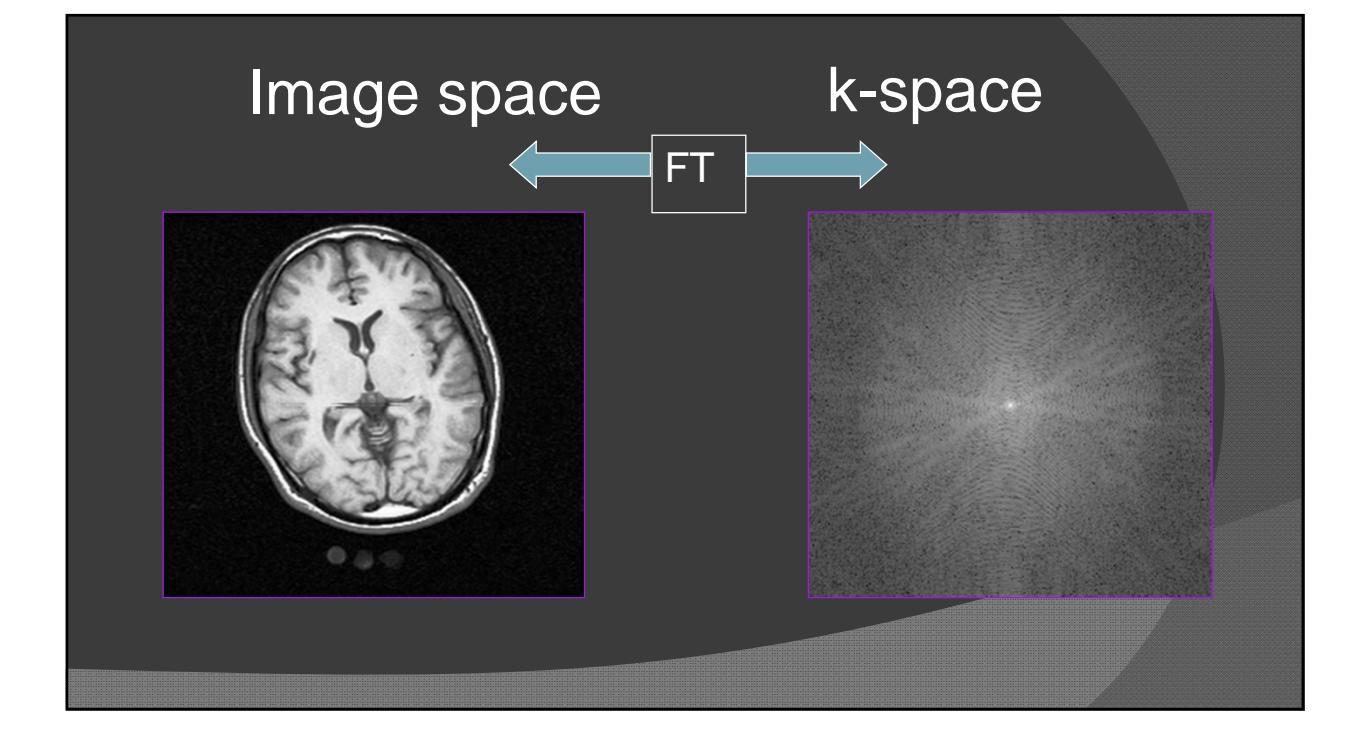
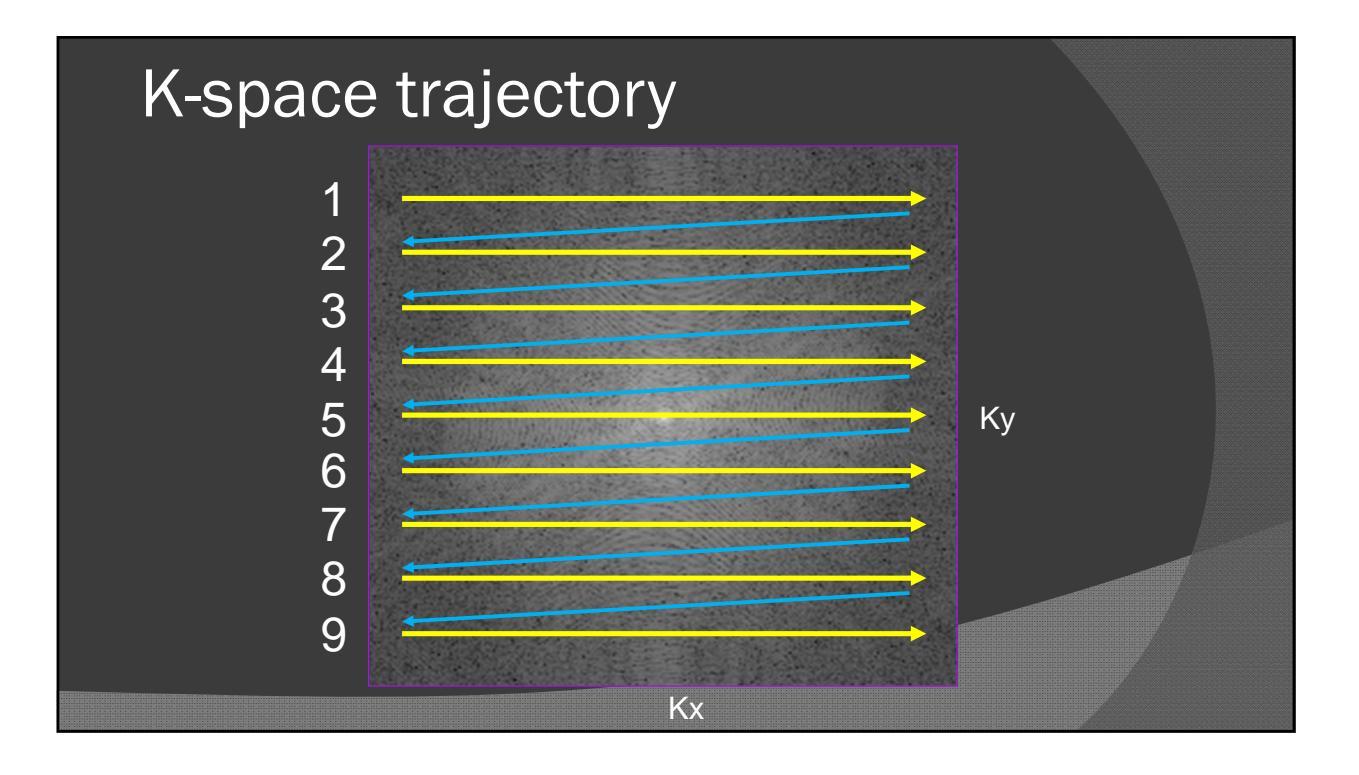
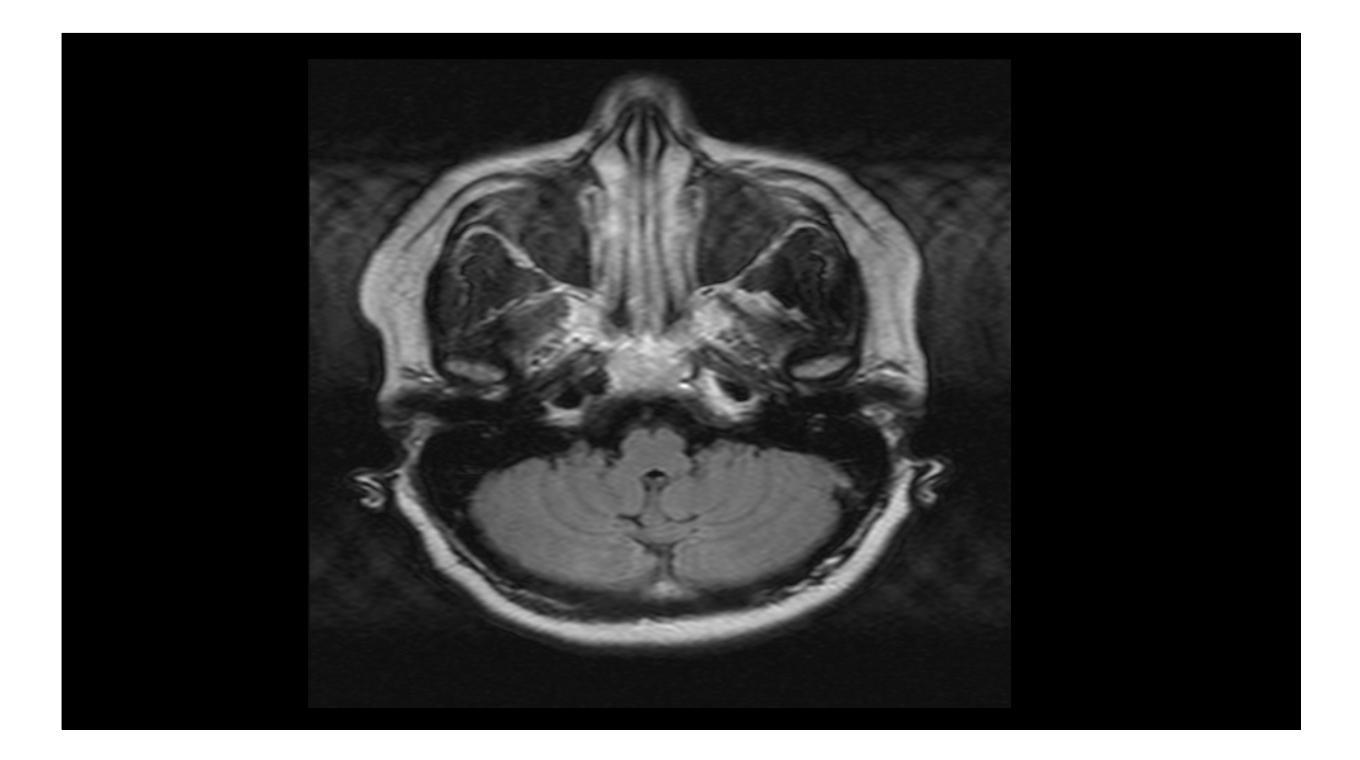
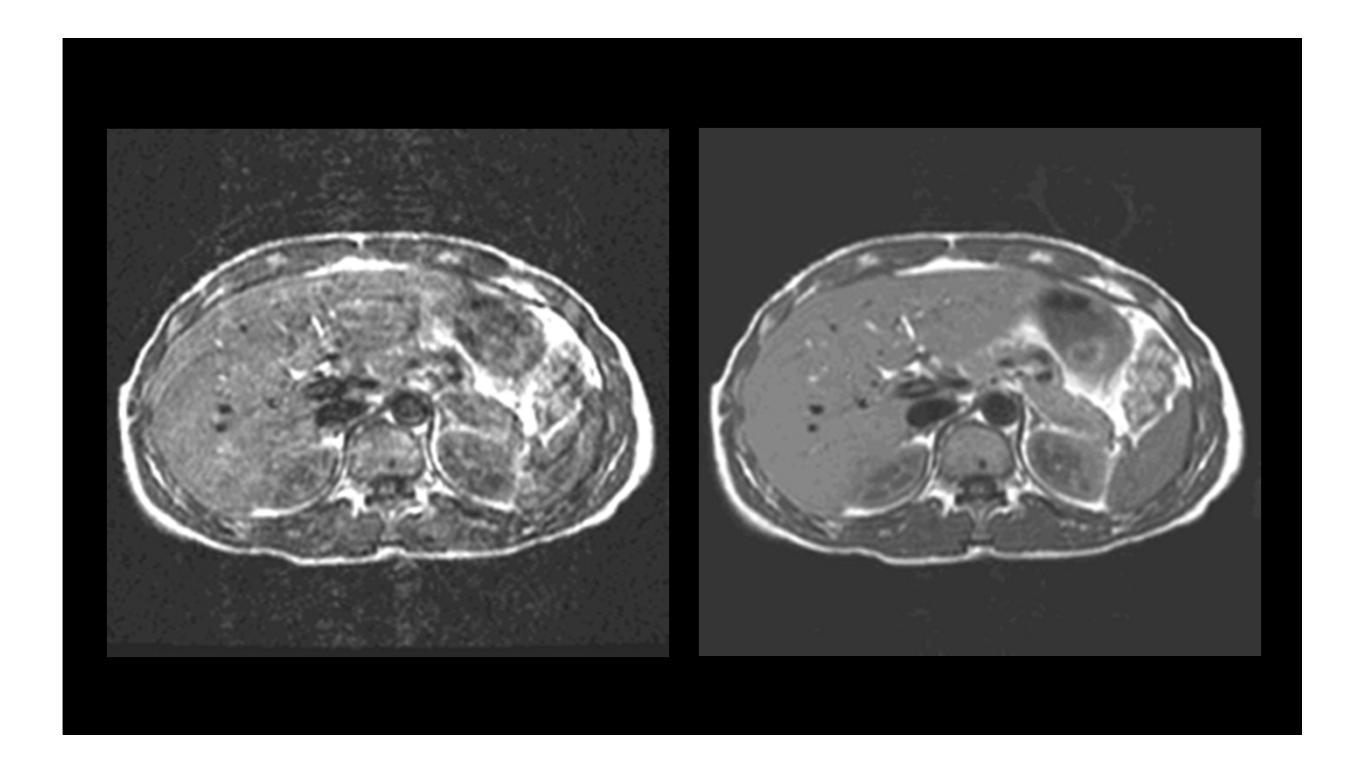
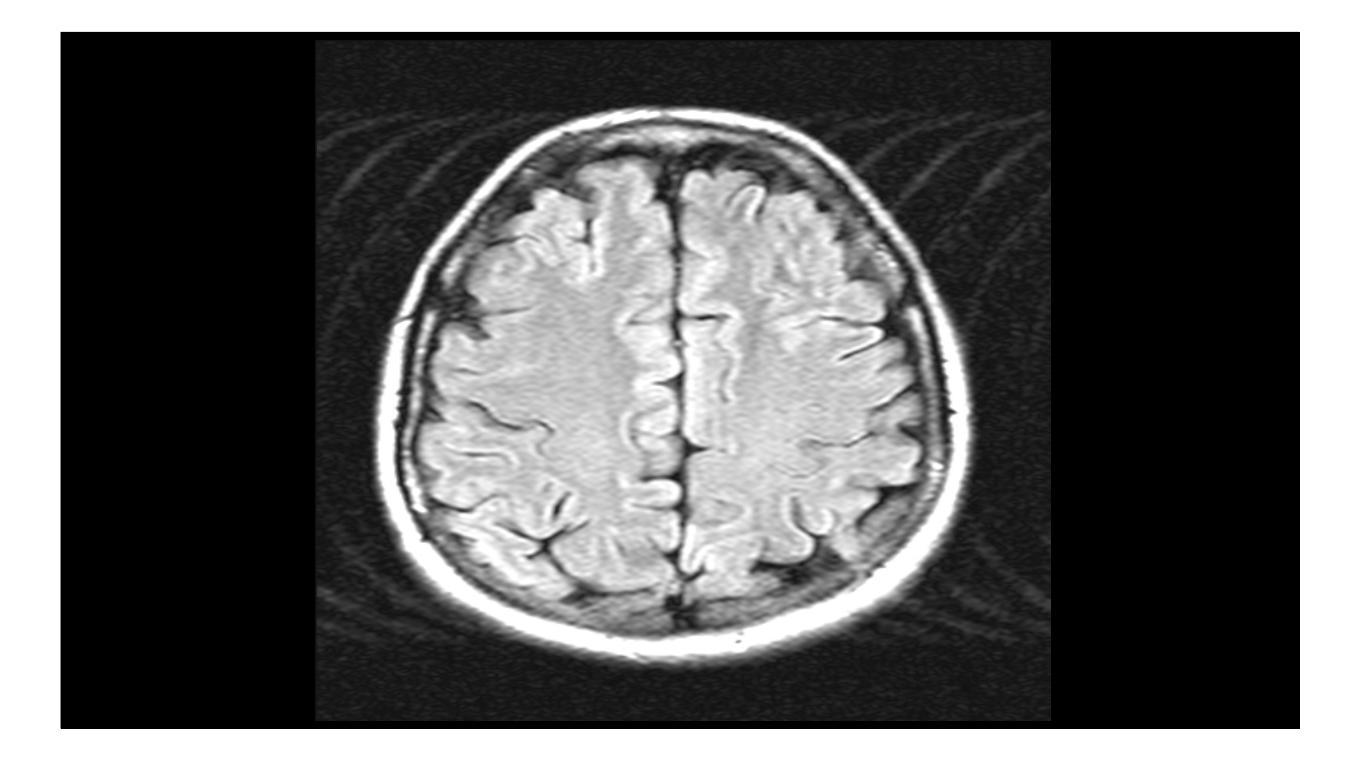
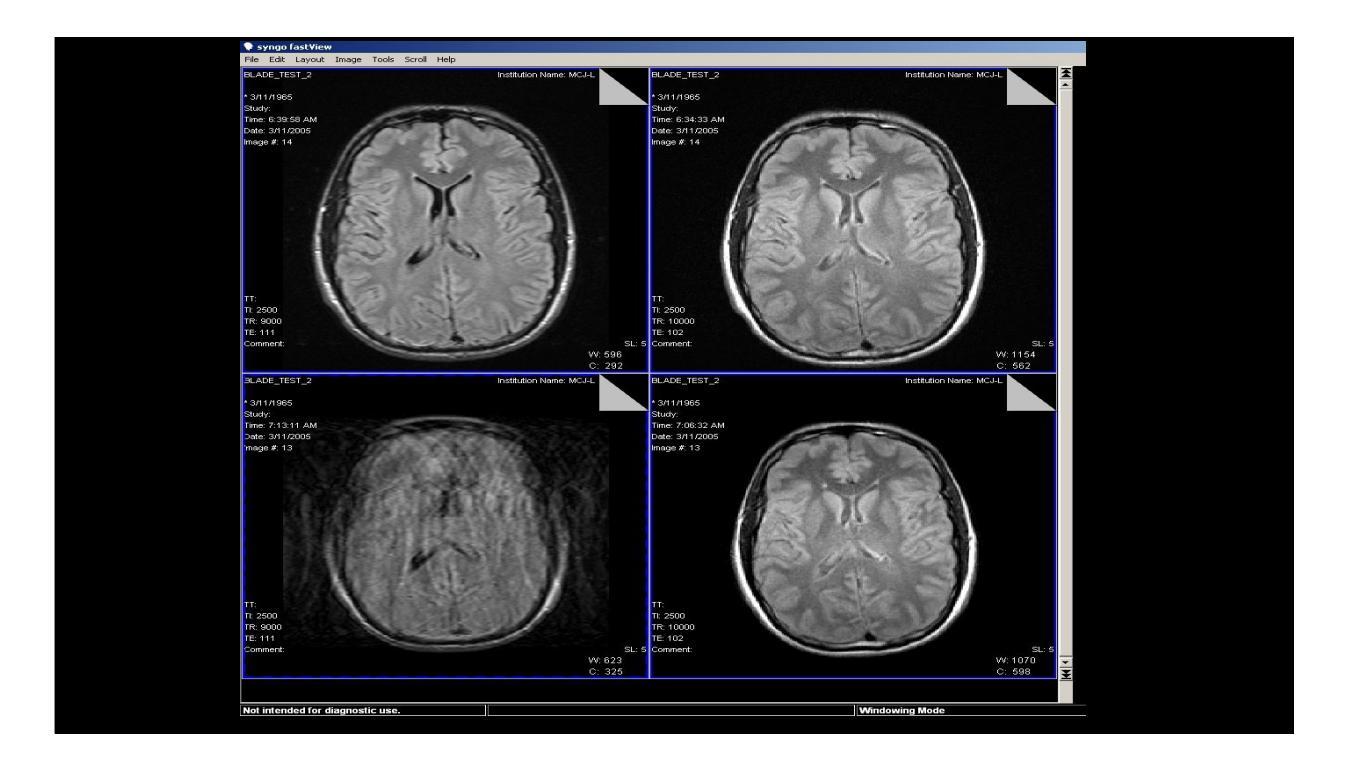
# Motion / Ghosting Identification: May appear as repetition of "ghosts" across image, may be distinct or blurred depending on type of motion. Typically occurs in phase encoding direction Causes: Patient motion, physiologic / involuntary, voluntary; equipment vibration / instability

- How to fix:
  - Remind patient to hold still, make patient more comfortable, decrease scan time, consider sedation
  - Use respiratory triggering / navigator pulses, motion correction, breath-hold options when available
  - Implement Propeller / Blade sequence options
  - Address equipment problems, test with phantom, test with cold-head off
  - Swap phase and frequency if artifact obscures pathology

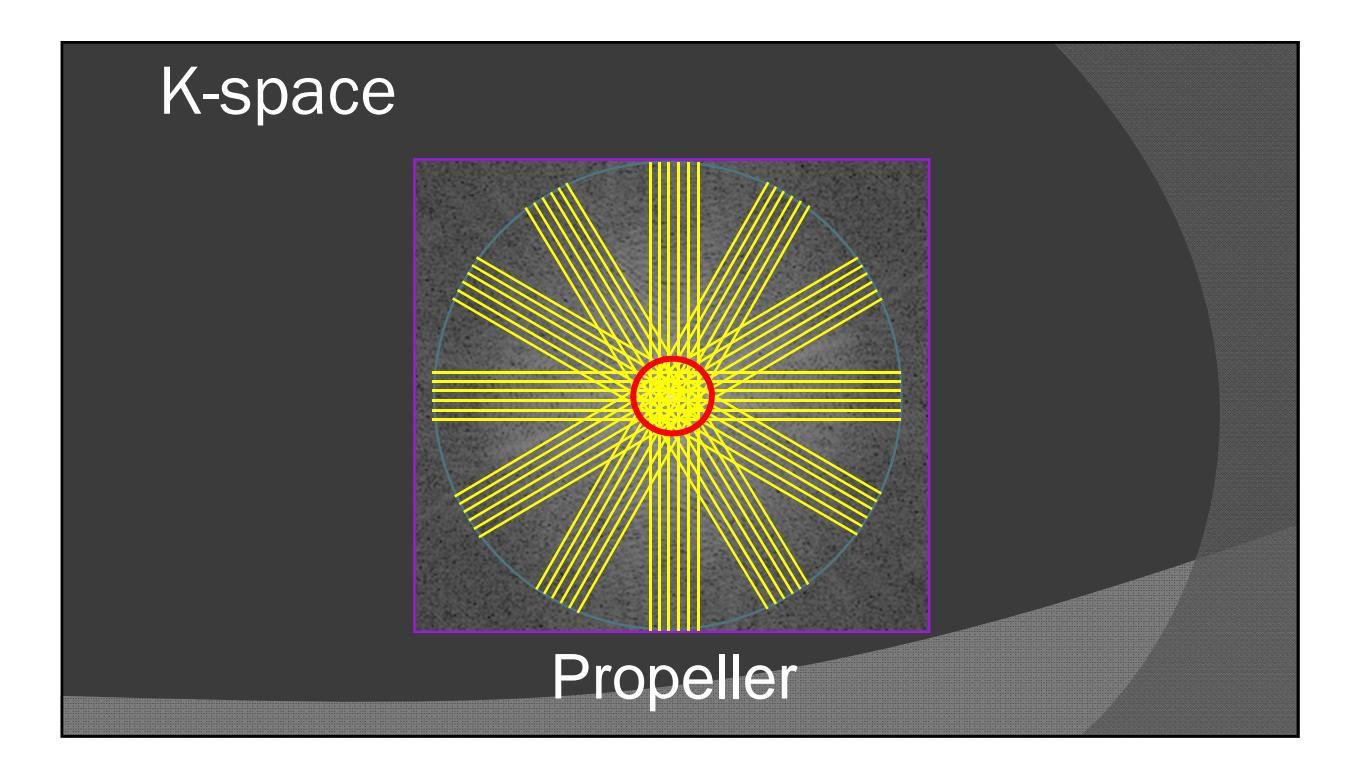
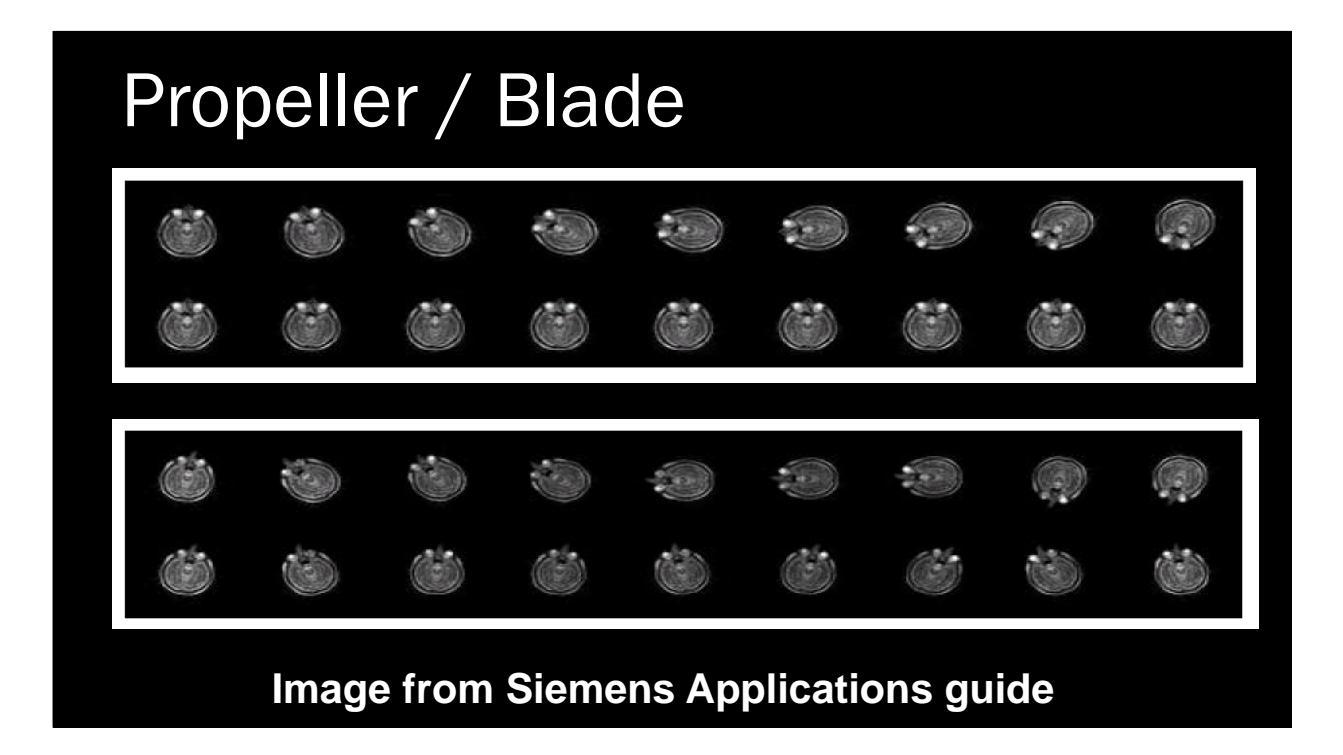
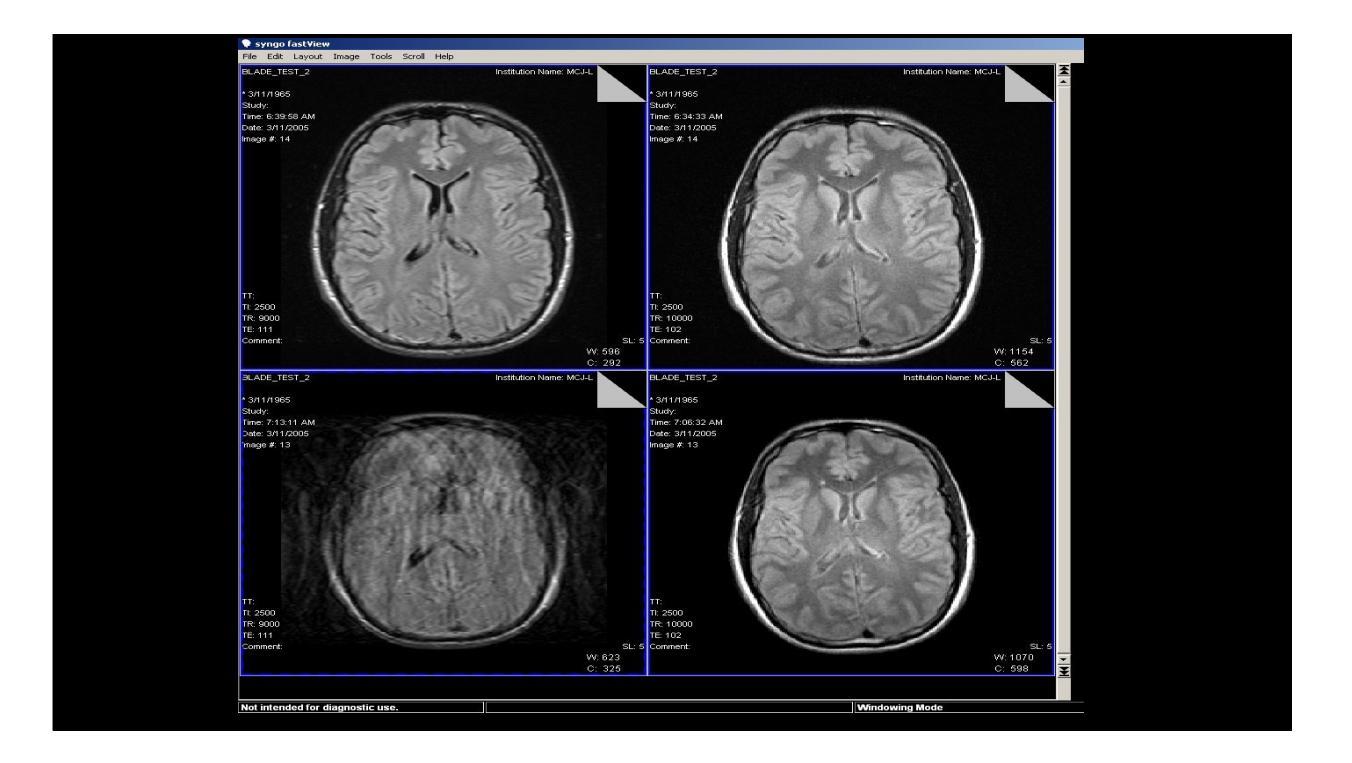
# Propeller / Blade

- Reduce sensitivity to motion
- May be used for uncooperative patients

Pipe, Magn. Reson. Med. 1999; 42:963-969

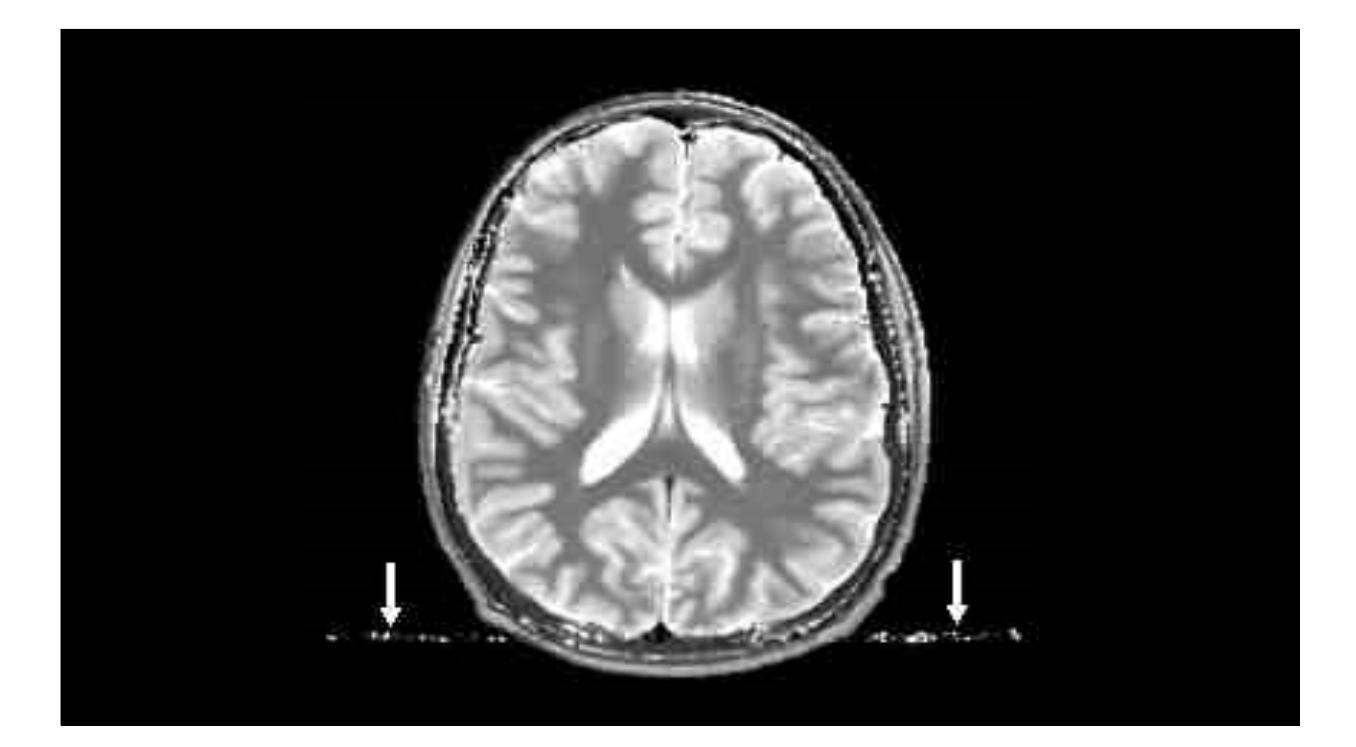
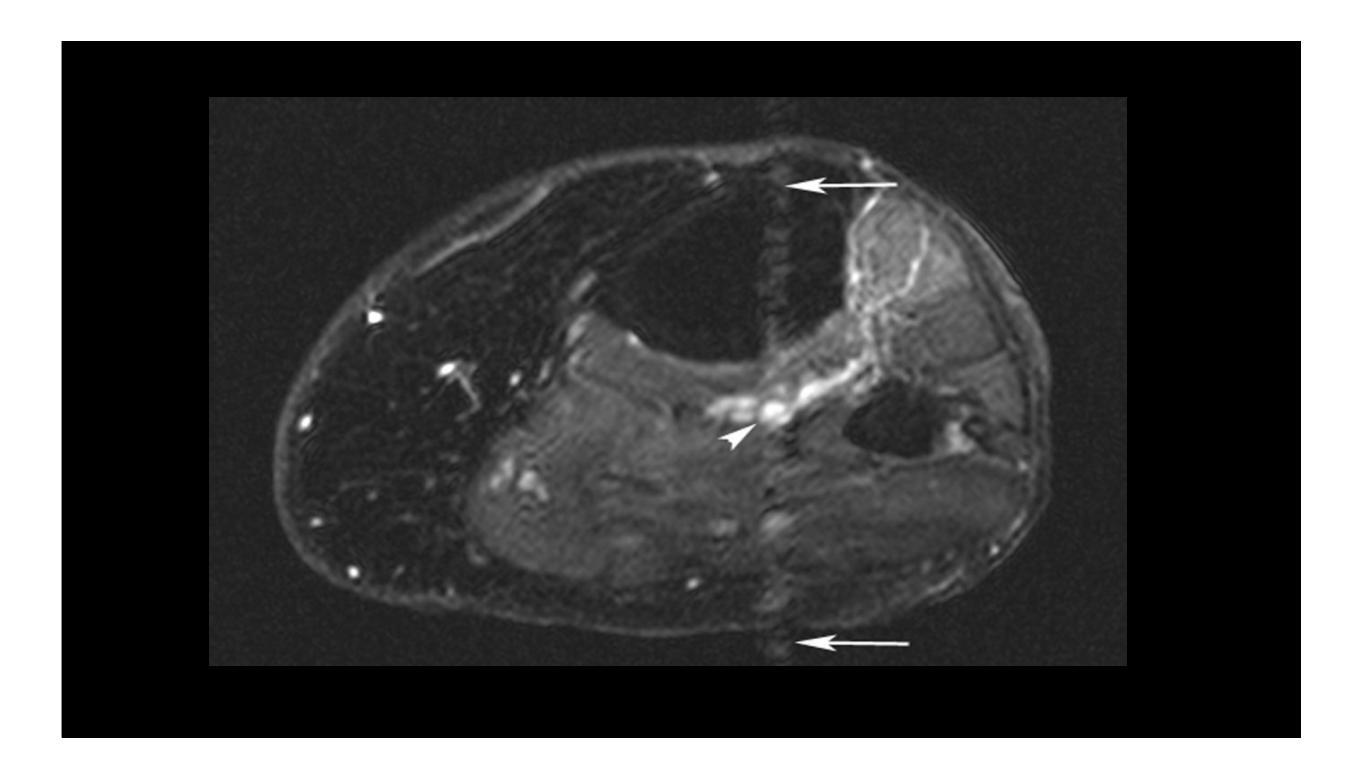
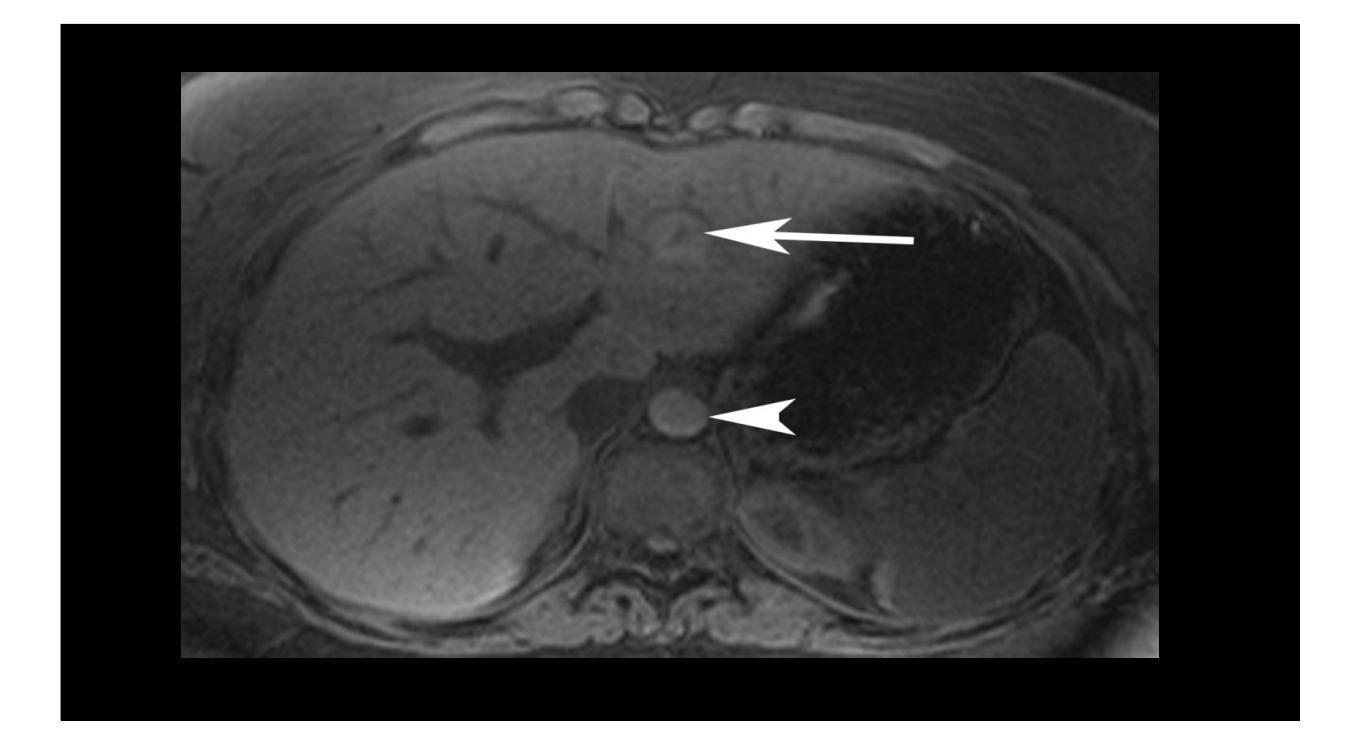
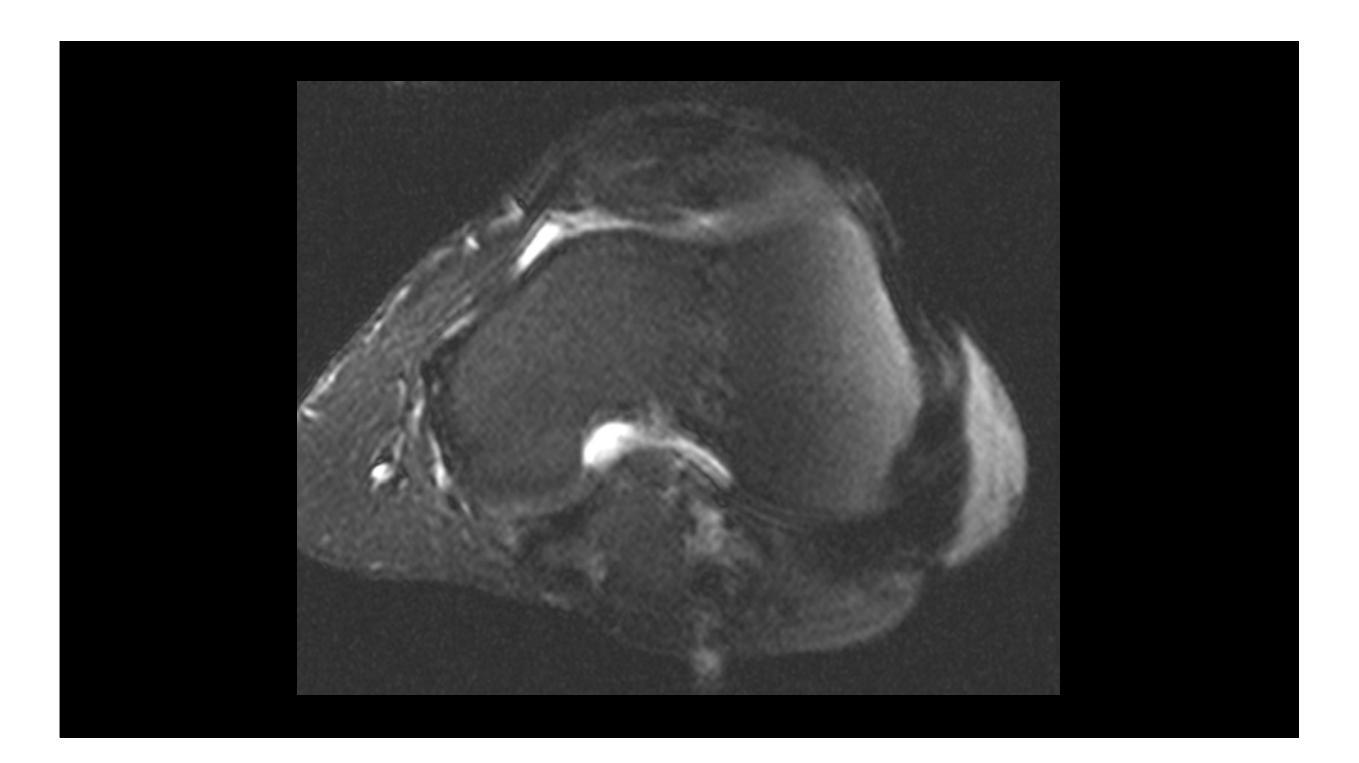
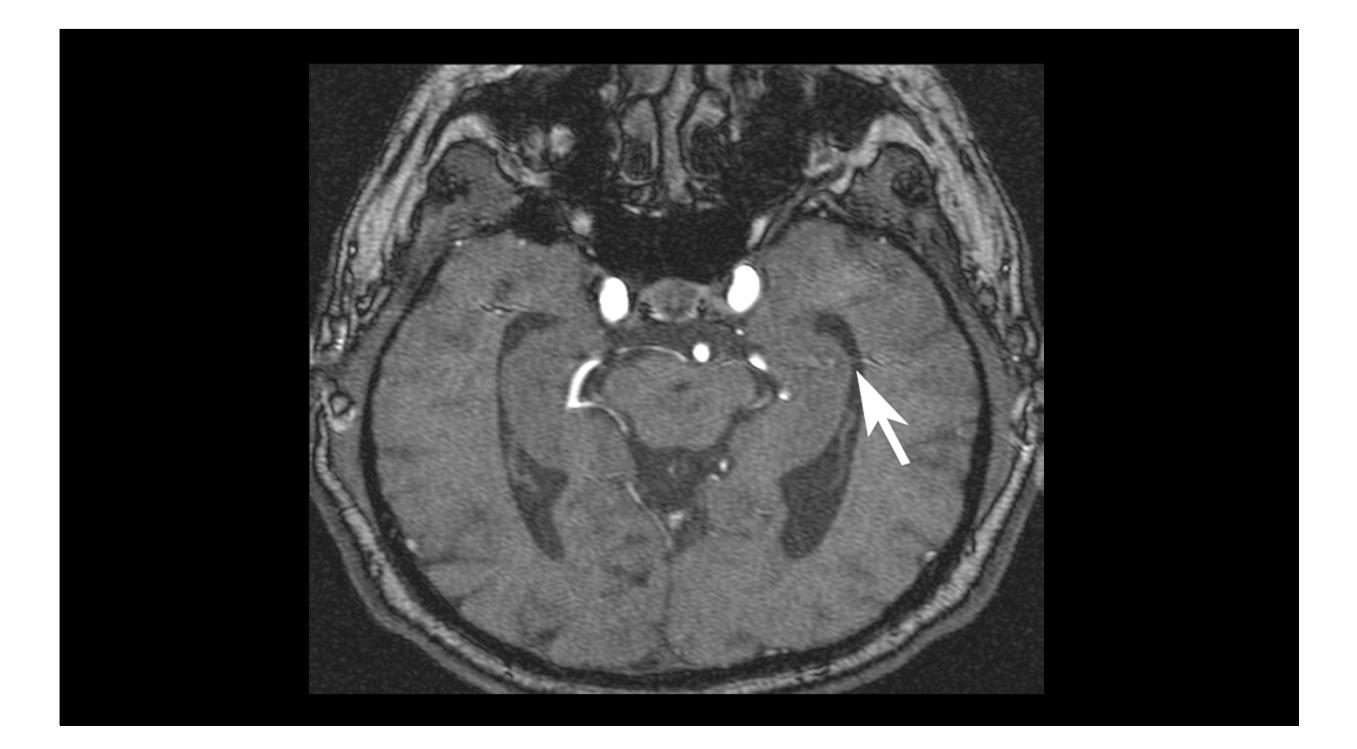
- Identification:
  - Ghosting, appears as repetition (phase encoding direction) of blood
- Causes:
  - Velocity induced phase effects

- How to fix:
  - Gradient moment nulling / flow compensation
  - Spatial saturation bands
  - Swap phase and frequency if artifact mimics pathology

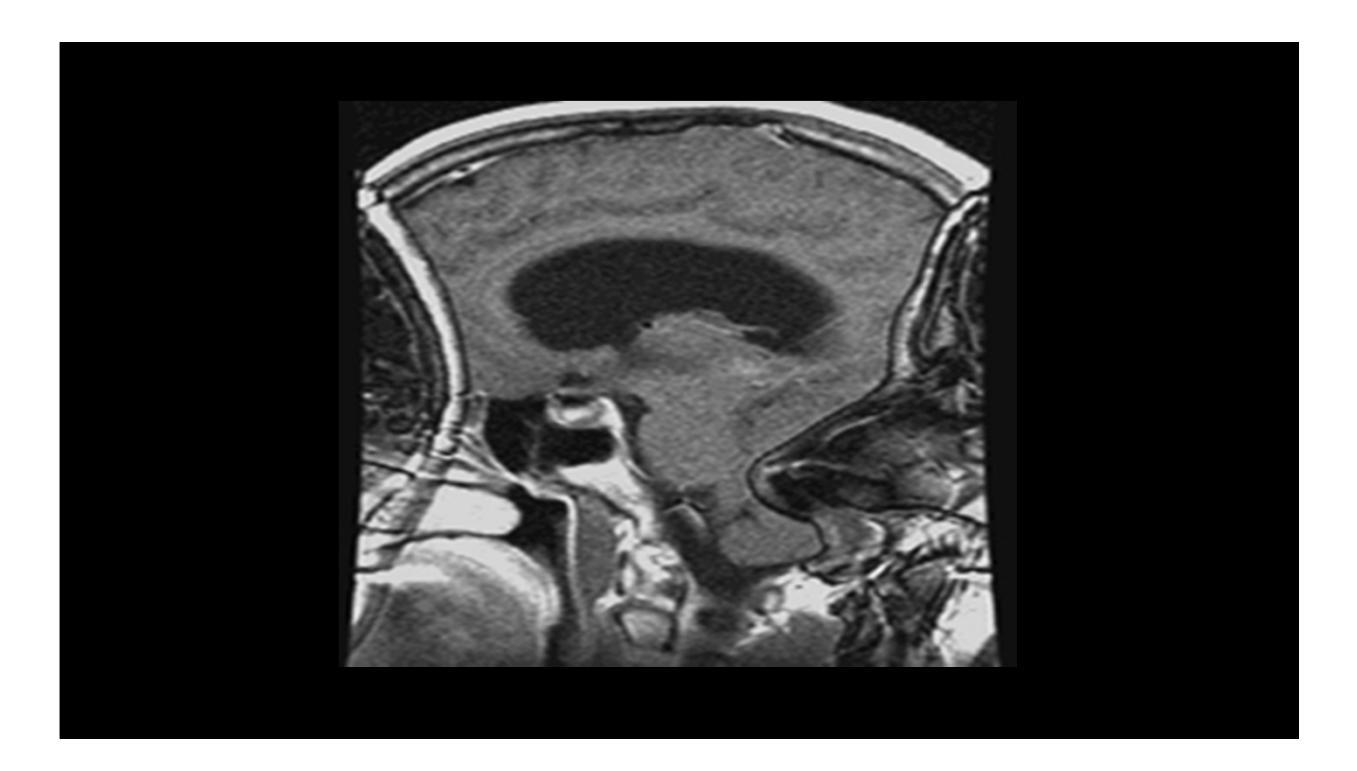
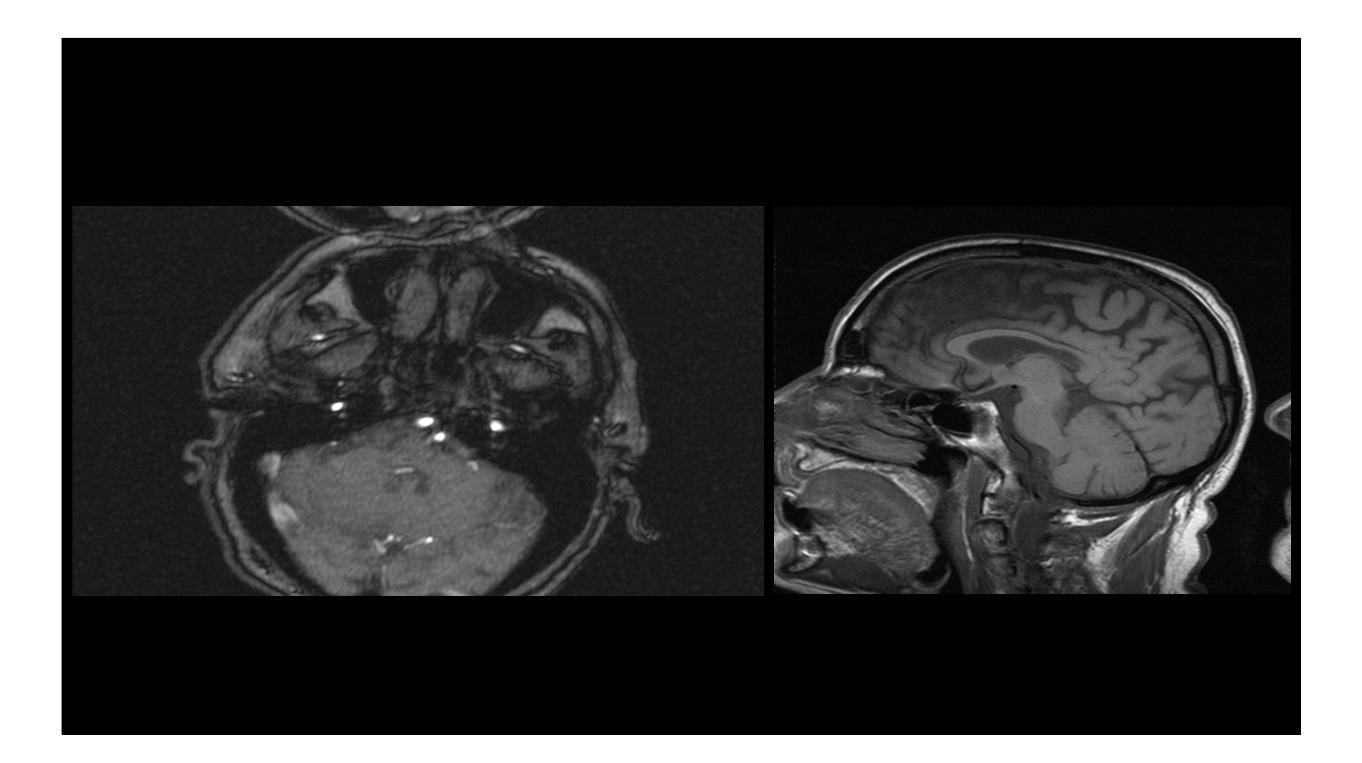
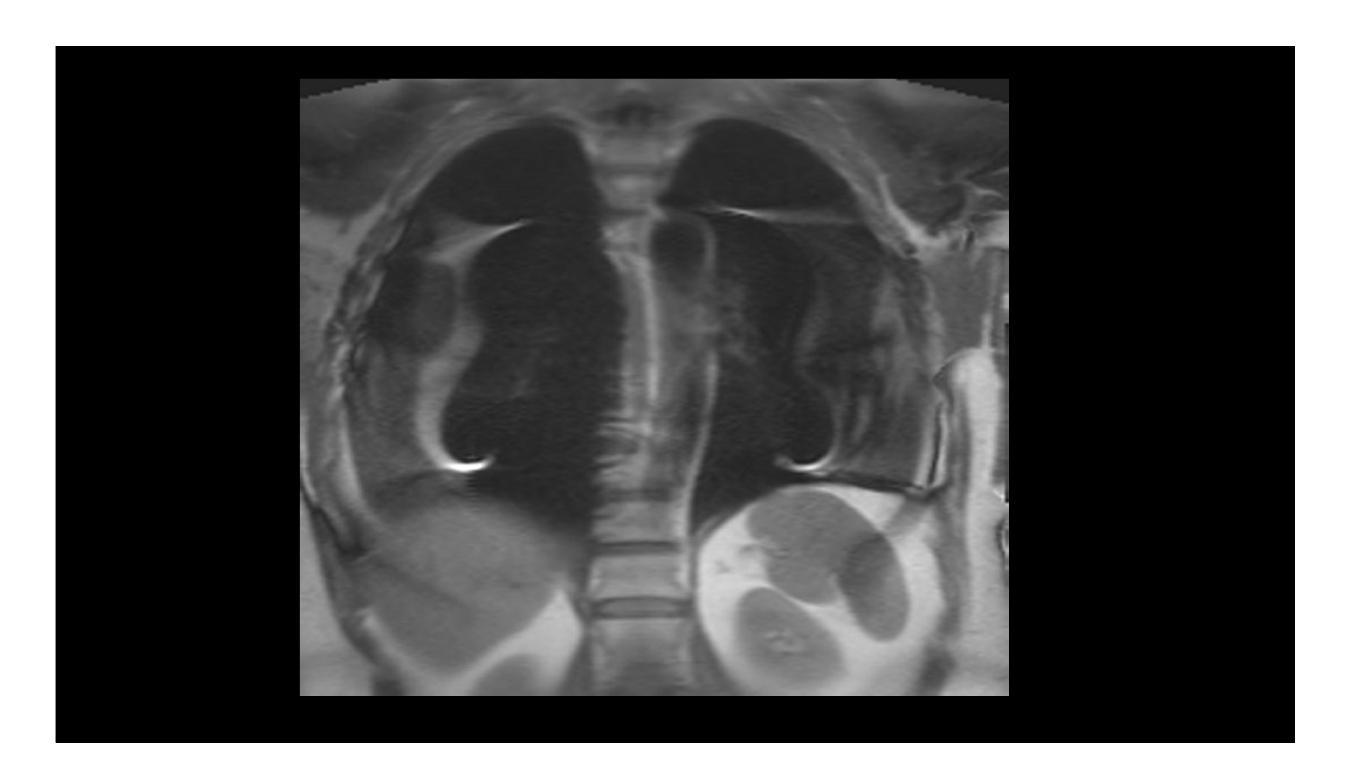
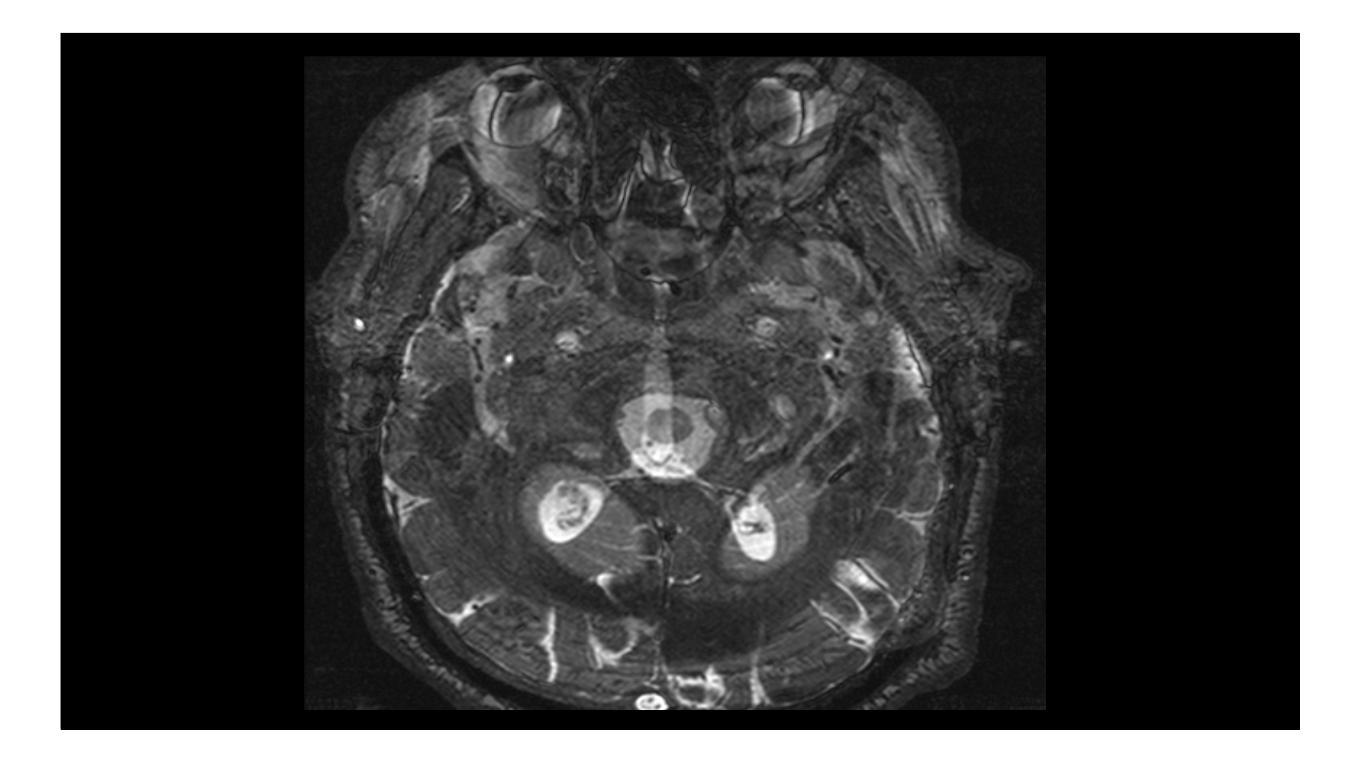
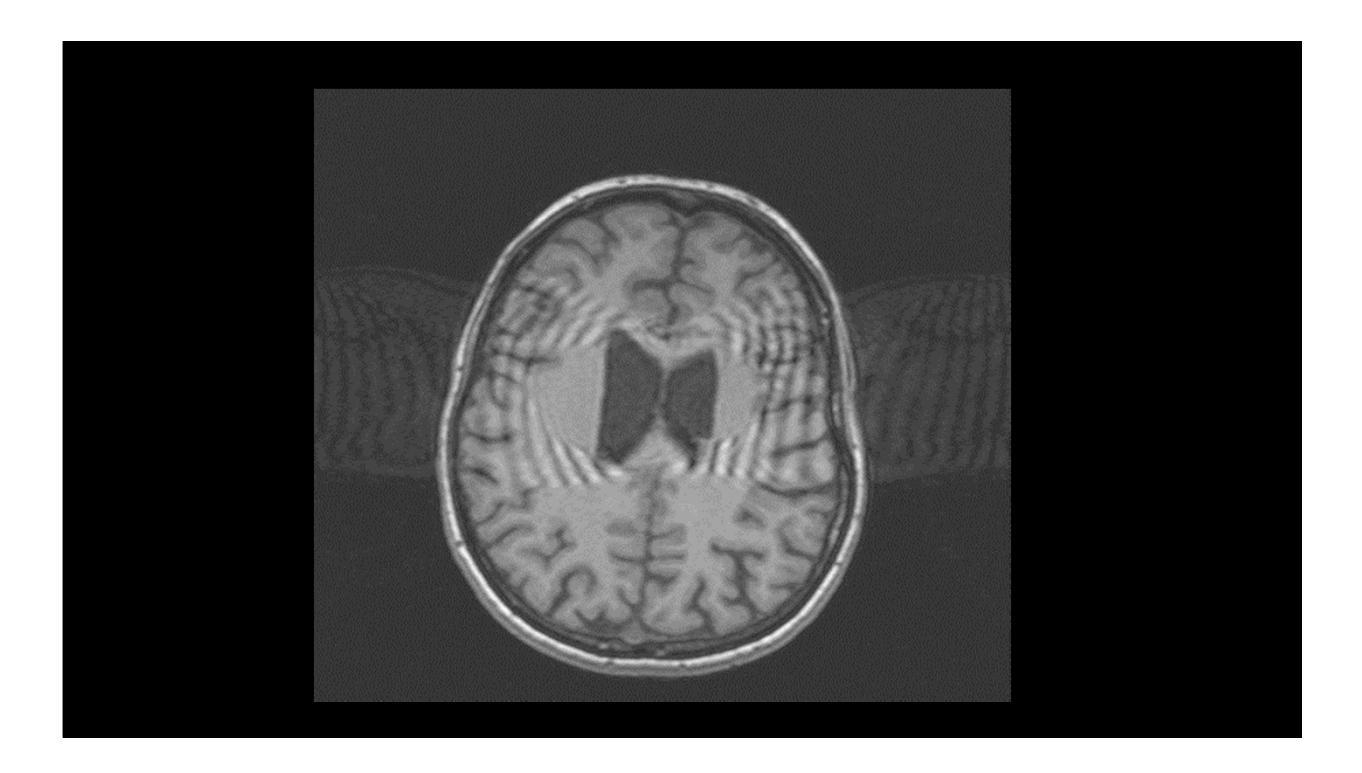
- Identification:
  - Patient anatomy appears in incorrect locations
- Causes:
  - Insufficient sampling
  - Small FOV with anatomy (signal) outside FOV

- How to fix:
  - Increase FOV
  - Increase over-sampling in phase encoding and / or slice directions (for 3D)
  - Use saturation bands for anatomy outside FOV
  - Turn off coils outside imaging volume
