### Outline: Artifact Identification, Cause, How to Fix

- Motion / ghosting
- Flow
- Aliasing / wrap
- Radiofrequency interference
- Metal
- Corduroy

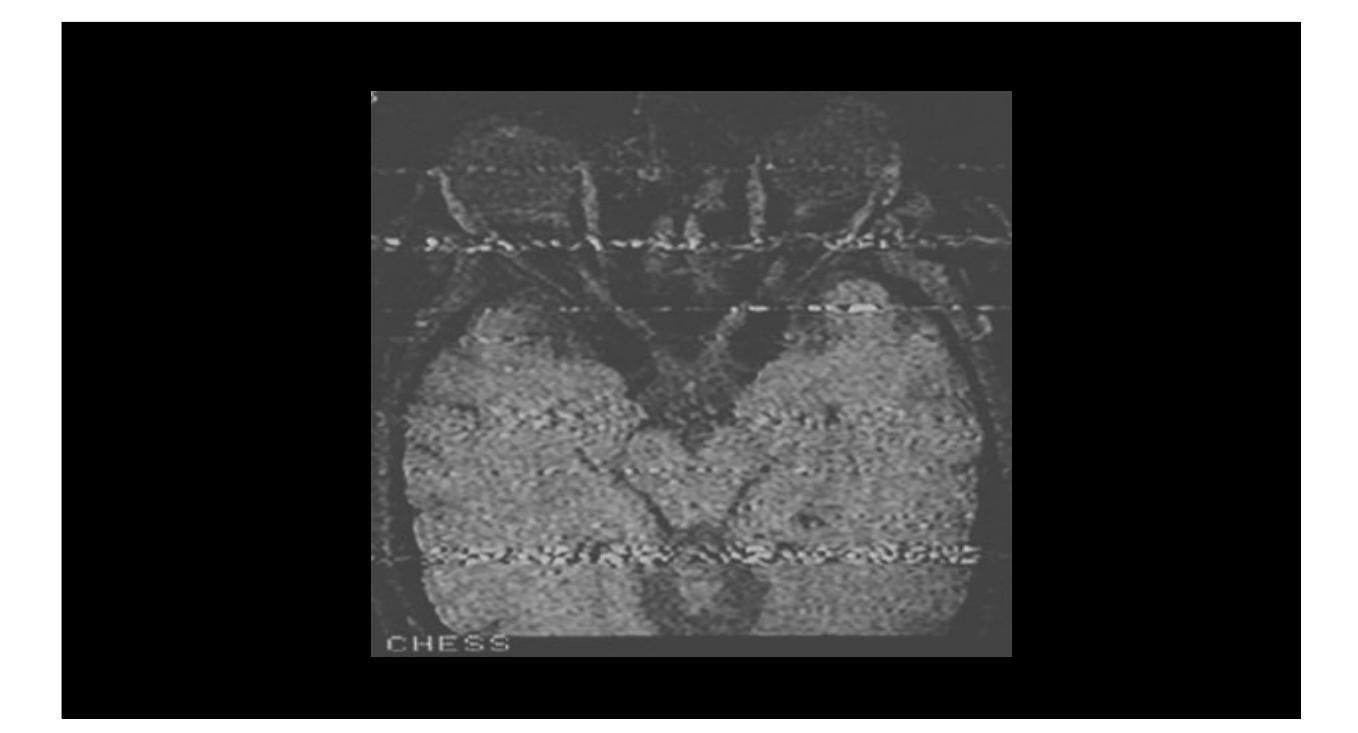
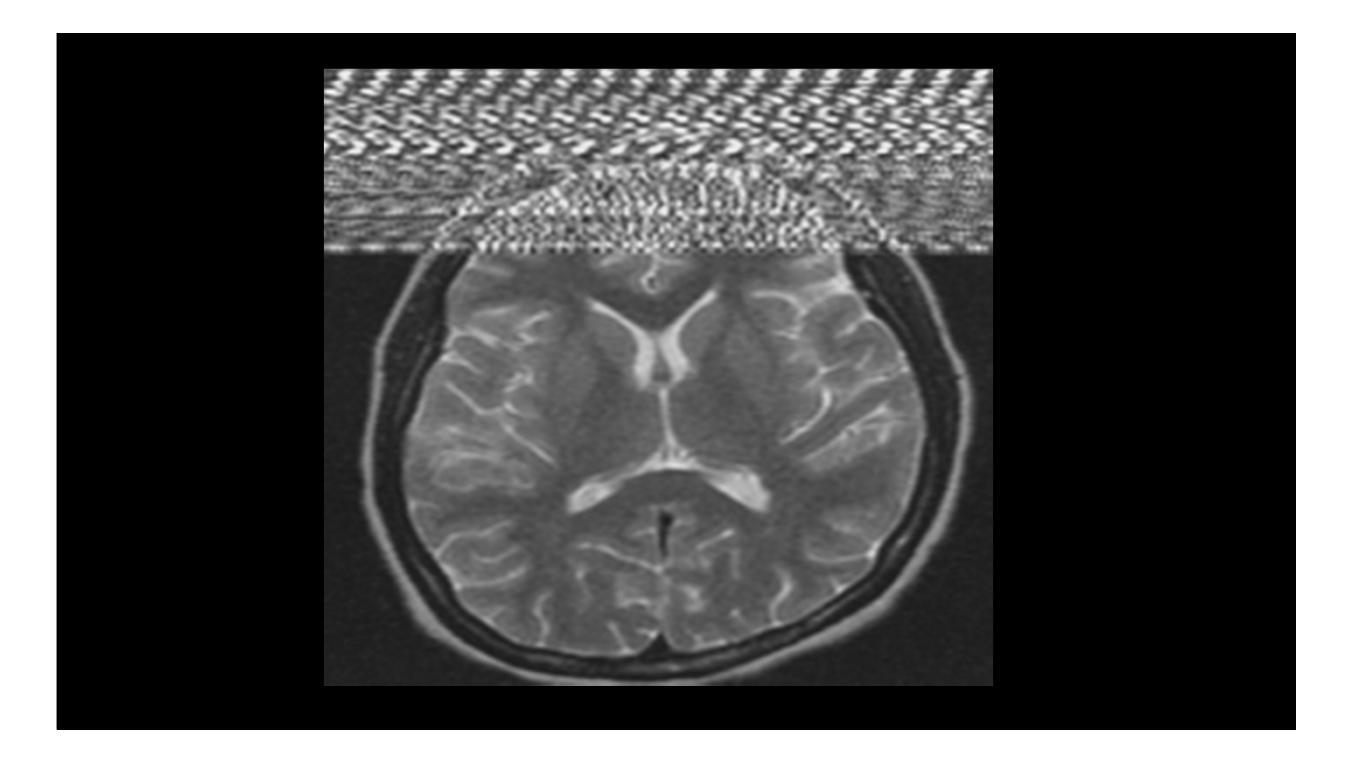
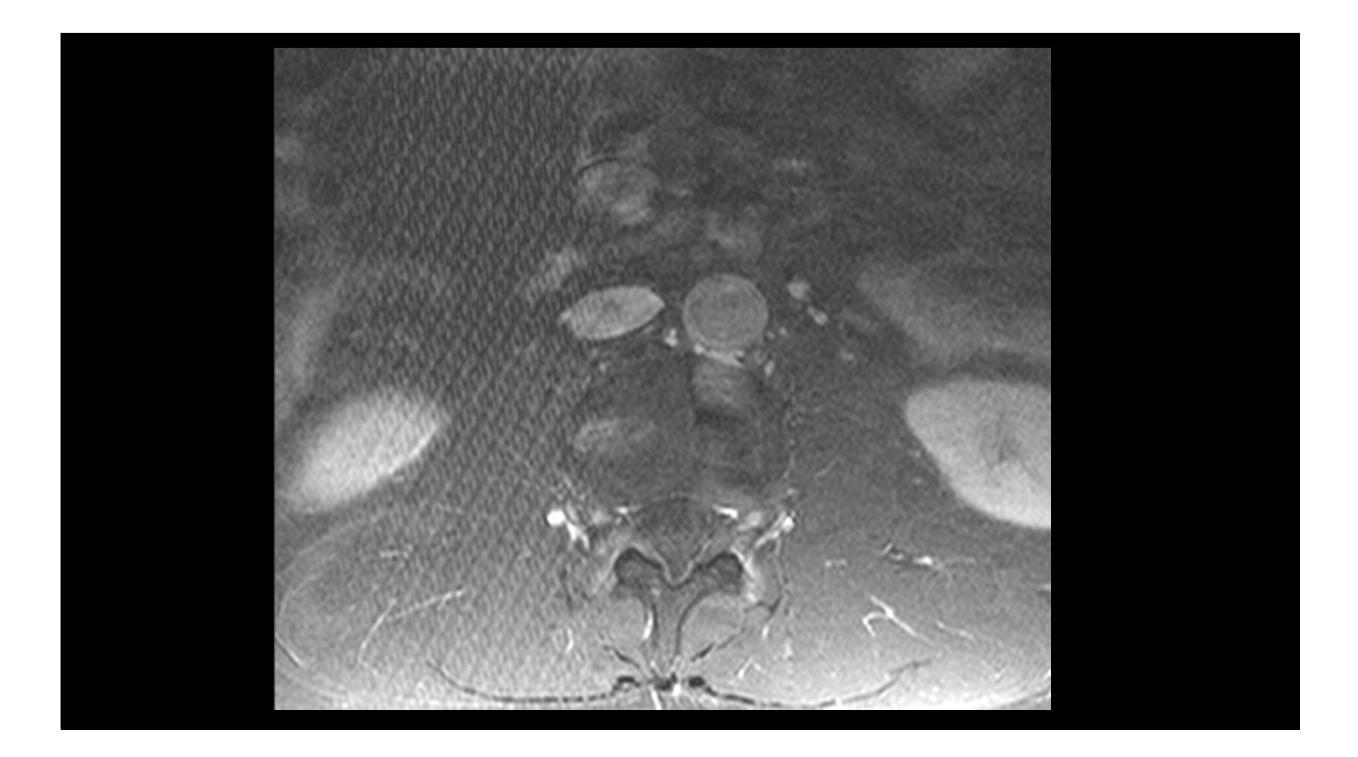
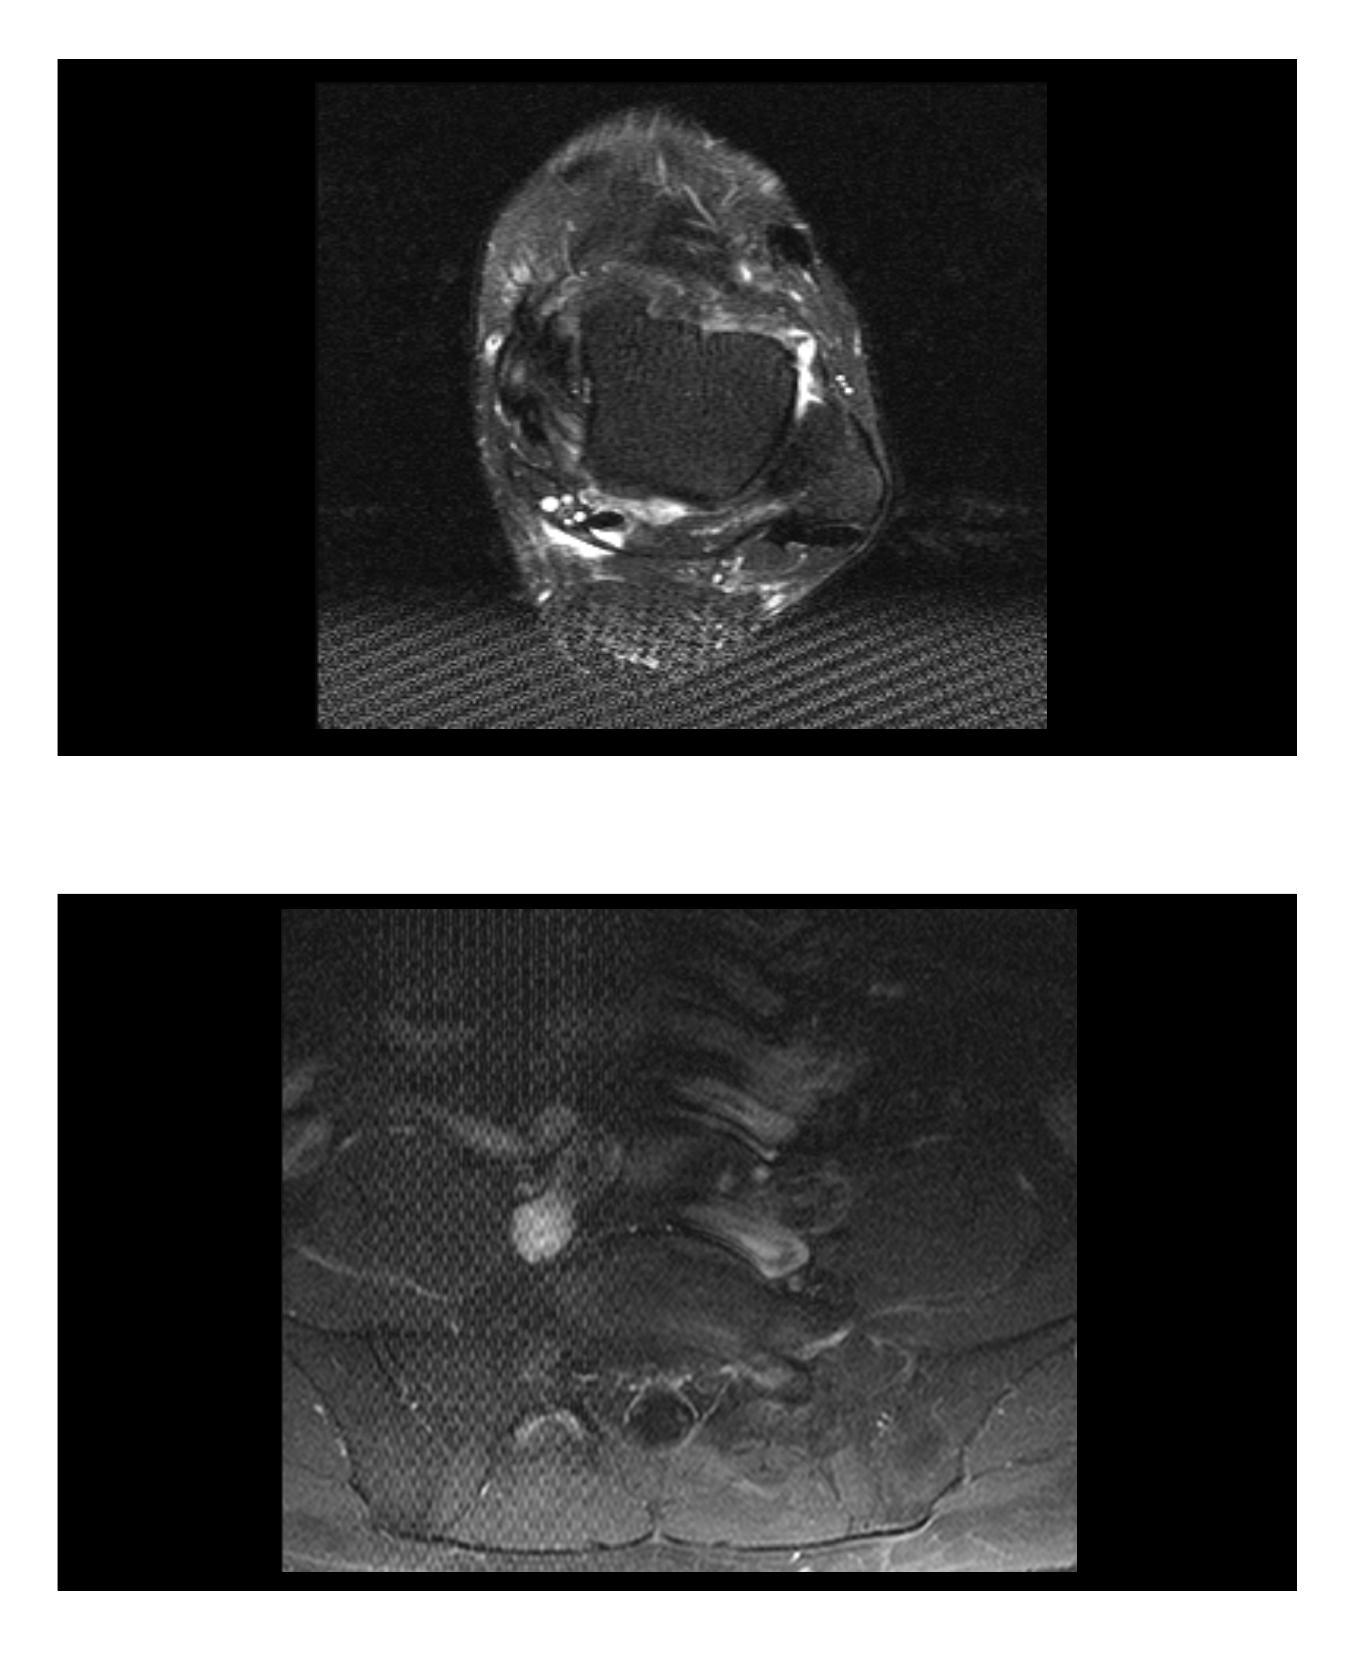
• Typically appears as single or multiple lines ("zipper") in the phase encoding direction

Unexpected radiofrequency signal from equipment inside room, or outside room with poor RF shielding

- Identify source, replace electronic components generating unwanted RF signal
- Check integrity of RF shielding, clean RF door threshold and RF fingers / plates

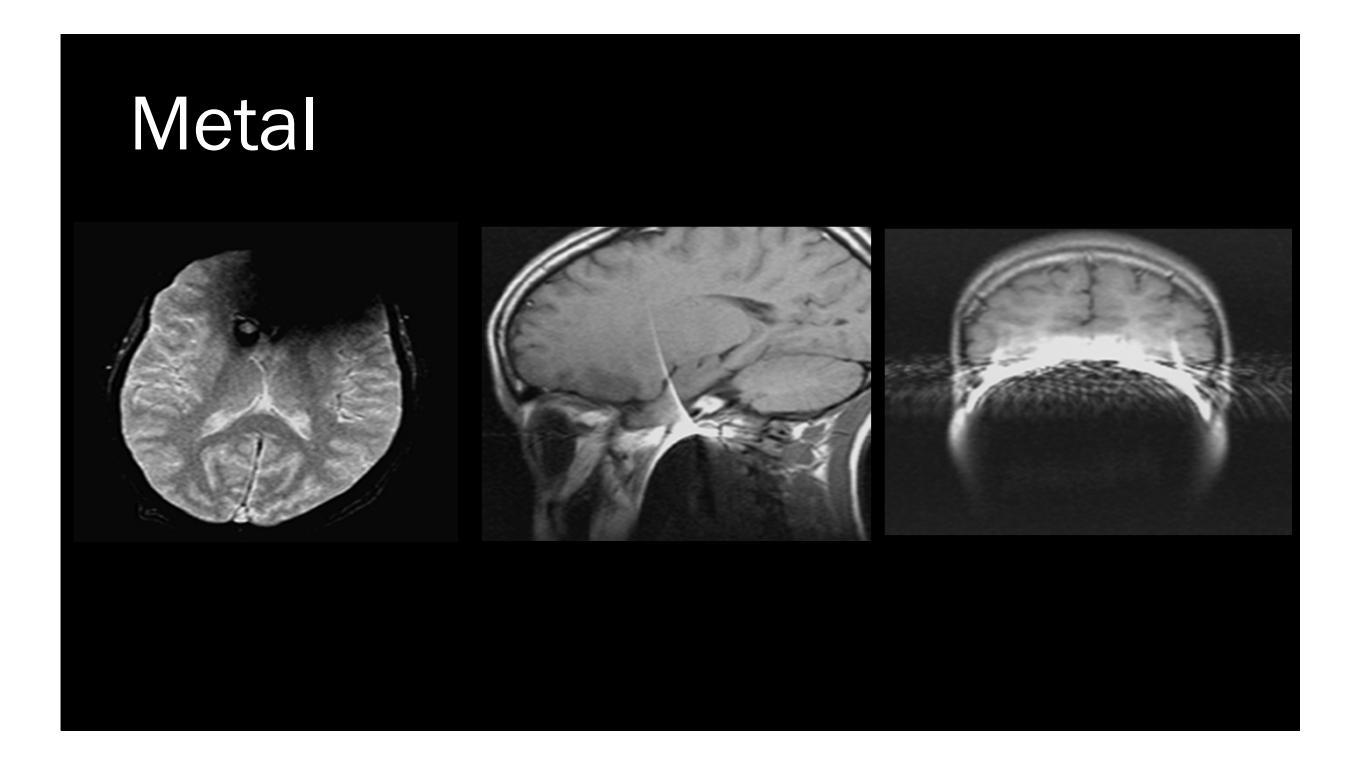
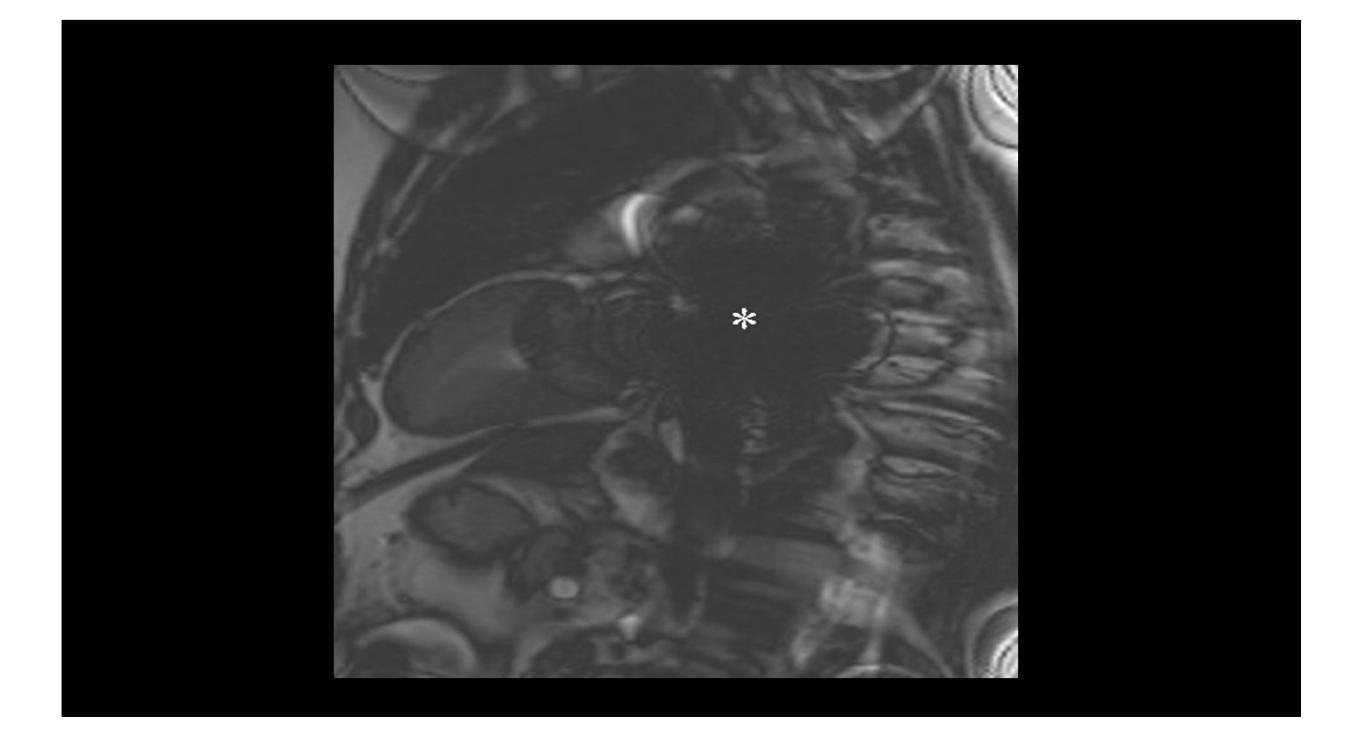
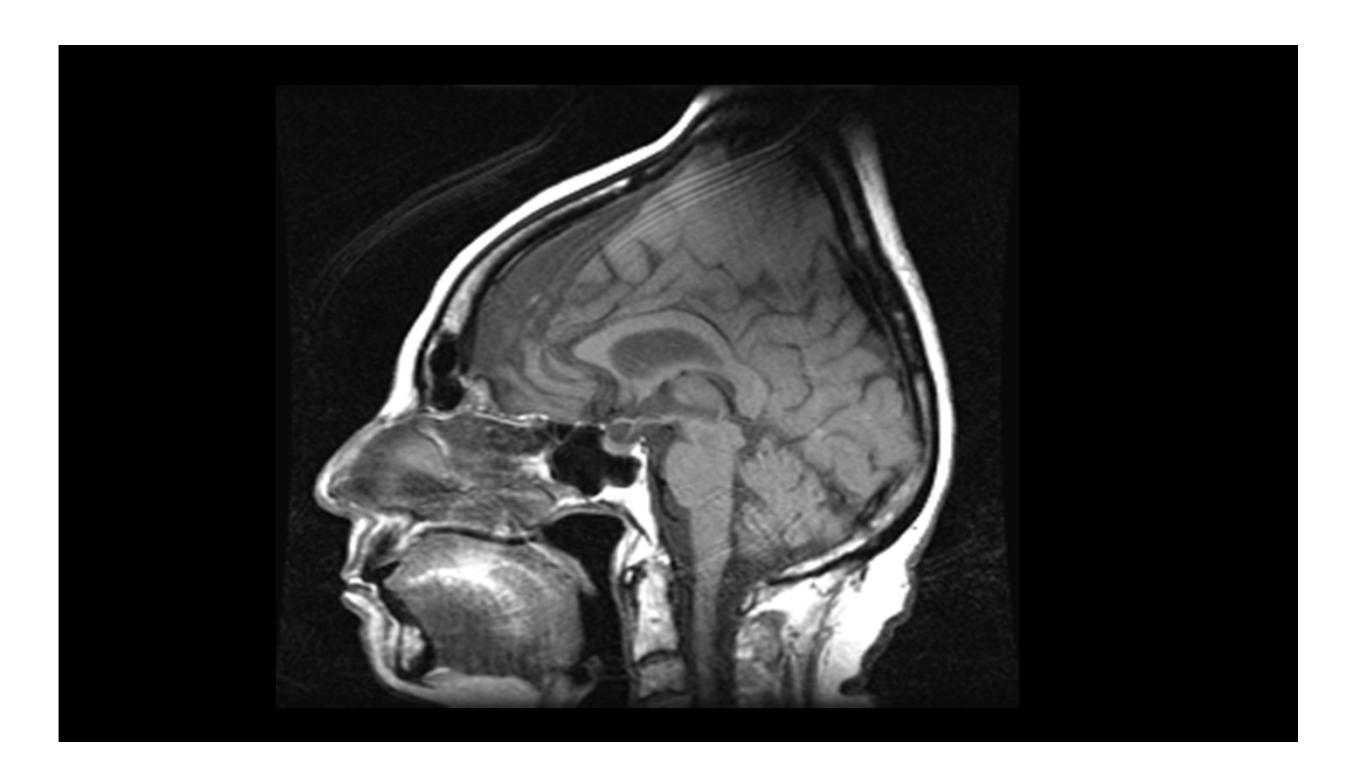
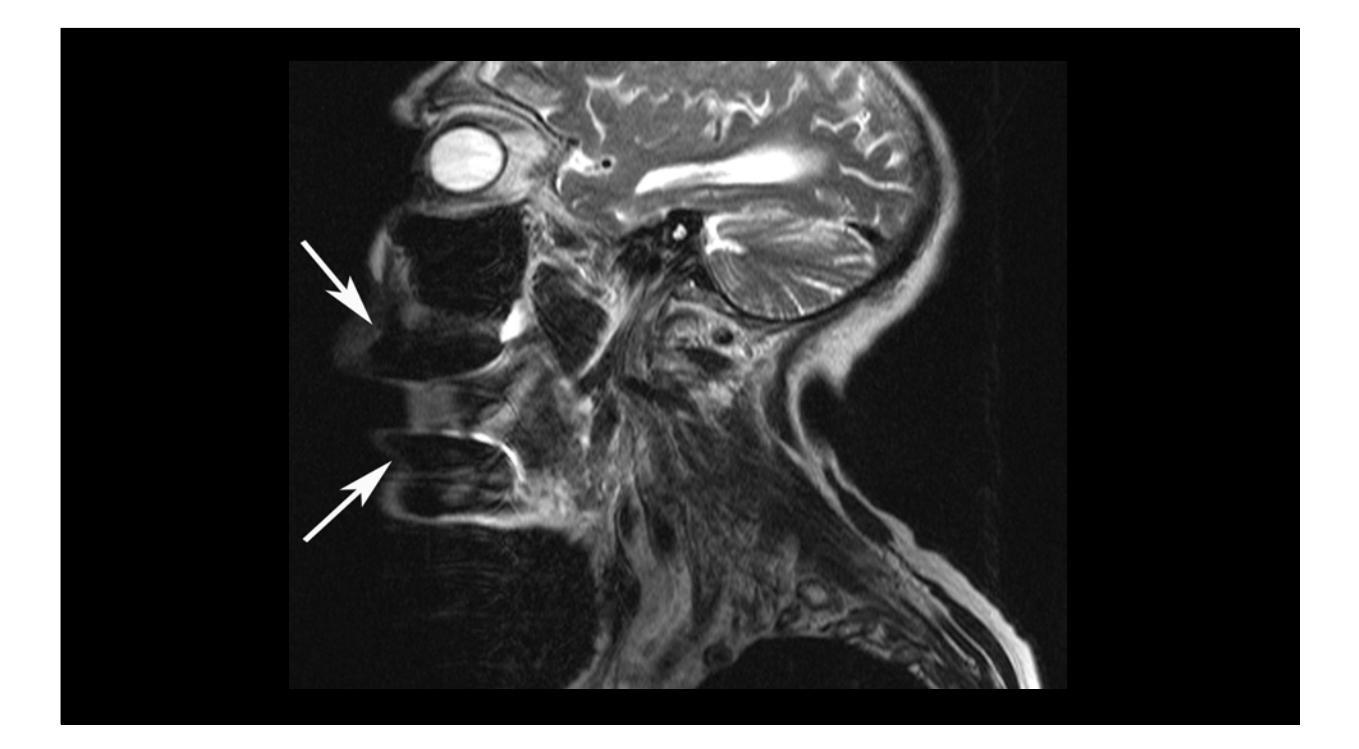
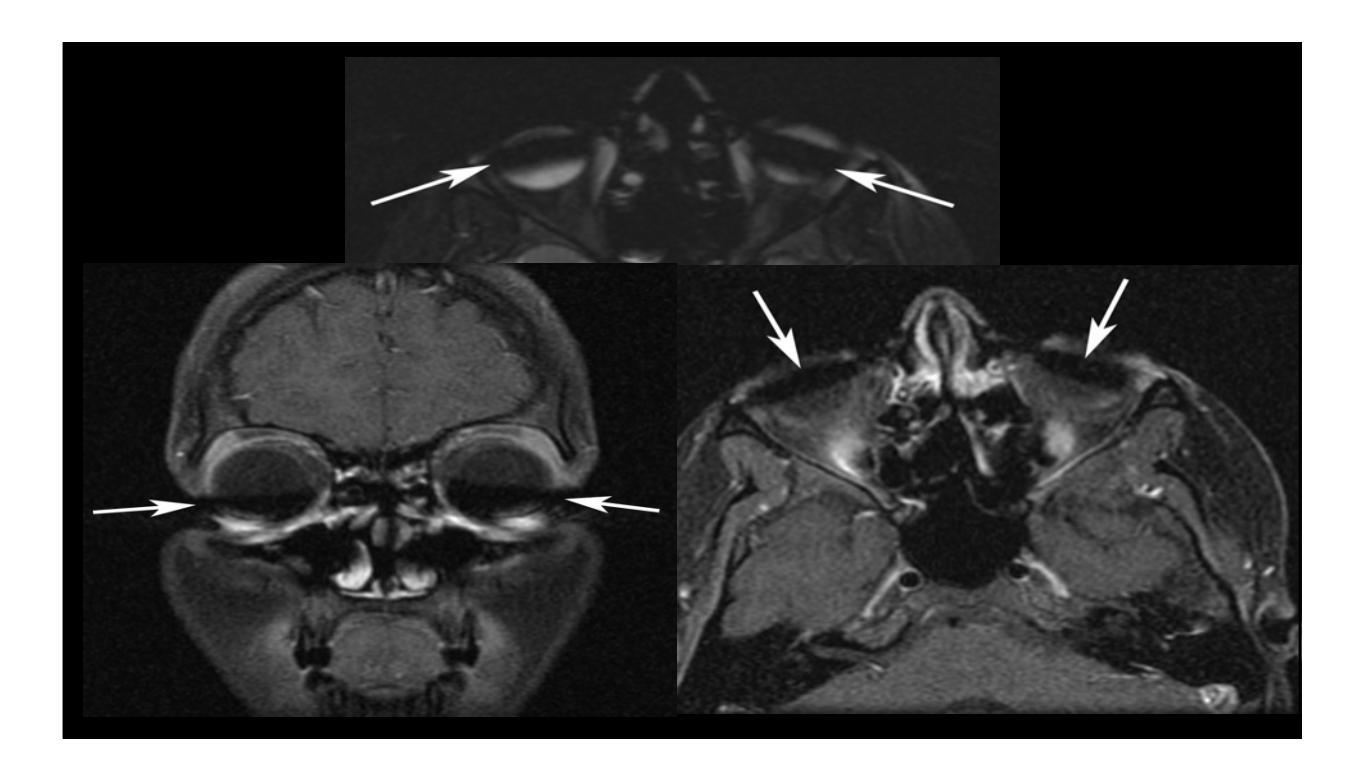
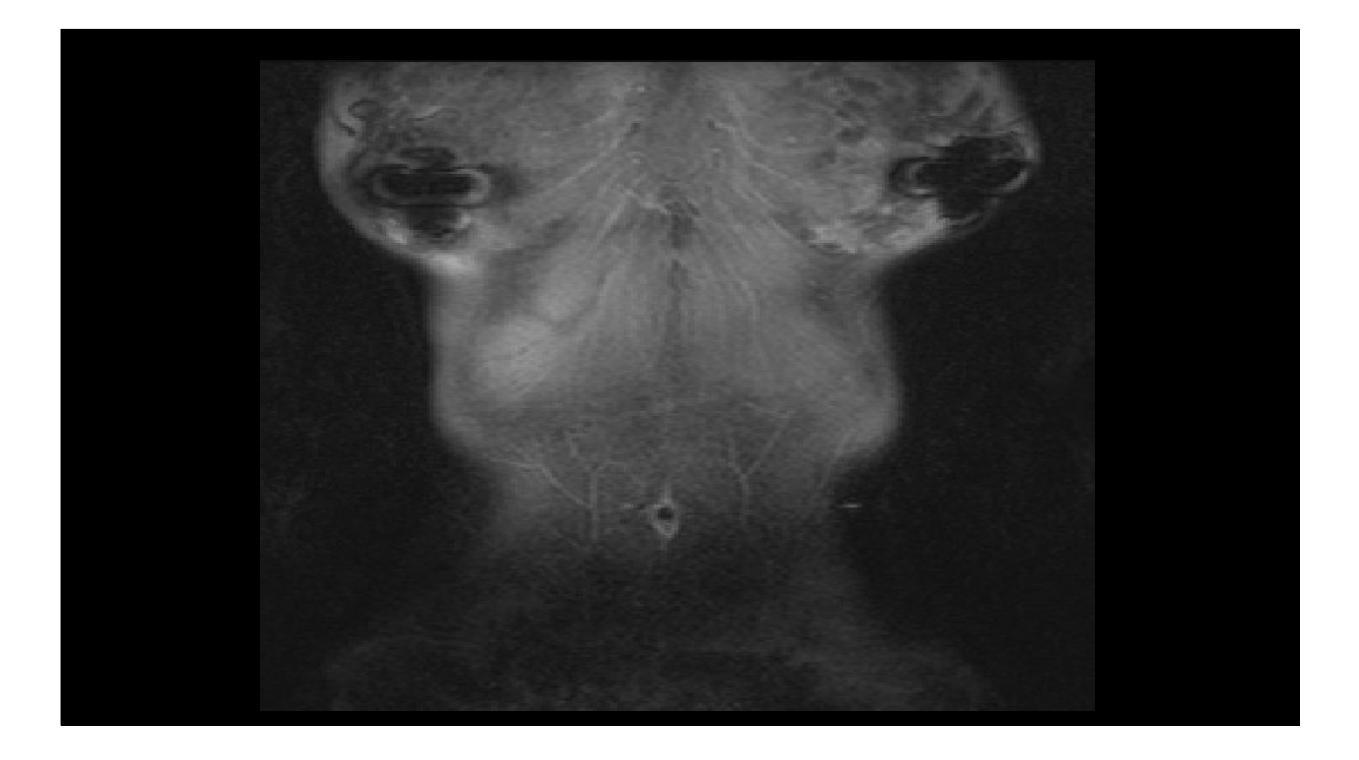
- Identification:
  - Signal void, often with adjacent very bright signal
  - Geometric distortion

Magnetic susceptibility, induced eddy currents, spin dephasing

- How to fix / reduce:
  - Properly screen patient, remove any metal that can be removed
  - Turbo spin echo and spin echo sequences reduce artifact compared to gradient echo
  - Decrease TE and echo spacing; increase bandwidth and resolution in frequency encoding direction
  - Swap phase and frequency to modify shape

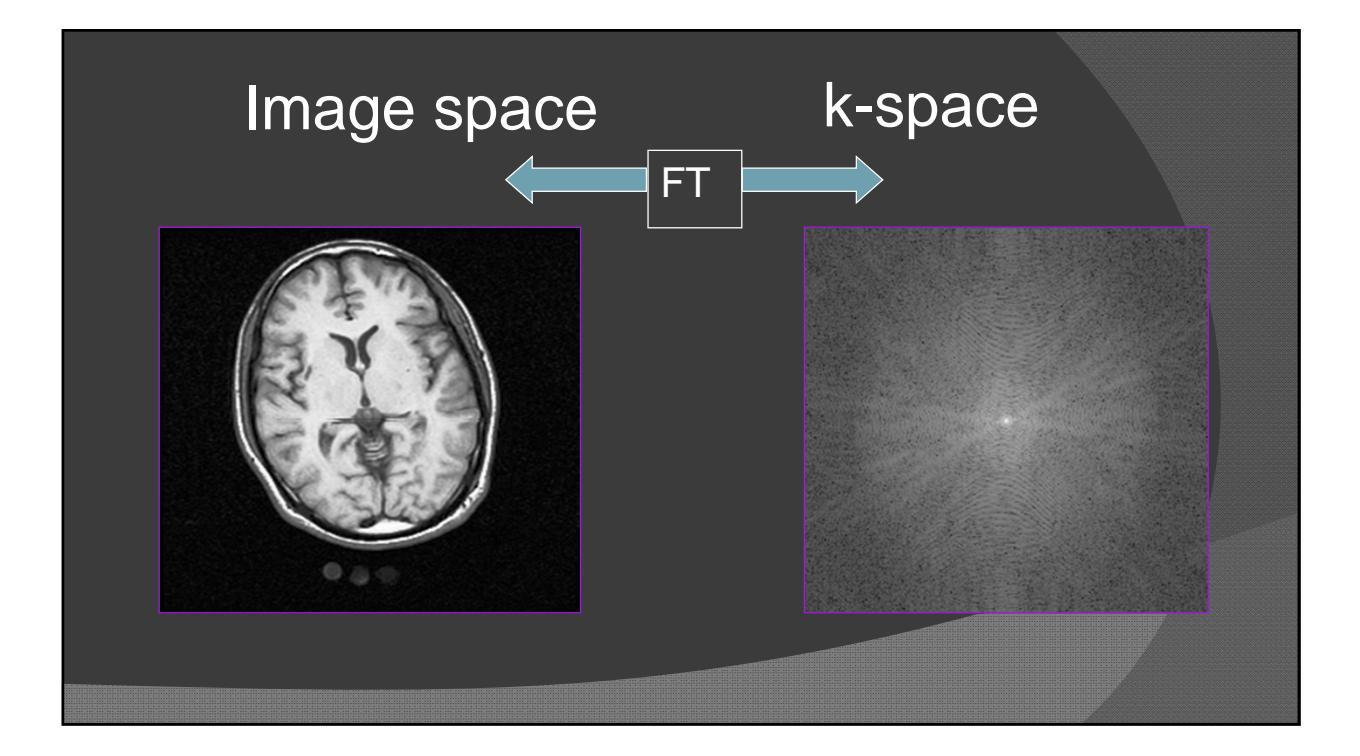
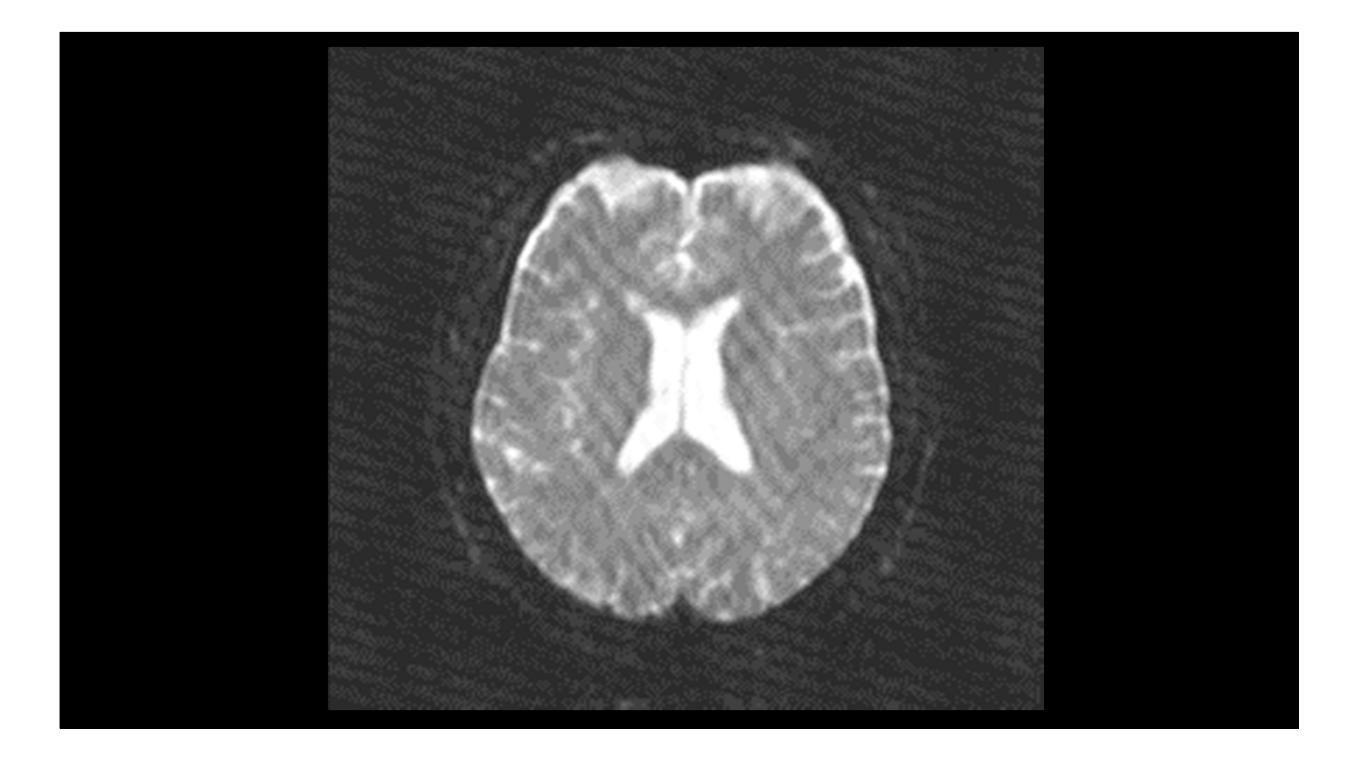
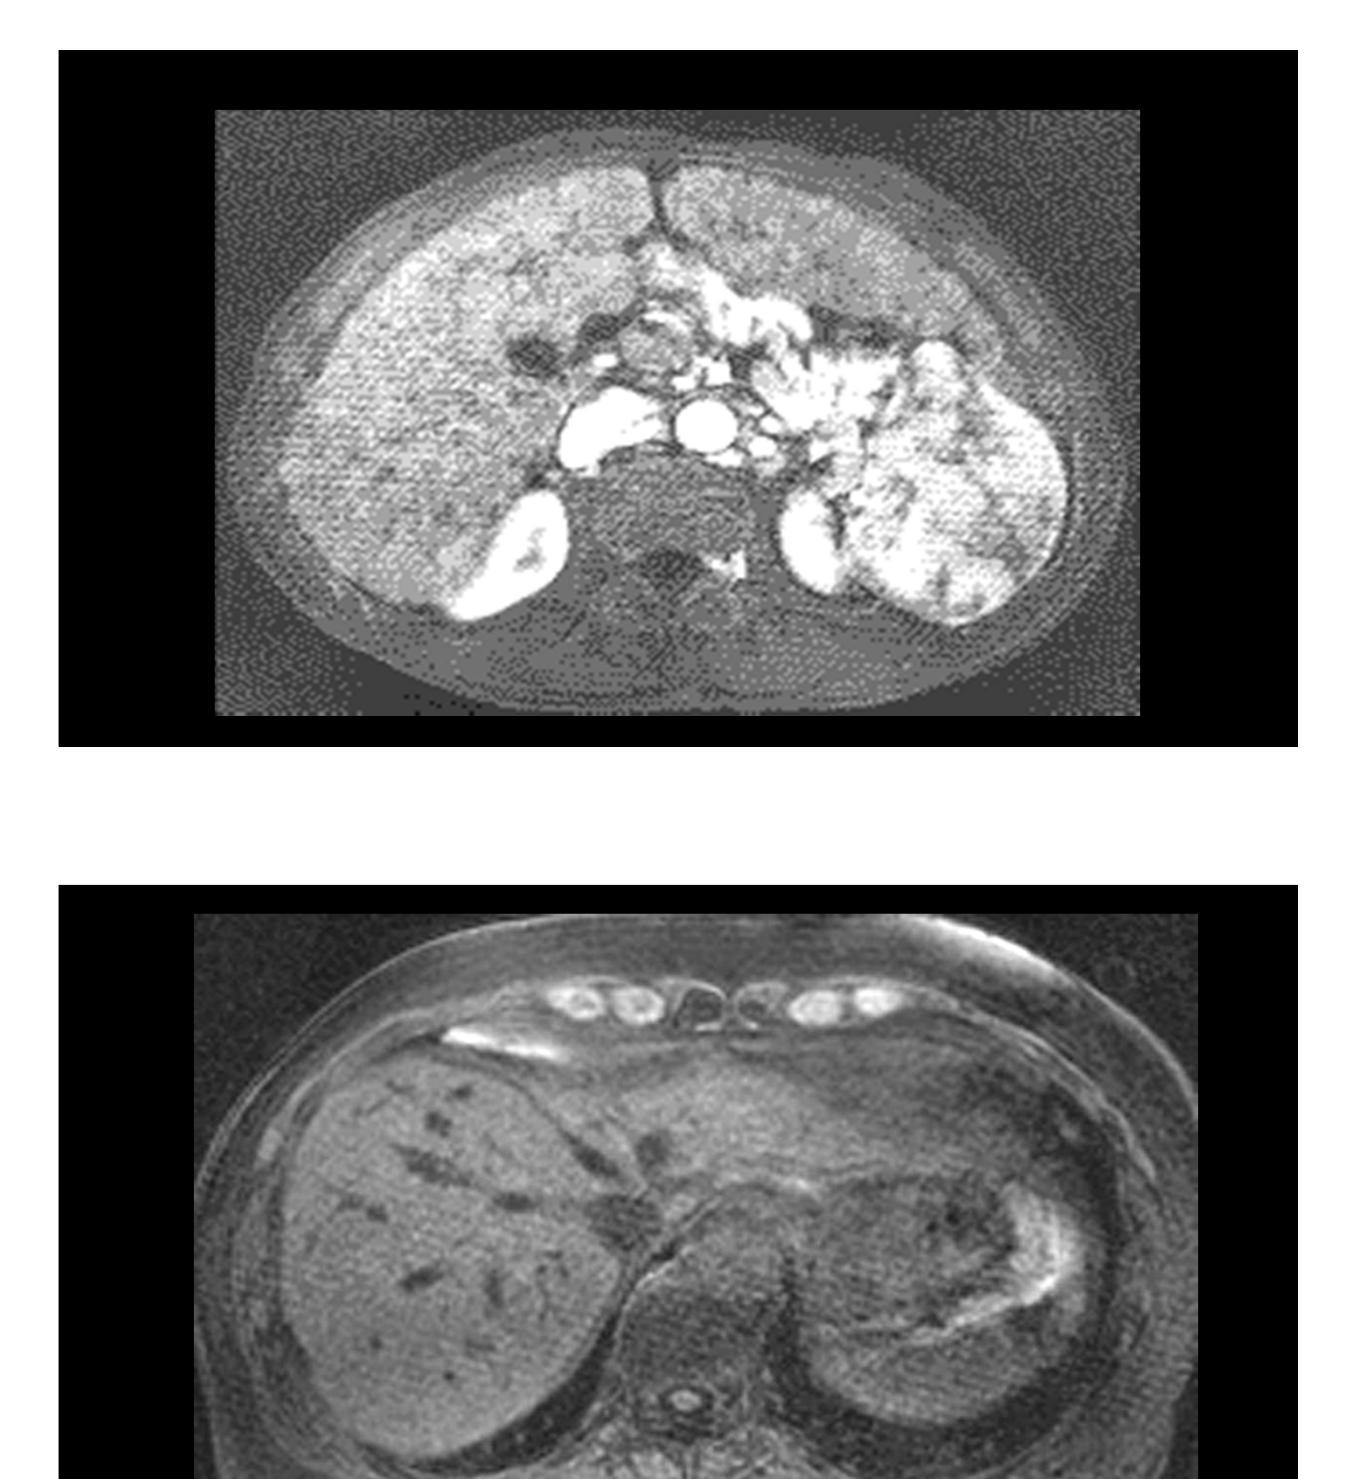
- Identification:
  - Pattern of regularly spaced lines extending across image
  - Can occur at different spatial frequencies and different angles
  - Multiple sets can combine to appear as a crosshatch pattern
- Causes:
  - Spike(s) in k-space

- Confirm room humidity in specification
- Perform scanner spike check
- Attempt to localize source if in room
