Beth Schueler, Ph.D. Mayo Clinic Rochester

THE ART OF THE IMAGE IN MAMMOGRAPHY Artifacts In 2D And 3D Breast Imaging: Their Origin, Presentation, And Remediation

AAPM Spring Clinical Meeting 2018

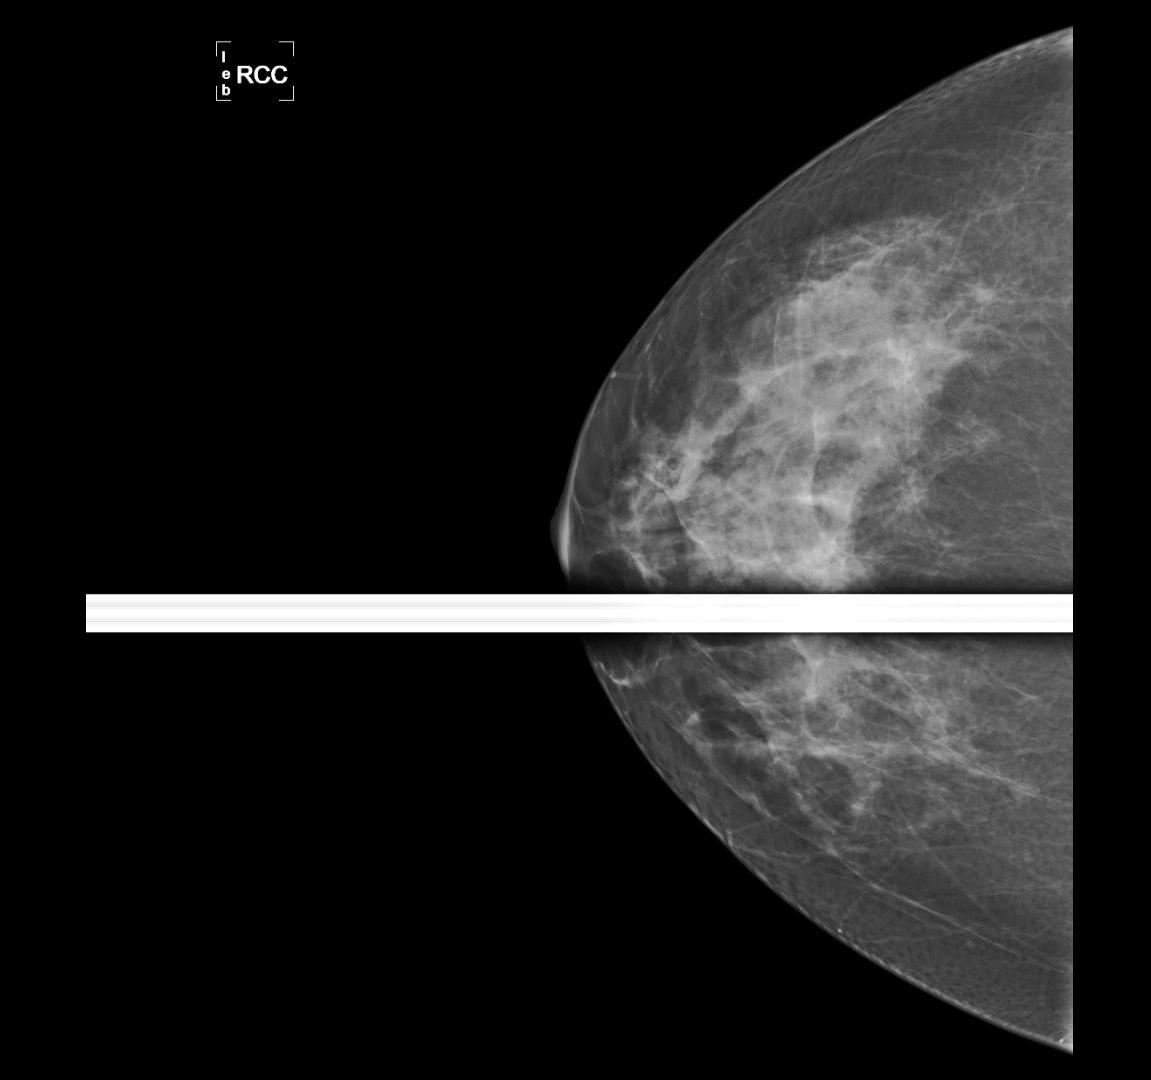
## Cause:

Detector readout malfunction, failure of switching gate lines

- Resolution:
  - Replace detector

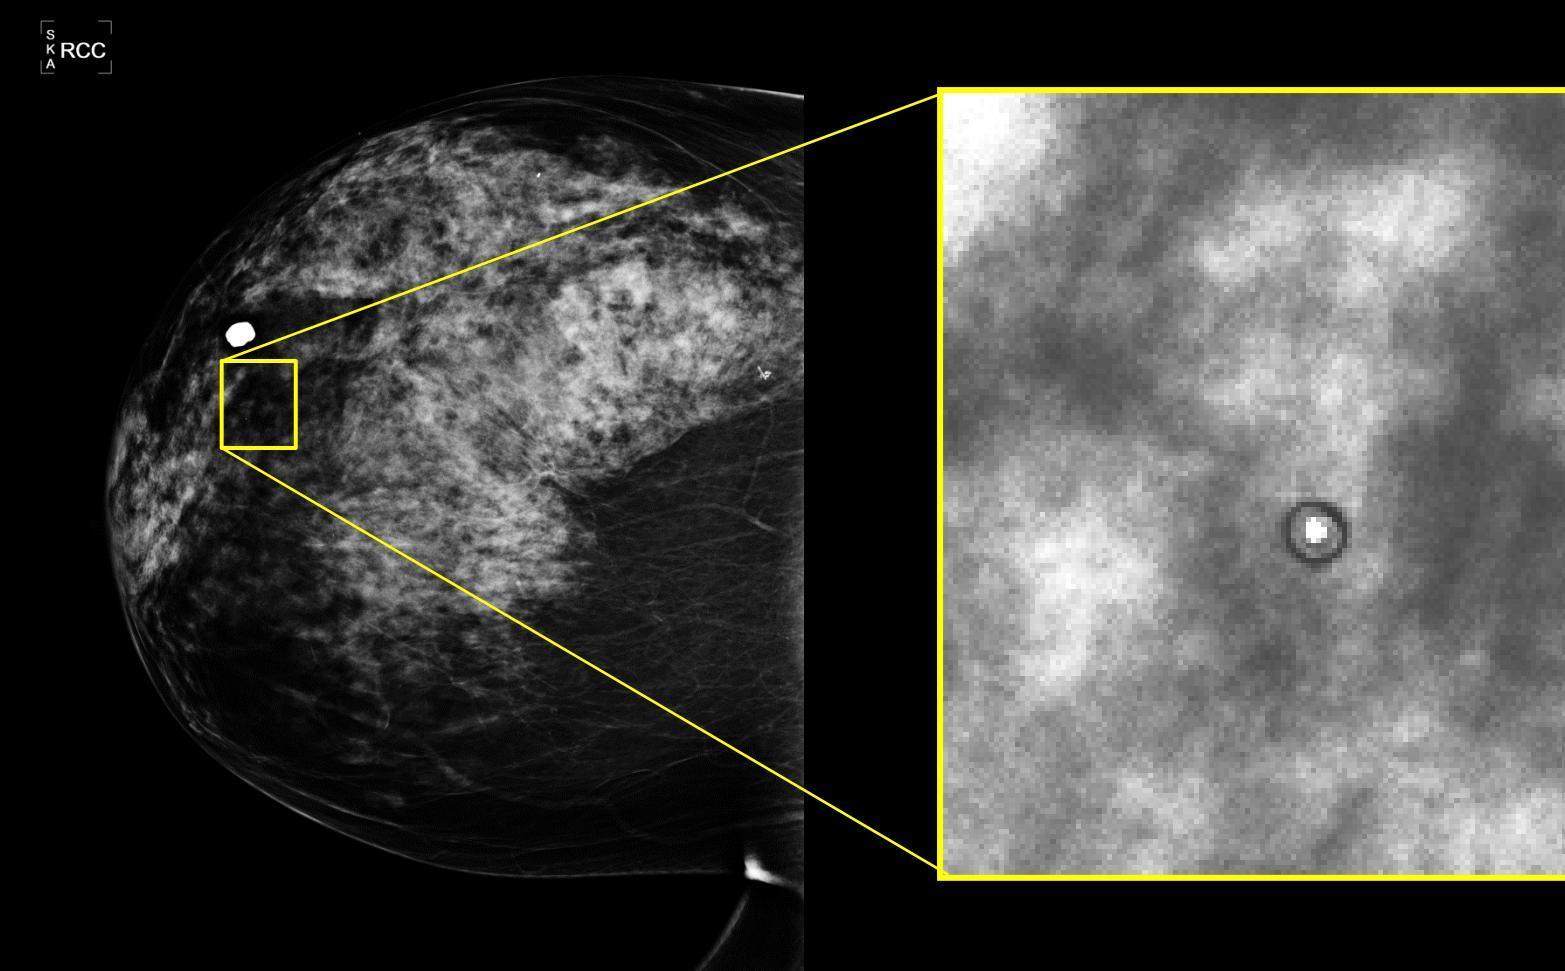
## Cause:

Dead pixel cluster resulting in charge build-up affecting signal in neighboring pixels

- Resolution:
  - Replace detector

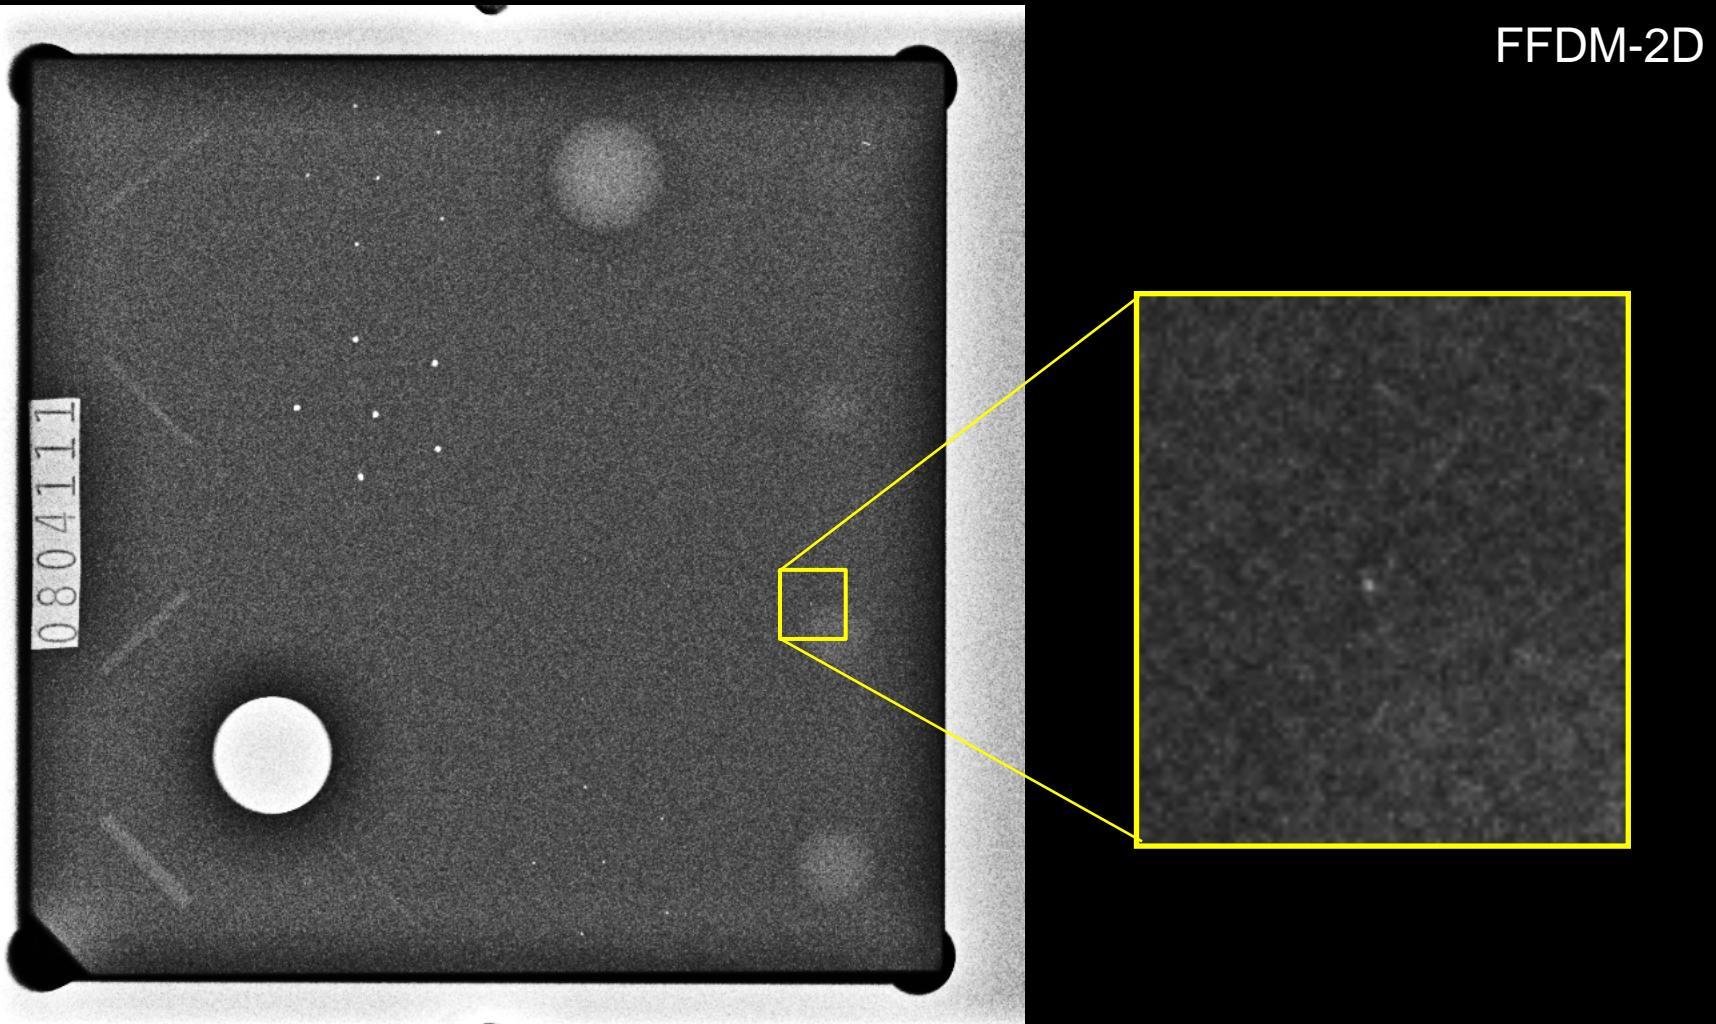
## • Cause:

### Dead pixel

• Troubleshoot by re-imaging phantom in a different location on the detector or perform an artifact test

Dead pixels may be either minus or plus signal

## Resolution:

Map out dead pixel (service function)

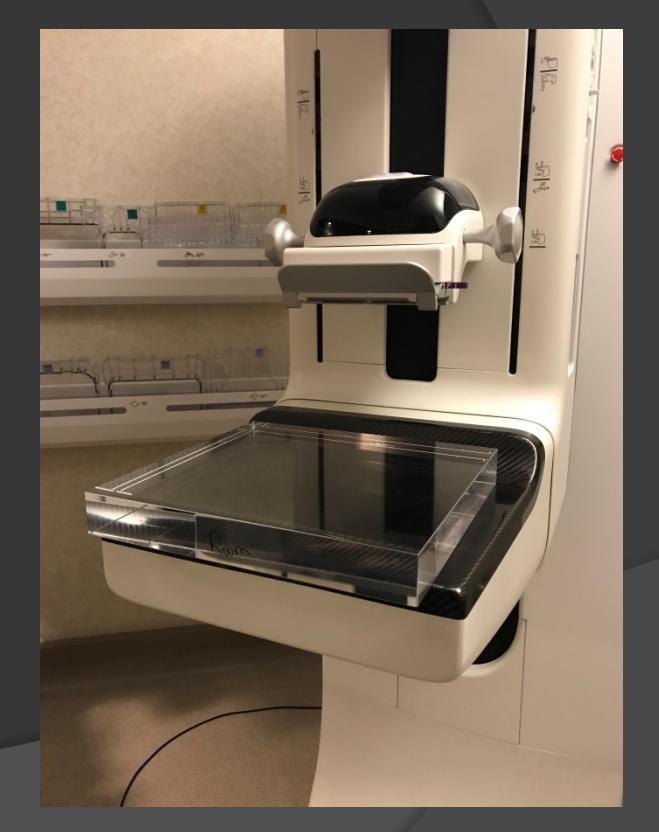
# **Dead Pixel Removal**

Map is created that replaces the specified pixel value with the average of surrounding pixels

- Manufacturer test method
  - Uniform phantom
  - Acquire image with typical clinical technique
  - View image with specified W/L
  - Repeat for different anode/filters and mag mode

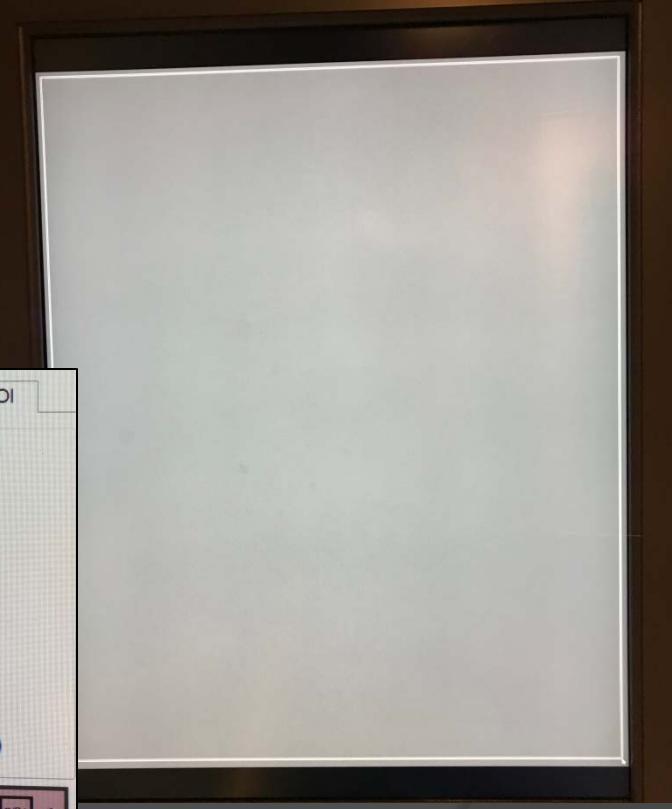
Zoom and pan image looking for artifacts
 Use ROI utility if available

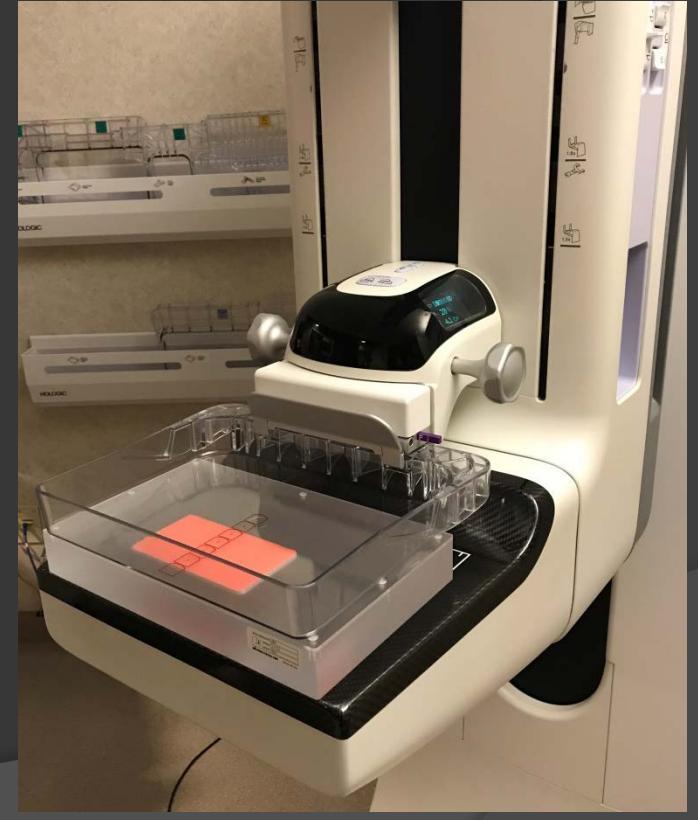
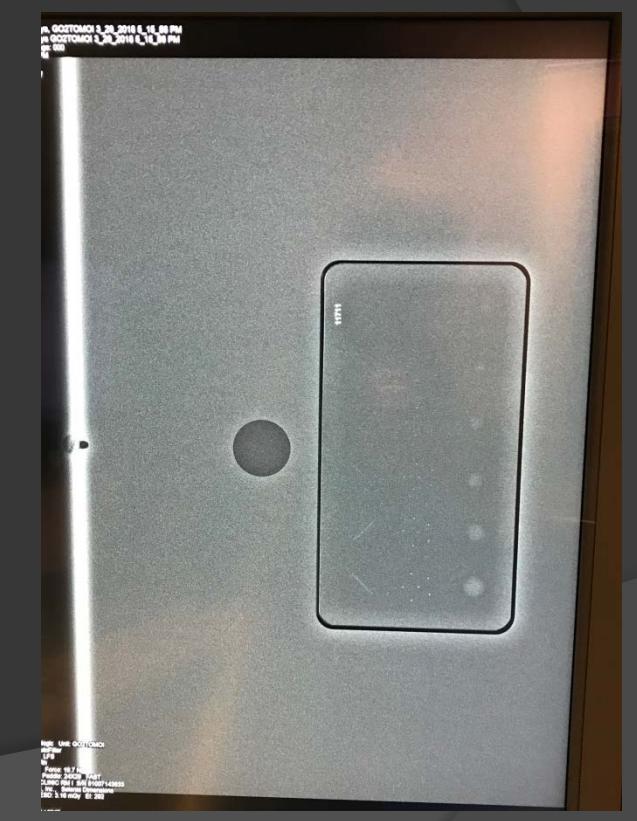
- 2016 ACR Digital Mammography QC Manual
  - Artifact evaluation part of phantom IQ test

- W/L to optimize visualization of test objects
- View as entire phantom
- View as full resolution (1 display pixel = 1 image pixel)
- Repeat for other anodes/filters, mag mode

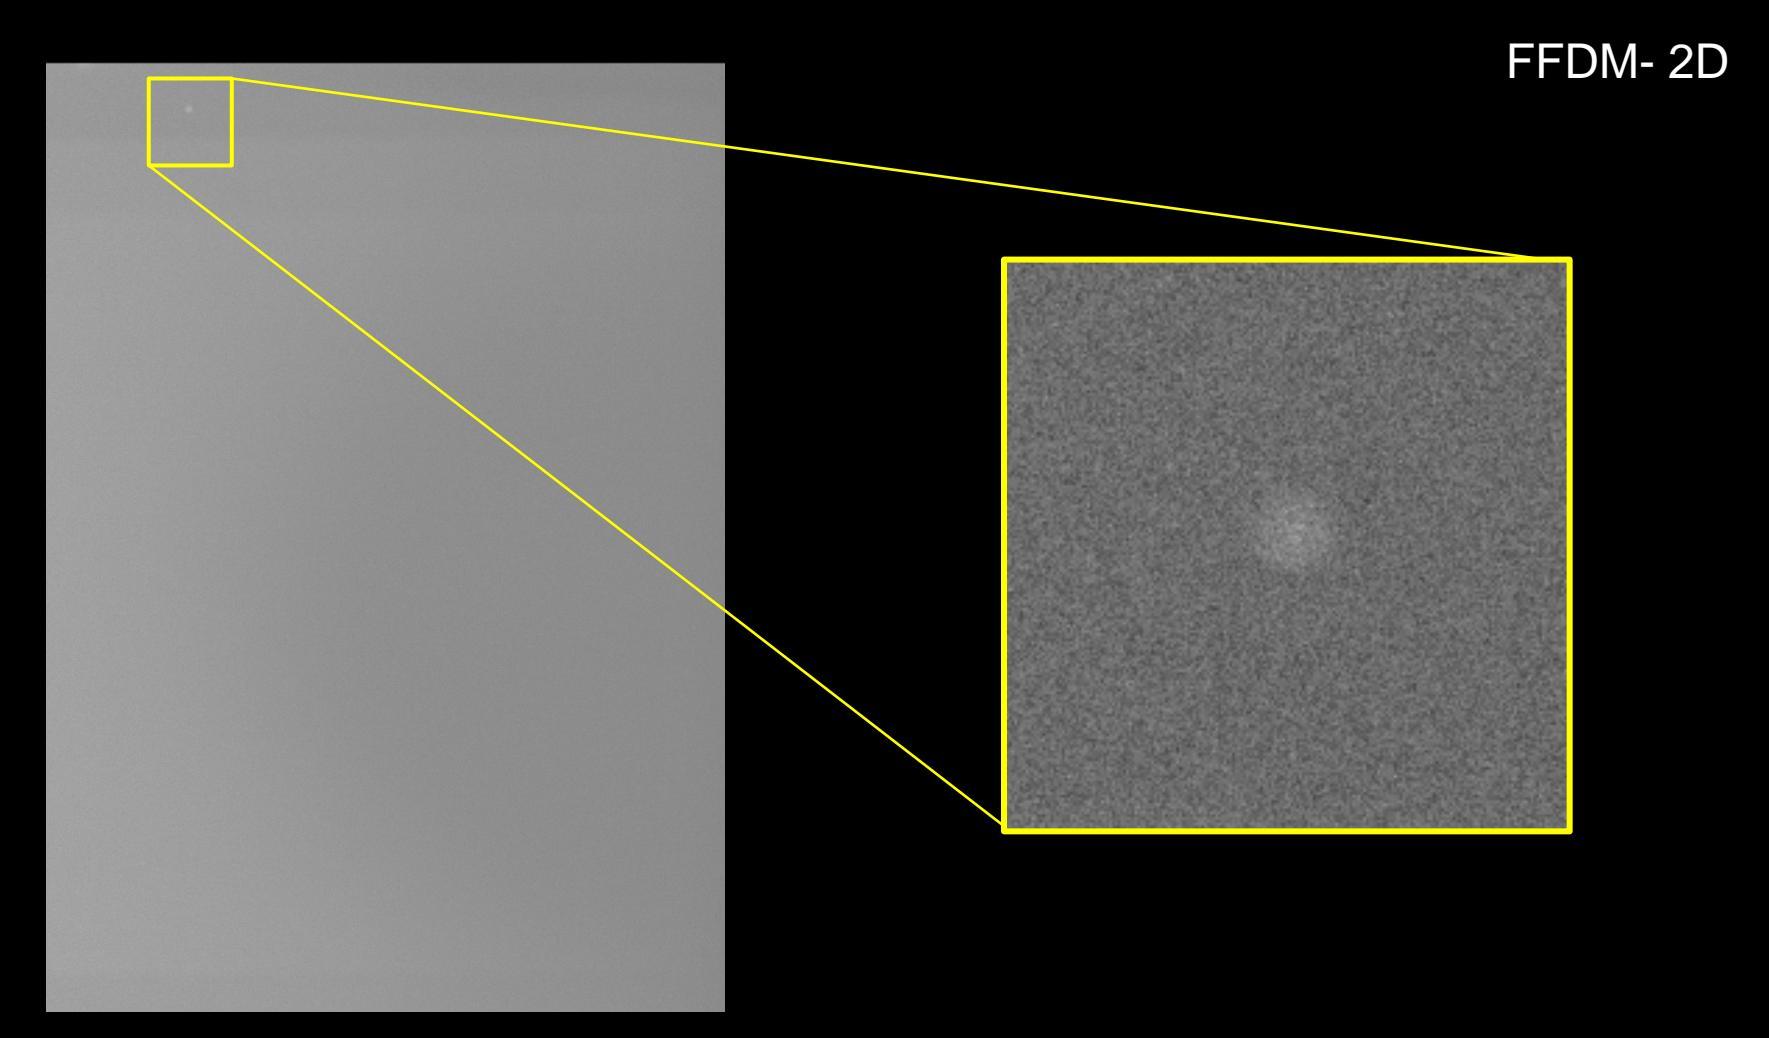
## Cause:

• Dead pixel cluster with averaging correction applied

## Resolution:

- Adjust pixels included in the averaging correction in the dead pixel map (service function)
- If cluster is large, replace detector

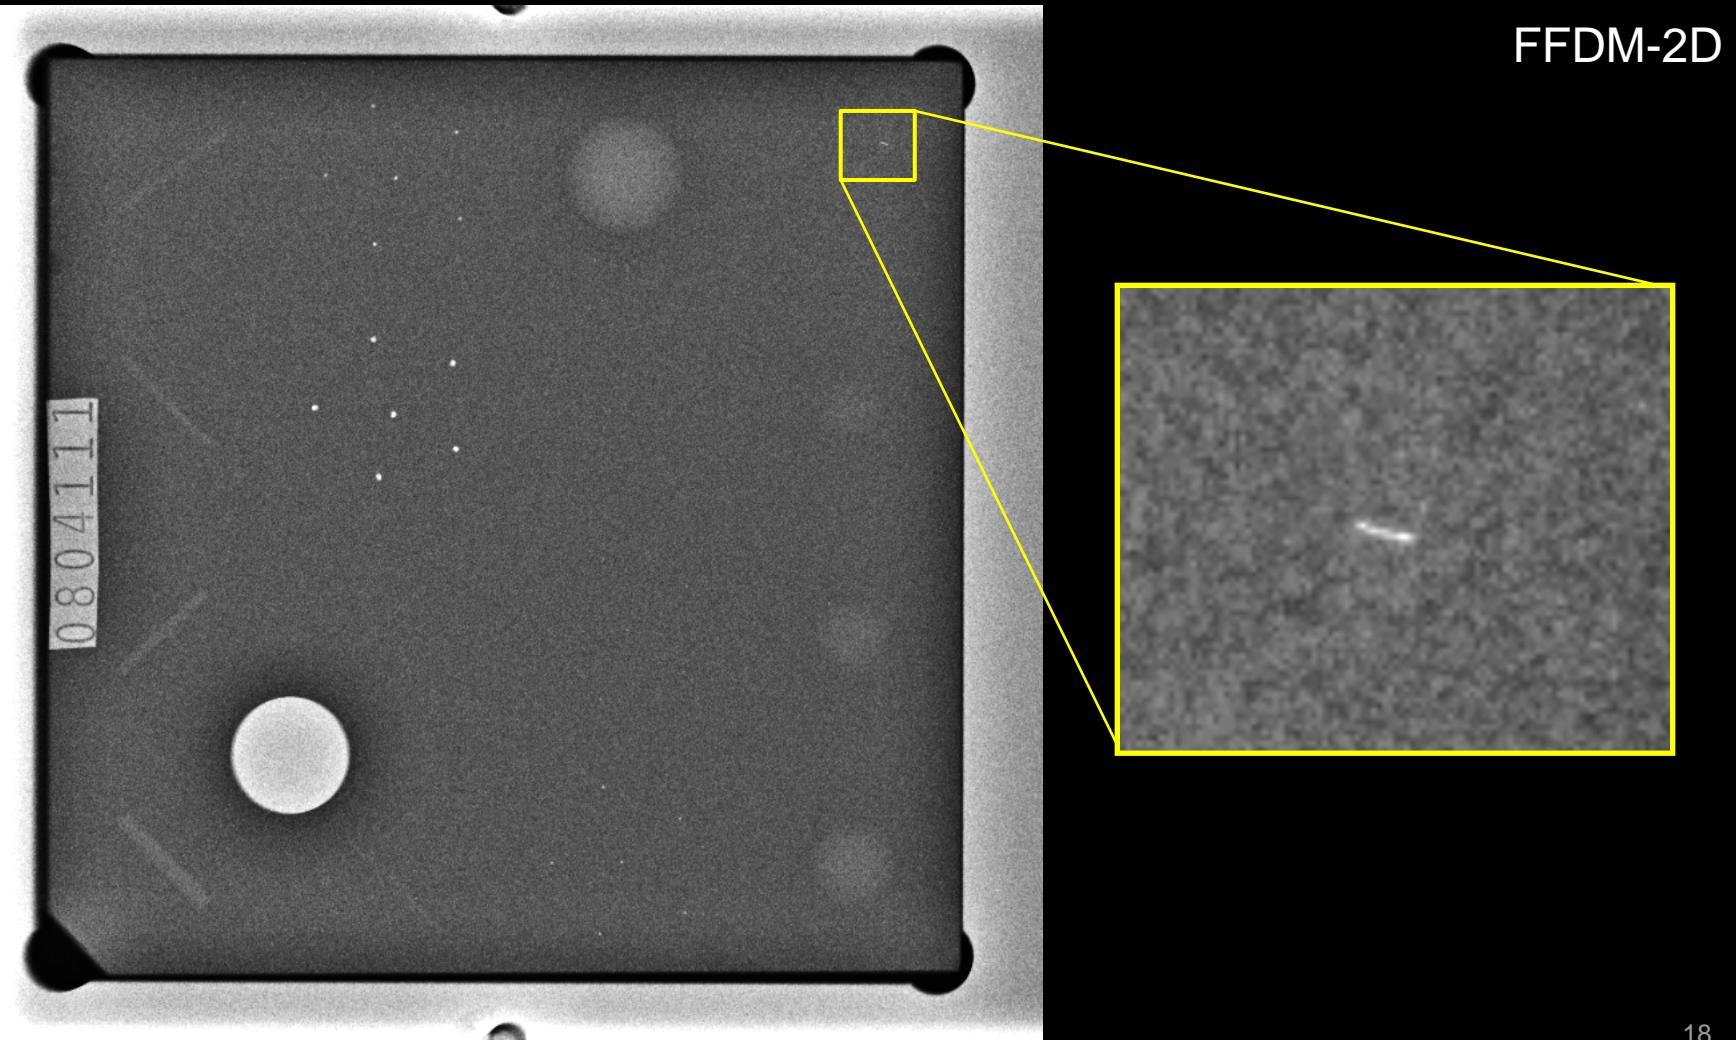
## Cause:

- Debris embedded in MammoPad breast cushion attached to phantom
  - Troubleshooting: If an artifact moves with the phantom, debris on phantom or wax insert is likely
- Resolution:
  - Replace MammoPad

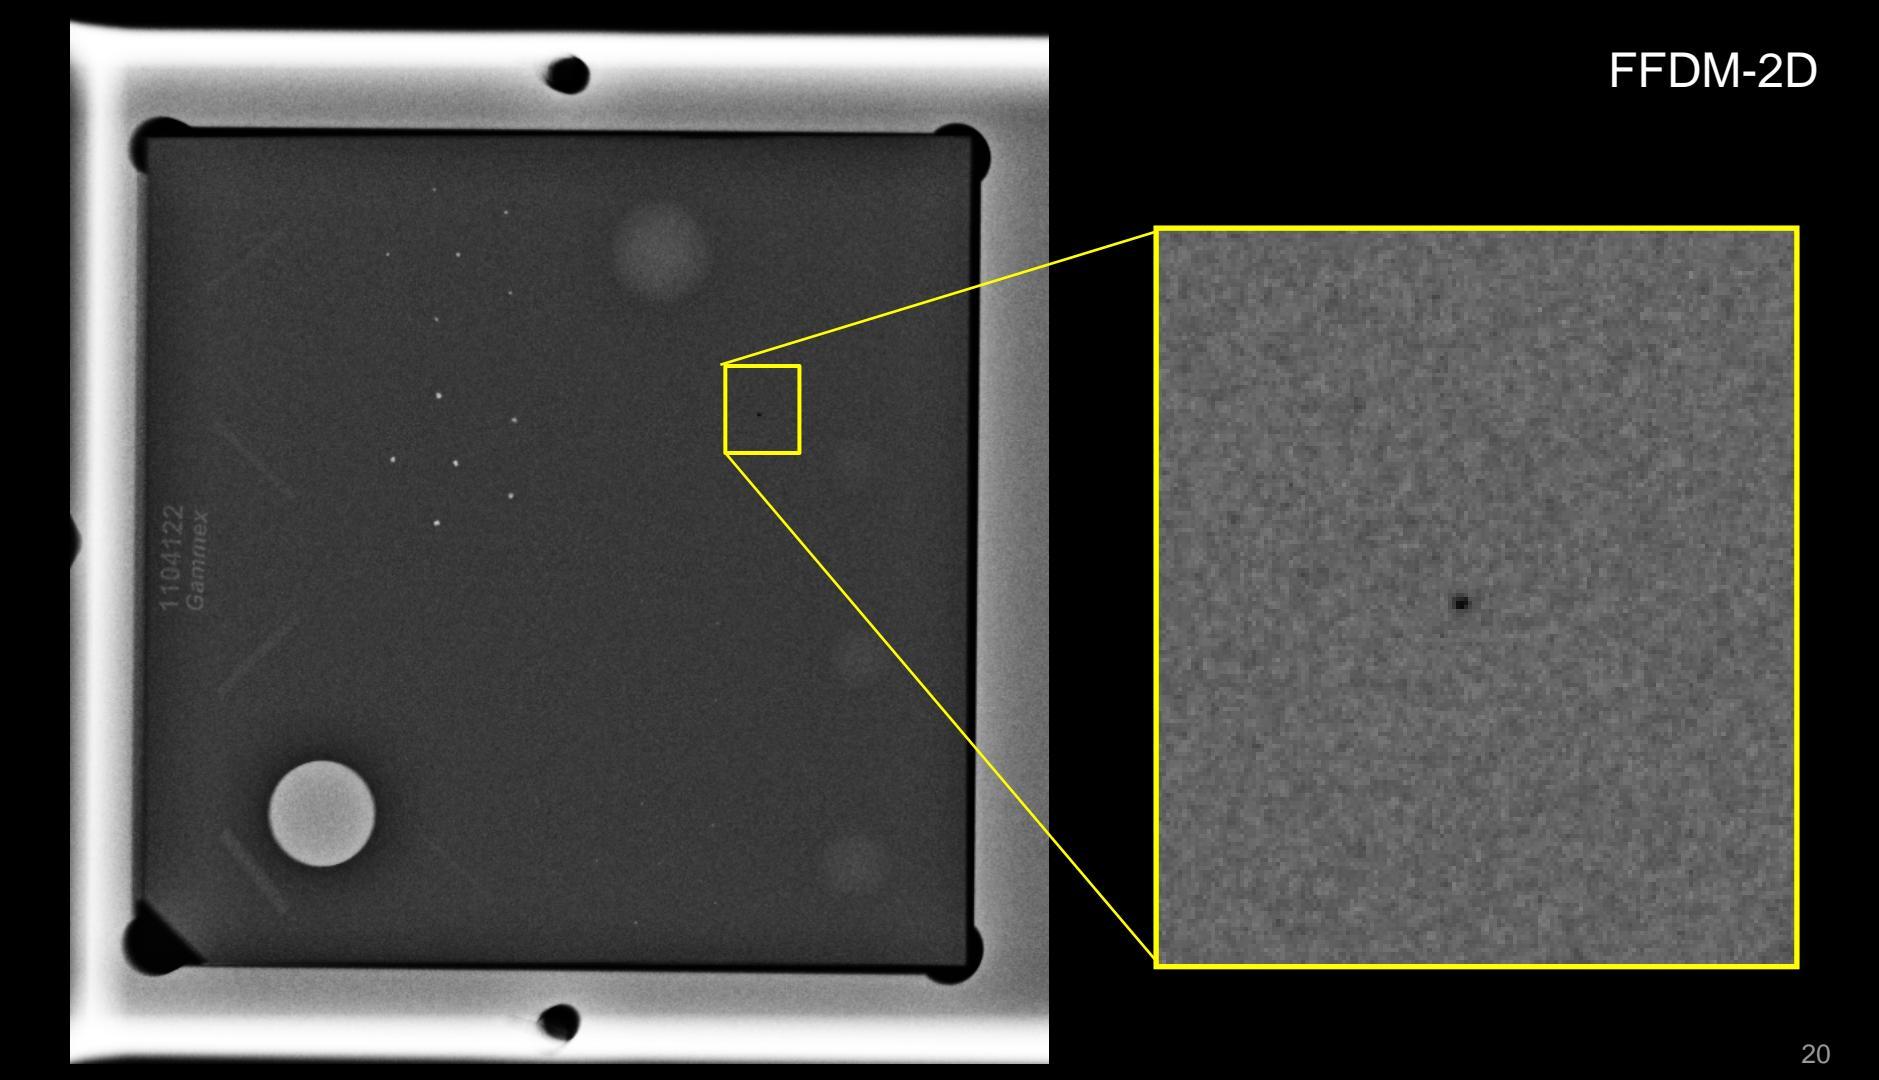
## Cause:

Debris on phantom during gain calibration resulting in a plus density artifact

## Resolution:

- Recalibrate detector
  - Ensure phantom and detector cover are clean
  - Carefully review flat field images acquired during gain calibration

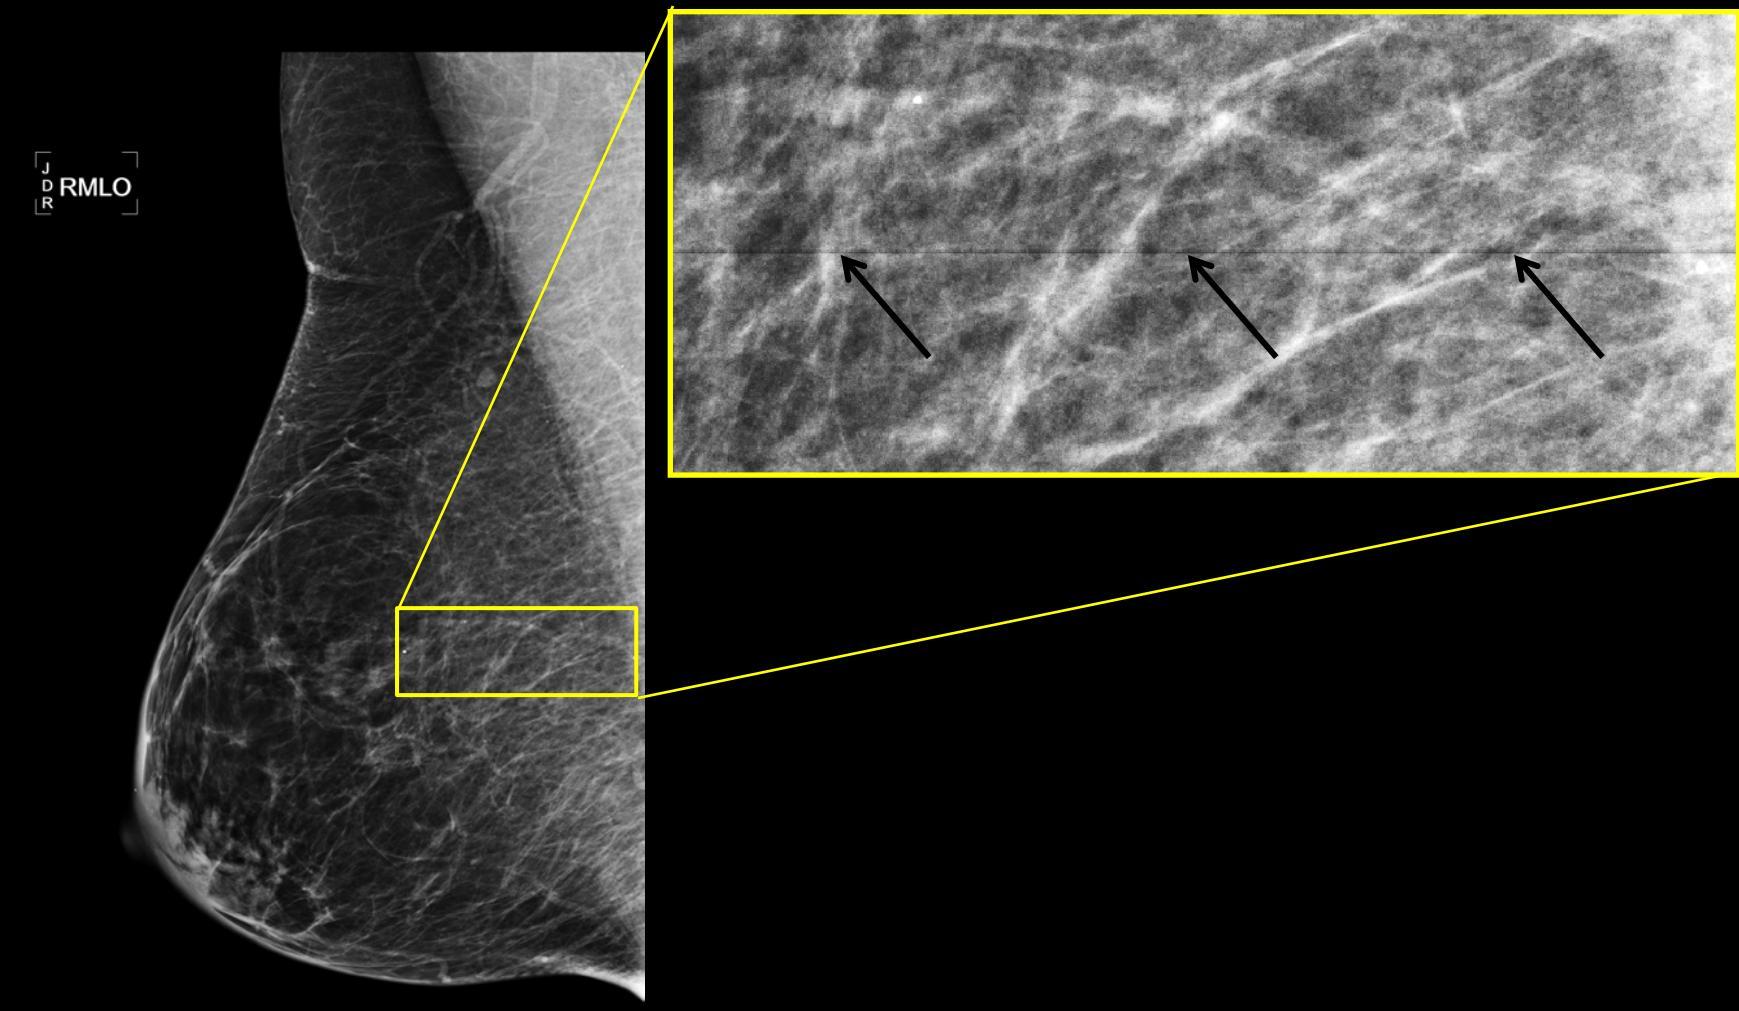
## • Cause:

Dead line in detector

## Resolution:

Map out dead line (service function) or replace detector

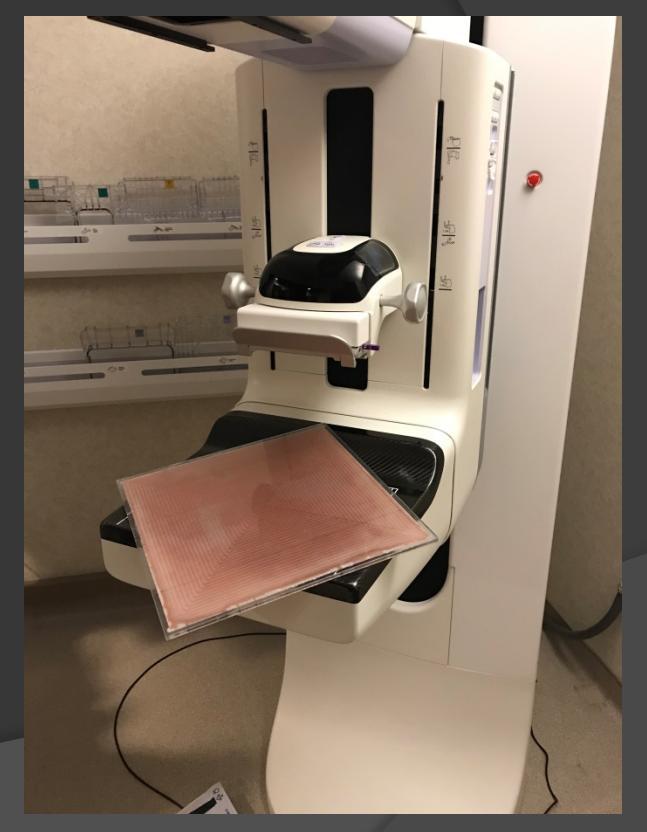
# **Dead Line Artifact Detection**

- Image mesh at 45 deg angle (screen-film contact test tool)
- Corrected dead lines are visible as discontinuities in mesh

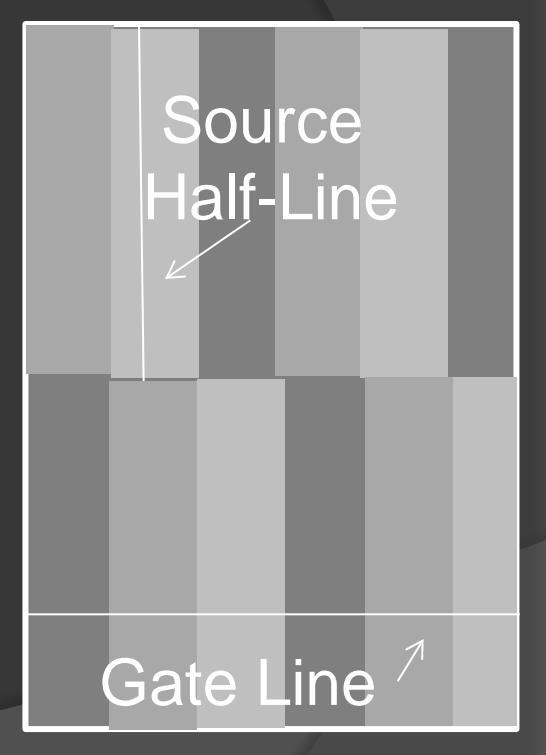
# Dead Pixel/Line Specification

## DirectRay Detector

- < 80 defective clusters (contiguous dead pixels)</li>
- < 20 defective lines (gate line or source half-line)
  - No adjacent defective gate lines
  - No more than 2 adjacent defective source half-lines
- < 3397 defective pixels</p>

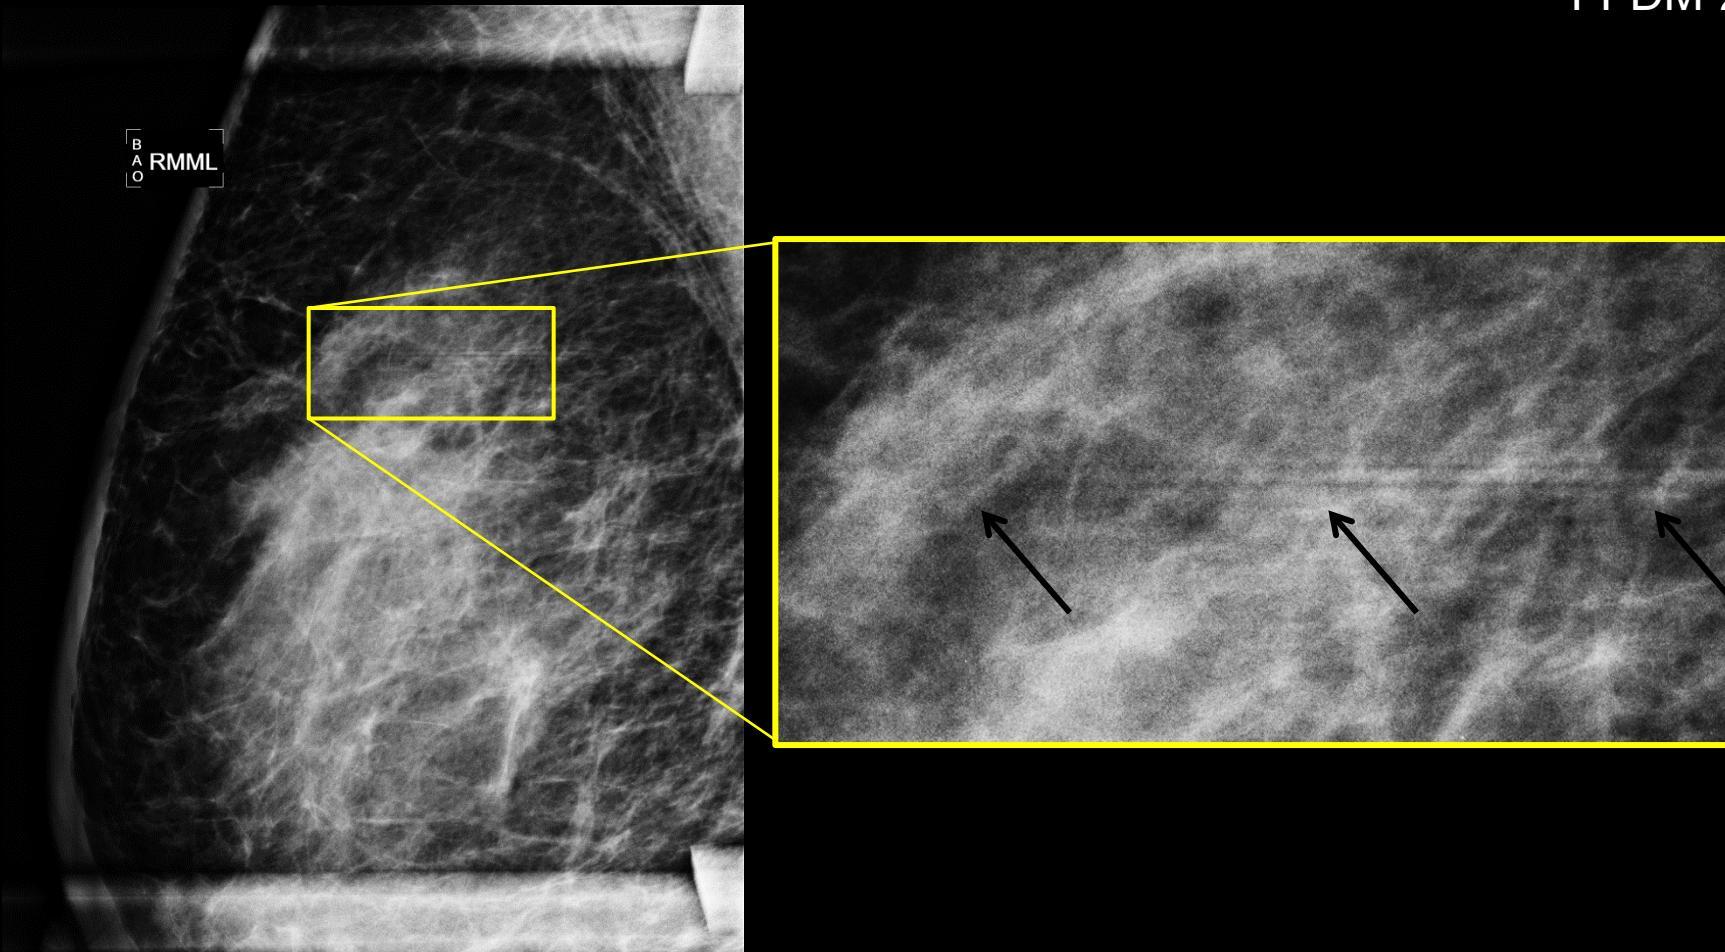
## • Cause:

- Intermittent electromagnetic interference
- Resolution:
  - Eliminate cause of interference
    - Replacement of the high voltage supply resolved this particular case
    - Other references attribute artifact to
      - cooling fans (Ayyala et al, Radiographics 2008)
      - external magnetic fields from an adjacent transformer (Jiang et al, AAPM 2017)

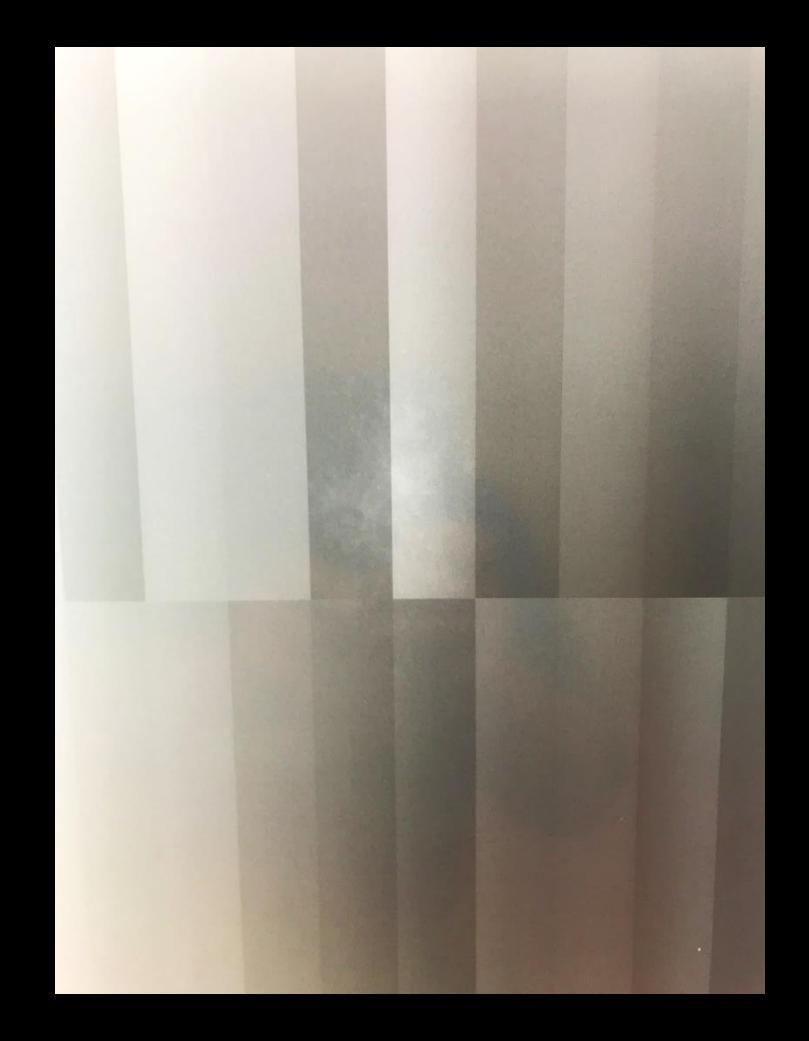
## • Cause:

• Degradation of detector array coating

## • Resolution:

Replace detector
