The Art of the Image: The Identification and Remediation of
Image Artifacts in Projection Radiography, part II

Alisa Walz-Flannigan, Ph.D. DABR
Mayo Clinic, Rochester, Minnesota
Walzflannigan.alisa@mayo.edu

American Association of Physicists Meeting, Indianapolis
8/7/2013

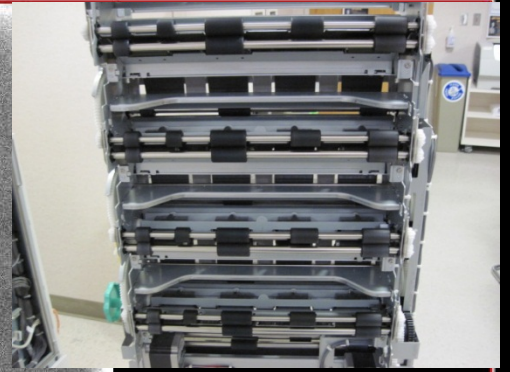
Roller damage

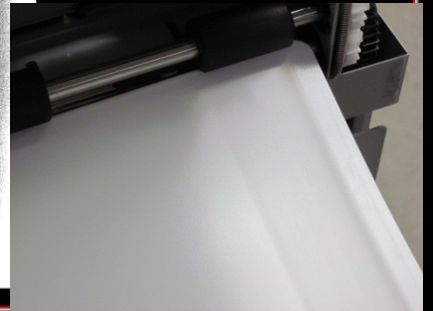
Wear marks

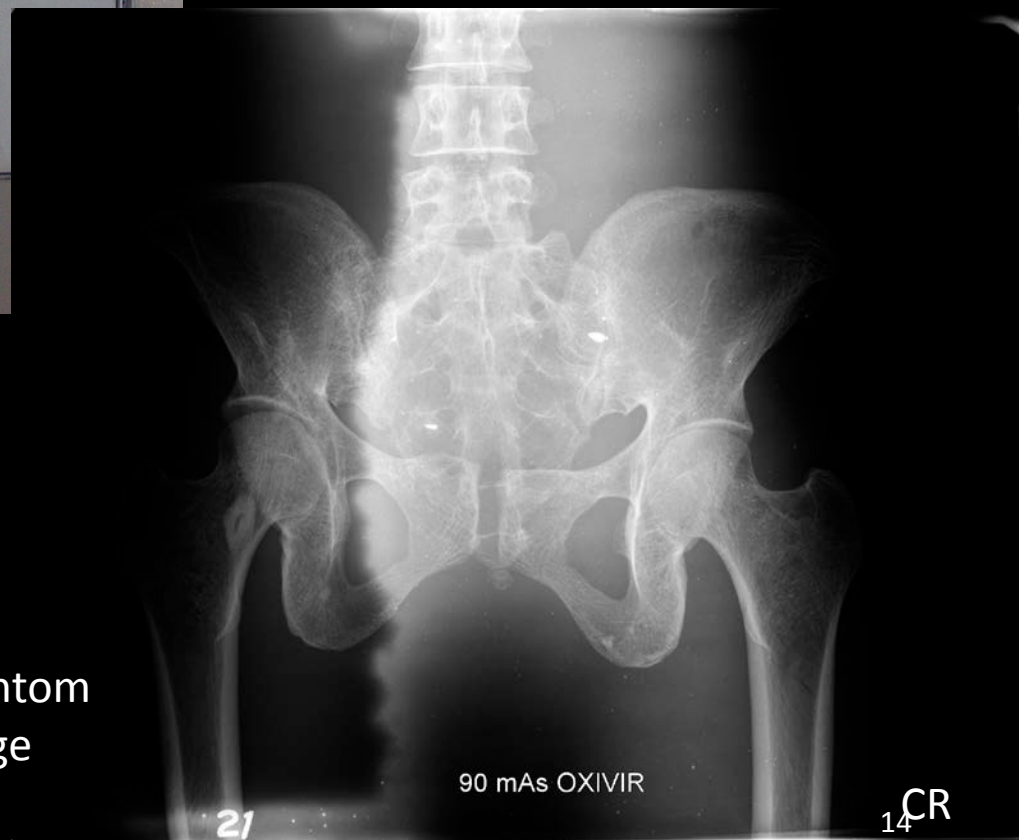
Dead line

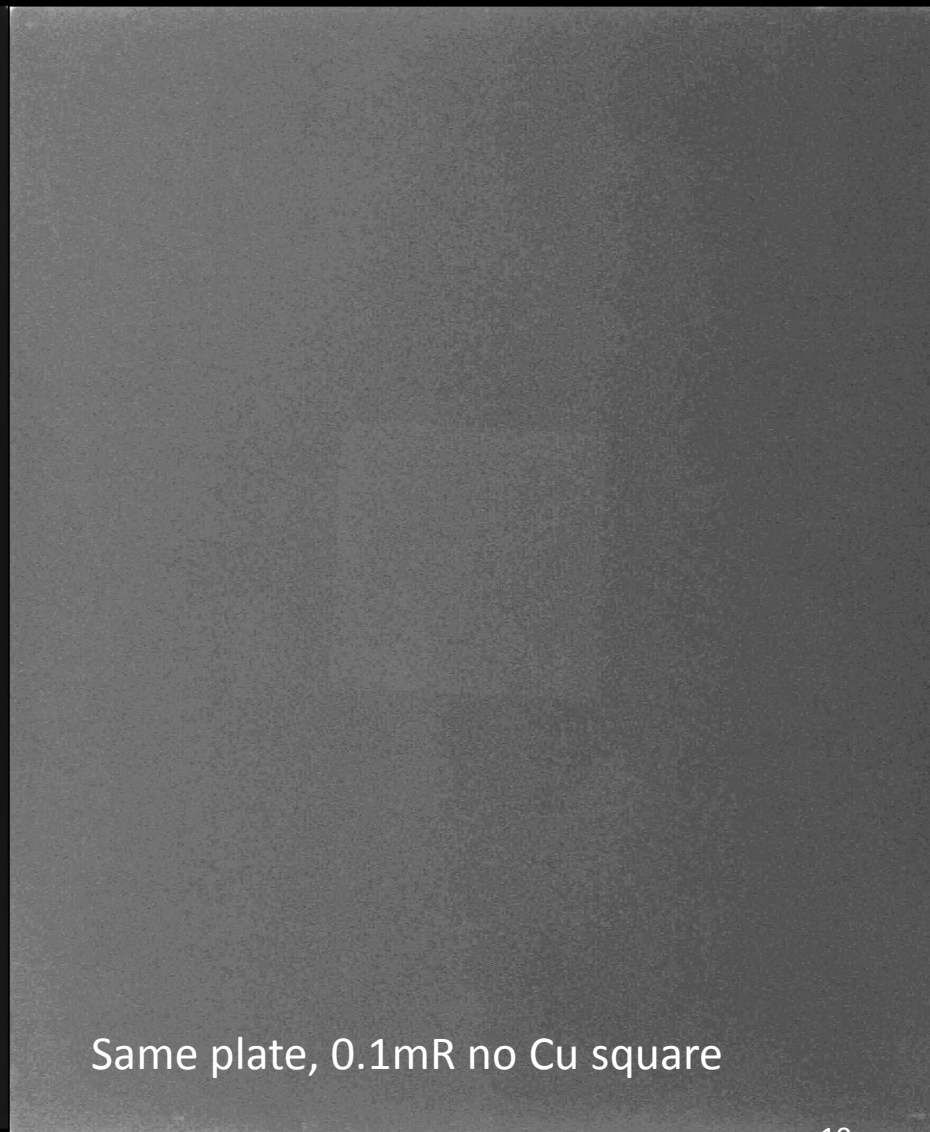
50mR with Cu square

Latent image test for that reader

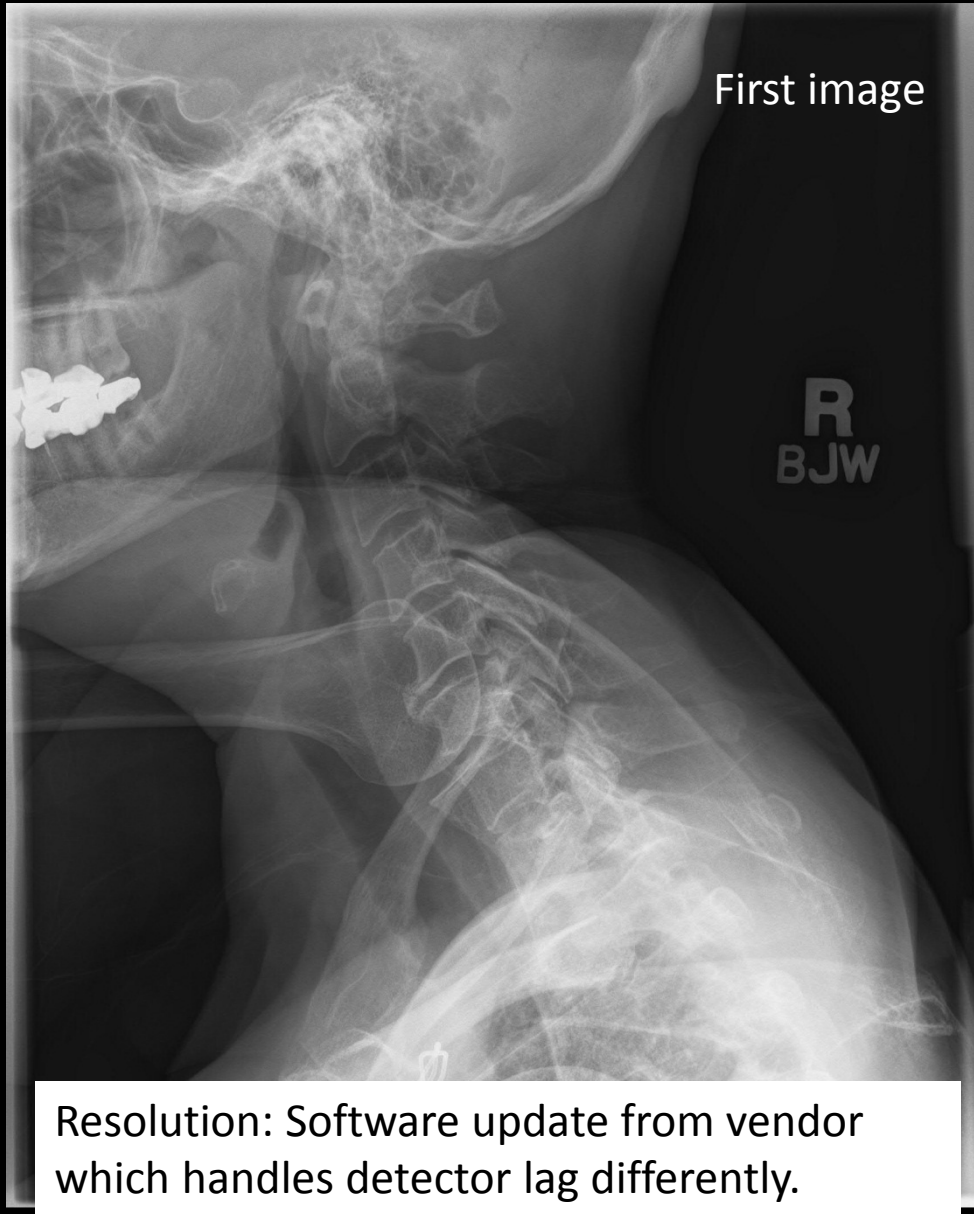
Inverse of DR Lag; Lag signal is recorded in signal offset map.

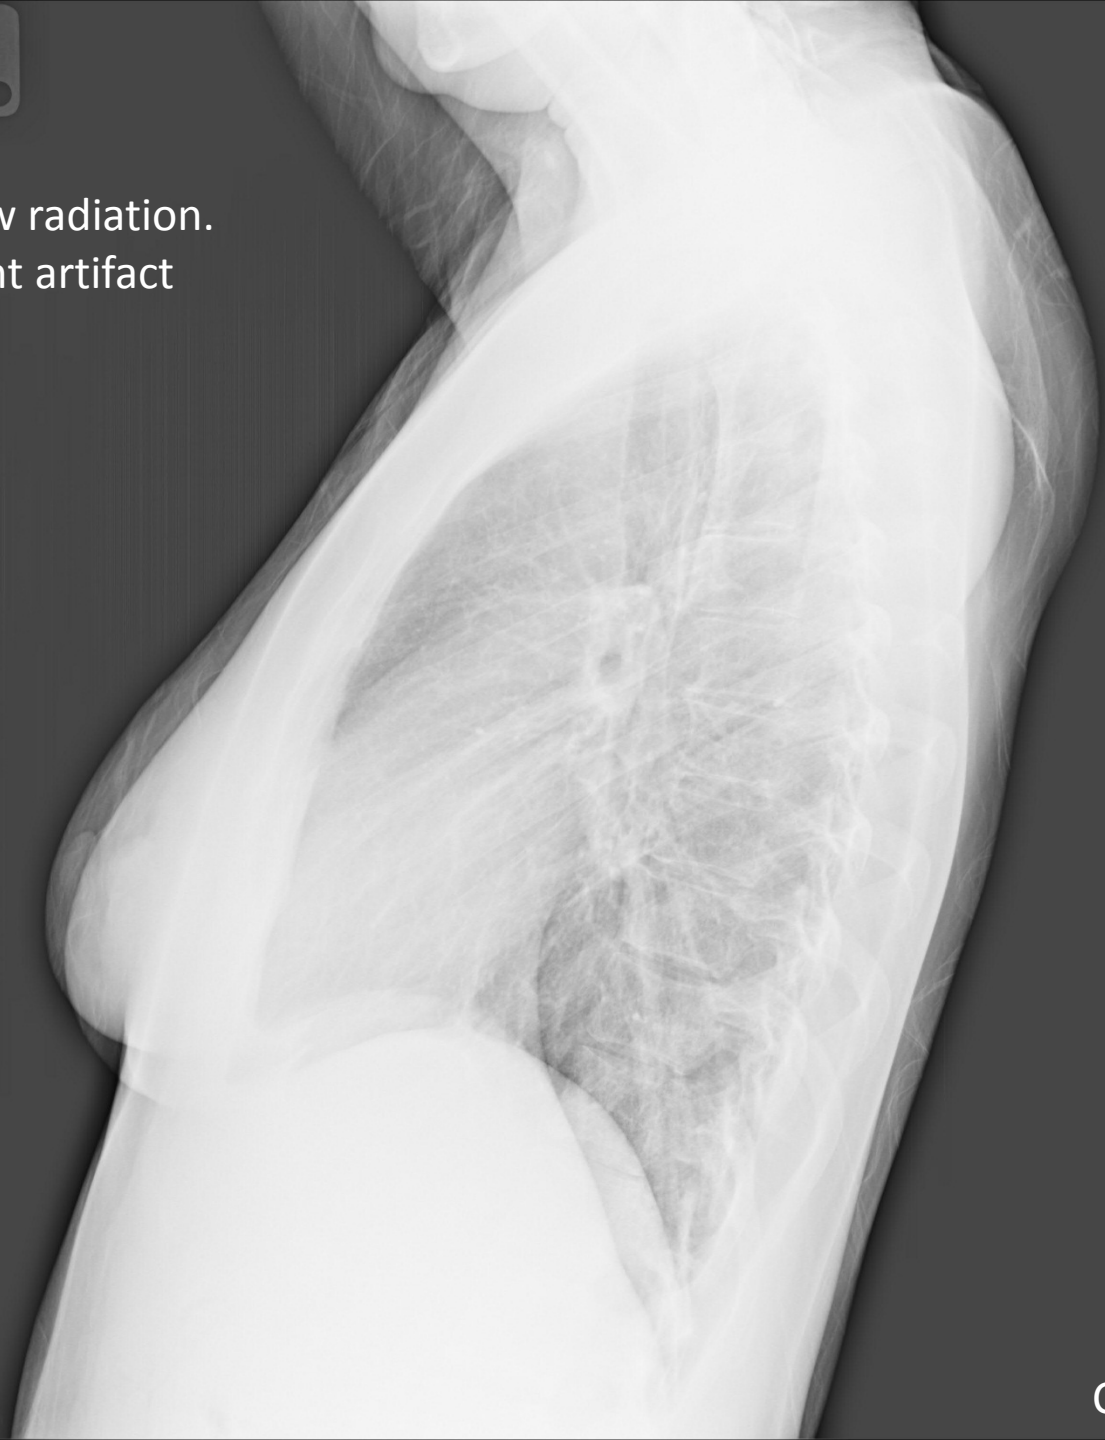
Structure visible in raw radiation.
Not a clinically relevant artifact
